A Center-Mounted Fuel Tank for GM C/K Pickup Trucks

Kennerly Digges

Automotive Safety Research Institute

ABSTRACT

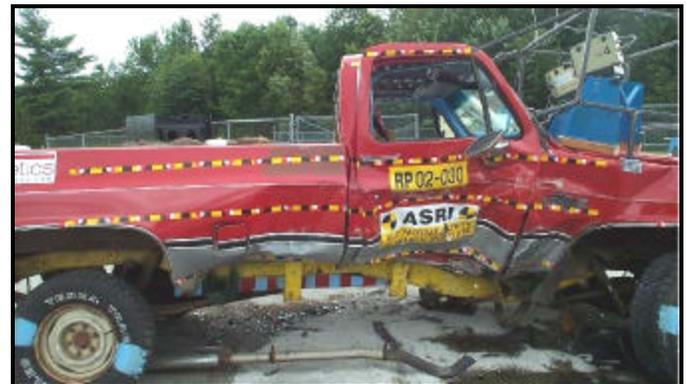
Figure 5: Typical pickup truck damage following a collision from a Caprice.

The similarity in the test set-up and input conditions resulted in similar vehicle kinematics. Following contact with the truck, the front end of the bullet vehicle was pushed downwards under the truck, lifting the truck up and carrying it in the direction of impact. The resulting damage to the vehicles, from test to test, was also similar (see **Figure 5**).
