RESEARCH TO EVALUATE SAFETY TECHNOLOGIES FOR VULNERABLE FUEL TANKS

Kennerly Digges

Paper Number 230

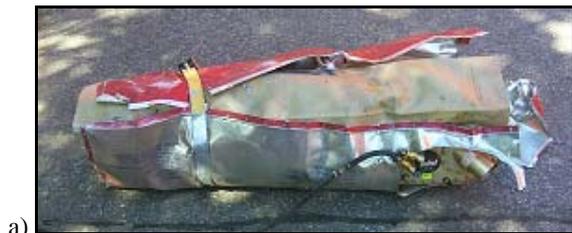
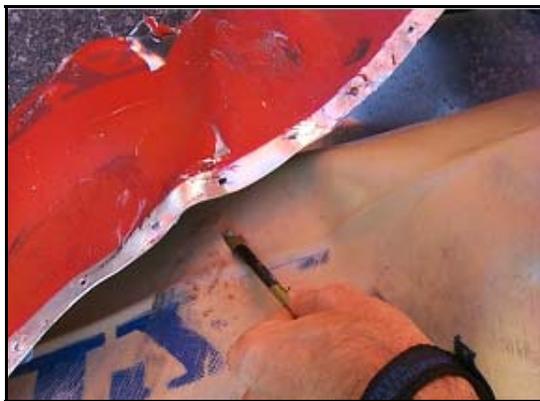
In the first test, the outer container of the fuel cell consisted of a riveted aluminum enclosure held in place by two steel brackets that supported the tank from underneath. During impact, the outer casing ripped open from a combination of direct loading from the bullet vehicle and from hydrodynamic pressure from the expansion of the internal bladder that was compressed between the vehicle frame rail and the bumper of the bullet vehicle.

Figure 8. Damage to the fuel cell aluminum housing (a) cut in fuel cell caused by sharp aluminum surface (b)

With the aluminum container ruptured, the fuel cell inside was ejected from the truck. In the process, all the fuel lines connected to the tank were severed. The

filler tube was disconnected from the tank, but a reverse flow flapper valve in the tank prevented spillage at the filler spud. Additionally, a rollover valve on the vent line prevented fuel leakage from the severed vent hose. There were no provisions in the fuel supply line to prevent fluid loss in the event that the line was severed and consequently it leaked fuel. However, the majority of fuel spillage stemmed from a tear in the bladder that was discovered along its lower inside edge. The damage was caused by the rear mounting bracket/strap that failed during the impact and perforated the aluminum outer housing creating sharp edges on the inside of the housing that cut or punctured the bladder. The damaged aluminum cover and fuel cell puncture are shown in Figure 8.

A second fuel cell system was assembled addressing the shortcomings identified by the results of the first test. Enhancements to the second fuel cell included fabricating the outer housing from steel rather than aluminum with through bolts instead of rivets to secure the hosing cover and the end plates of the container. The mounting brackets, which previously supported the tank from underneath, were replaced with brackets from which the tank was suspended. The intent of the new bracket arrangement was to allow the tank to deform without being restricted by the mounting brackets. To prevent fuel leakage from severed fuel lines, self-sealing breakaway connectors were installed on the fuel delivery and returns lines. As with the previous fuel cell, the vent line relied on an internal rollover valve.

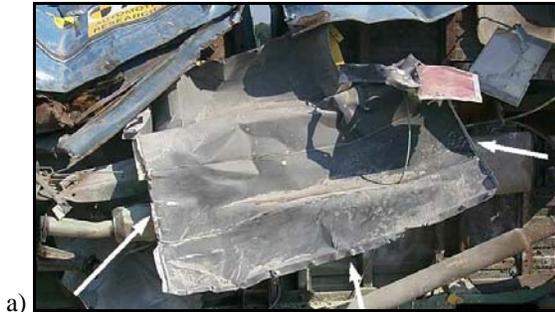
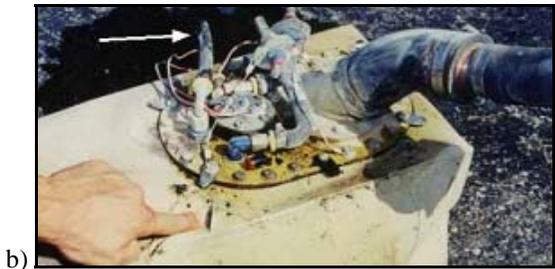
Despite the enhancements to the outer container and the mounting system the tank bladder was again ejected during the impact. The bolts that fastened the outer container together pulled through the sheet steel and the outer container unraveled allowing the bladder to be ejected. The top cover of the container tore along the rear-mounting bracket adjacent to the bladder bulkhead, resulting in a sharp pointed corner that perforated the top surface of the bladder.

In the process of being ejected the breakaway connectors on the fuel and return lines disconnected as intended and no leakage resulted. The vent line was severed, but no leakage occurred due to the upright orientation of the tank. The vent line contained a rollover check valve located inside the tank. This valve was not exercised in the crash. The fuel cell laceration and the ruptured steel container are shown in Figure 9.

Figure 9. Steel housing for bladder [arrows show ruptured seam (a)]; cut in top of fuel cell [arrow shows sealed break-away fuel coupling (b)]

Fuel leakage was minimal following the crash although it was apparent that leakage from the puncture in the bladder would have been inevitable had the bladder been lying on its side rather than upright.

There are three grades of fuel cell bladders FT3, FT3.5 and FT5 offering increasing resistance to tearing and puncture. An FT3 bladder was used in both tests, therefore, by incorporating a higher rated bladder and by designing better protection for the bladder, it may be possible to improve its resistance to damage from direct exposure to slash or puncture hazards. Further research to improve the bladder was not initiated, because the alternatives for relocating the tank appeared to be more economical.

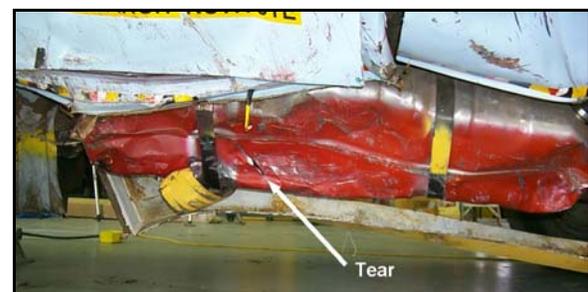
Notwithstanding the additional bracing of the rear support, neither the protective frame nor the vehicle structure to which it was bolted were capable of resisting the severe downward torque applied by the impacting vehicle, thereby, leaving the tank exposed and vulnerable to direct loading by the bullet vehicle. A significant tear in the tank resulted in excessive fluid loss. Damage to the tank and frame are shown in Figure 10.

Figure 10. Damage to the tank protective frame

A retest of the tank protection system was performed with a second system based on the initial frame except with two additional attachment points to specifically counteract the downward moment applied by the impacting vehicle. The front end of the guard was fastened vertically to the cab floor and

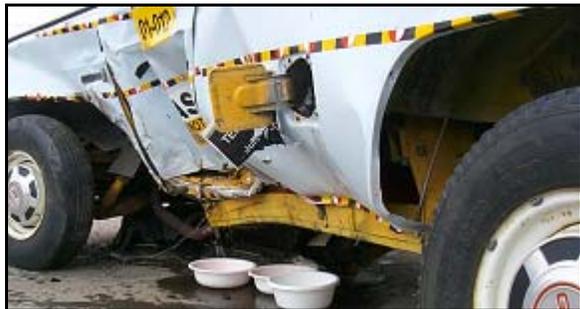
A plastic tank was installed for the second test instead of a steel tank as used initially. Despite the improved performance of the protective frame, the guard compressed the tank cutting the top outside front corner of the tank resulting in excessive fuel leakage. The damage to the modified tank protective frame is shown in Figure 11. The damaged area of the tank was not exposed directly to the impacting vehicle. Rather, the damage was likely caused by the truck's structure which intruded into the tank space.

Figure 11. Damage to the modified tank protective frame

Development of the tank protection system was discontinued because the system performed poorly, and it was heavy and costly.

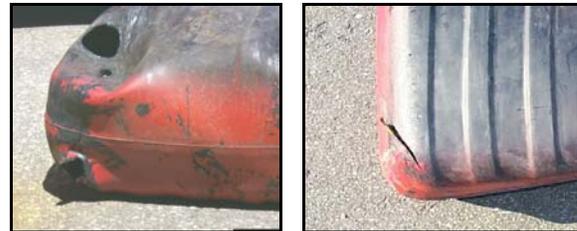
Tears in the tank, as a result of excessive deformation, were only one of the failure modes. Punctures and cuts from aggressive components on the truck itself or on the bullet vehicle were also prevalent. Damage to the tanks is shown in Figure 12. The available aftermarket plastic tank did not offer any improvements over the existing OEM steel tank. Considerable additional development appeared necessary for significant improvements. This approach was discontinued.

Figure 12. Puncture and slash damage to plastic tank

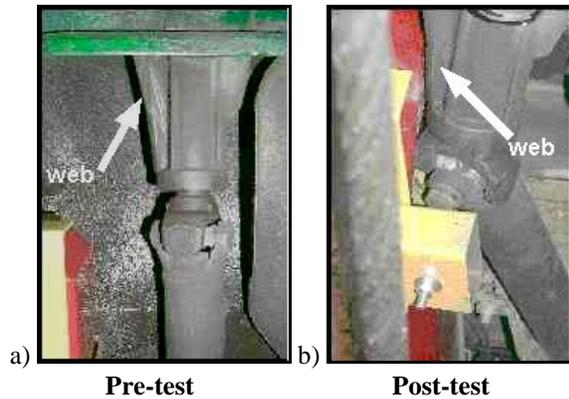
Relocating the tank between the frame rails reduces its vulnerability to side impact, but may increase vulnerability in some other crashes. In severe crashes into a rigid frontal barrier the engine and transmission move rearward. An aggressive web on one of the alternative transmission produced a leak in one frontal barrier test. In addition, the drive shaft may buckle in the direction of the tank causing damage. Figure 14 shows the location of the aggressive transmission web and the drive shaft relative to the tank before and after a frontal crash test.

Figure 14. Drive shaft and transmission clearance in severe frontal crash – before (a) and after (b)

The final center-mounted tank design addressed both of these undesirable loadings. The transmission contact was mitigated by increasing the tank to transmission clearance and by chamfering the corner of the tank to reduce the stress concentration when contact occurs. The drive shaft contact was addressed by maintaining OEM drive shaft clearance for center-mounted tanks and by positioning the tank brackets to resist drive shaft loading. The tank thickness of 1.52 mm. provided added protection compared with 0.86 mm. in the OEM tank.

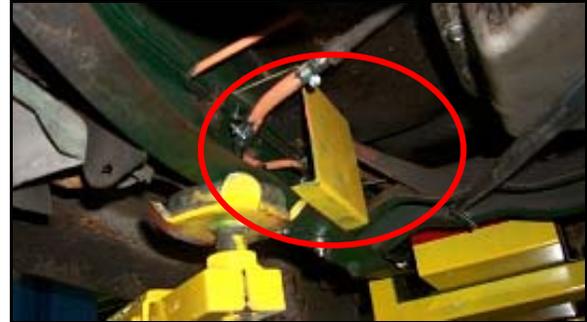
The Caprice impact produced extensive deformation to the pickup frame. In some cases the fuel lines and/or fuel selector valves were severed by being pressed between the inside of the frame and the engine. This problem was aggravated in one test in which the exhaust manifold had been removed. In that test, the fuel line was severed when entrapped

Figure 15. Shielding plate to protect fuel lines from entrapment by the transmission

between the frame and a flange on the transmission. To improve the survivability of fuel lines, a structural shield was added inside the frame to protect the fuel filter. The shield is shown in Figure 15. No fuel line ruptures occurred on tests with the shielding in place.

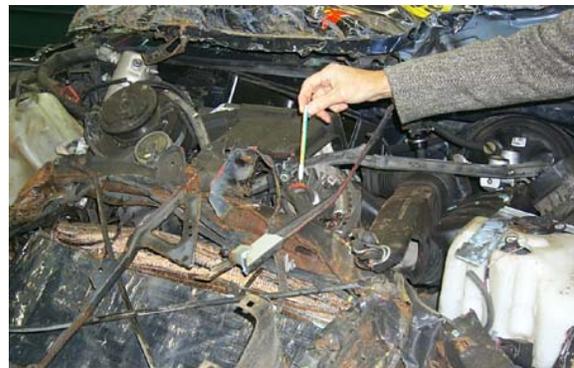
It was found that the front hood of the bullet Caprice was peeled away in the side impact tests exposing many sharp edges. Figure 16 shows the protruding alternator and other sharp edges that scraped the bottom of the pickup tank in a crash test. These hard points may have contributed to the tear in the OEM tank shown in Figure 10. For the center-mounted tank, the hard points resulted in scraping and minor gouging of the tanks. However, no leakage occurred from this source in any tests of the center-mounted tank.

Figure 16. Caprice engine compartment after test showing hard points that contacted the fuel tank

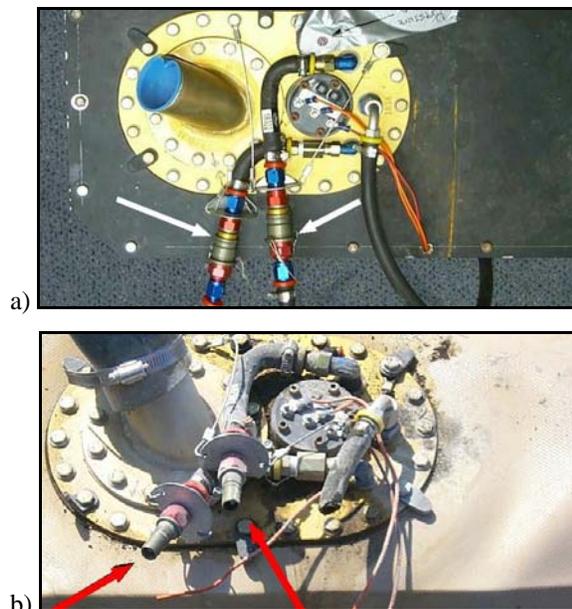
Self-sealing breakaway connectors were installed on the fuel delivery and returns lines on the racing fuel cell. In a Caprice test, the fuel lines connectors disengaged and no leakage occurred. The self-sealing breakaway connectors are shown in Figure 17 before and after the test.

Figure 17. Self-sealing break-away couplings in fuel line before test (a) and after test (b)

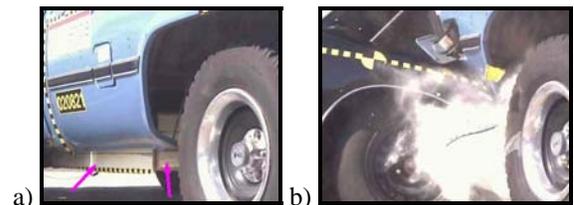
The fire suppressant panels that were affixed to the tank fractured during the test and a cloud of fire suppressant powder could be seen in the video engulfing the underside of the truck. The fire panels can be seen in Figure 18 before the initiation of impact and after the release of the fire suppressant has begun.

Figure 18. Fire panels installed on the fuel cell [see arrows in (a)] and the initiation of the cloud of fire suppressant during impact (b)

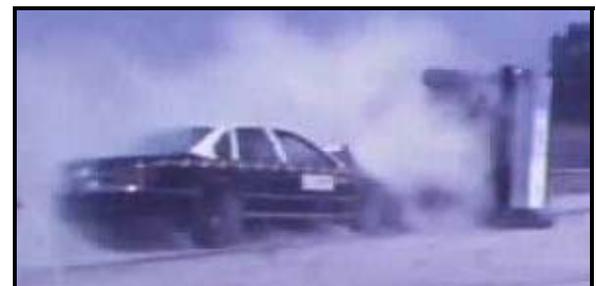
The suppressant cloud remained for the duration of the impact event and was still present approximately 3 seconds after impact when the truck rolled over, at which time forward movement of the vehicles had ceased. The suppressant cloud, immediately after the truck rolled onto its side, is shown in Figure 19.

Figure 19. Fire suppressant cloud immediately after the truck rollover
