VEHICLE BONFIRE TO INDUCE CATASTROPHIC FAILURE OF A 5,000-PSIG HYDROGEN CYLINDER INSTALLED ON A TYPICAL SUV

FINAL REPORT
Consisting of 28 Pages

SwRI® Project No. 01.06939.01.005
Test Date: September 14, 2006
Report Date: December 14, 2006

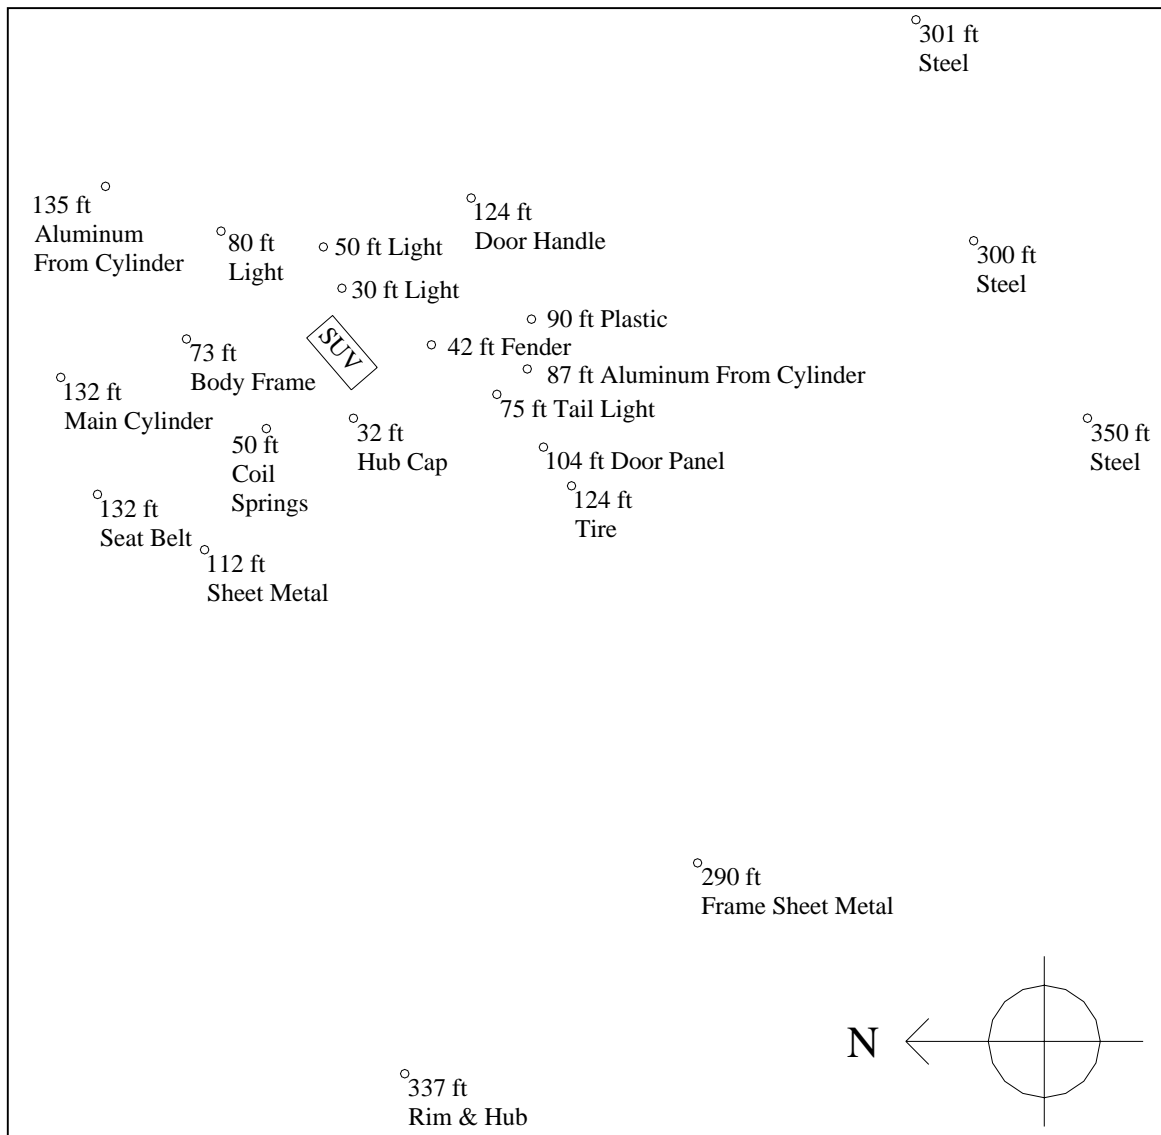
Figure 2. Locations of Various Parts Following Explosion.

Various parts of the cylinder, vehicle, and bonfire system were strewn about the test site in all directions, up to 350 ft away. Figure 2 shows the location of the major components found around the test site. The main portion of the cylinder, thrown approximately 132 ft northward, weighed approximately 105 lb (48 kg). The portion of steel thrown approximately 350 ft southward of the test location weighed approximately 5 lb (2.3 kg).

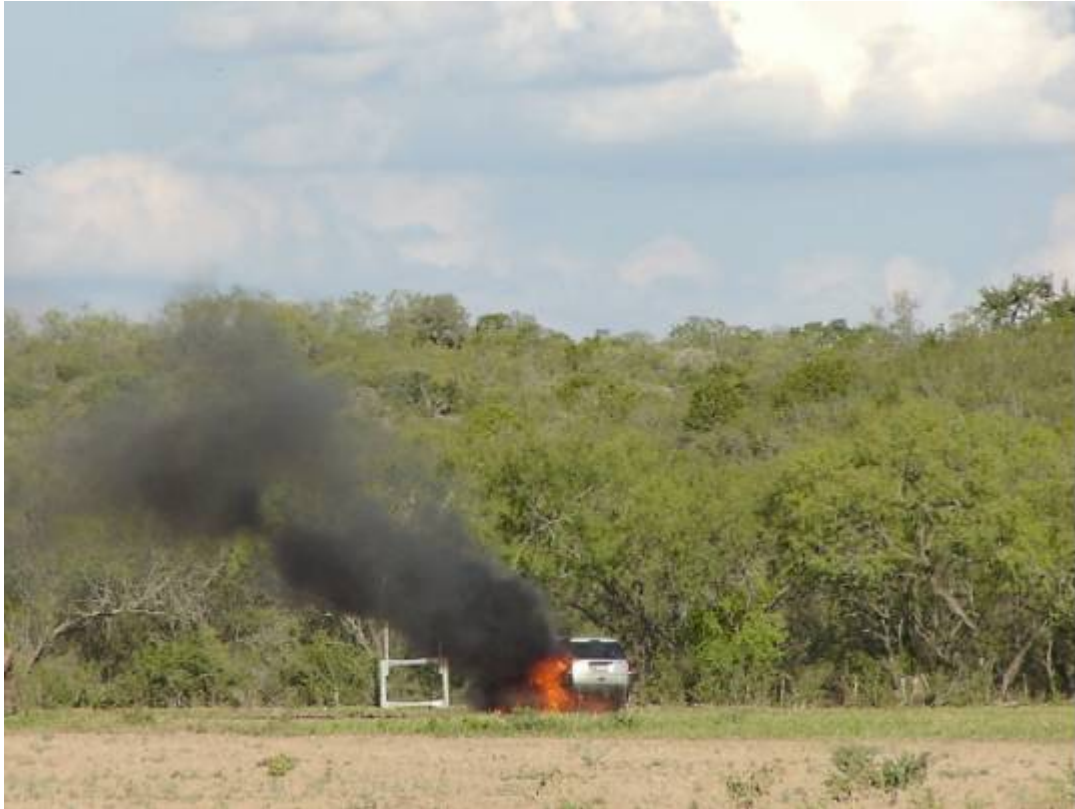
Figure B-5. Increasing Involvement of Automobile, Approximately 5 Min of Exposure.

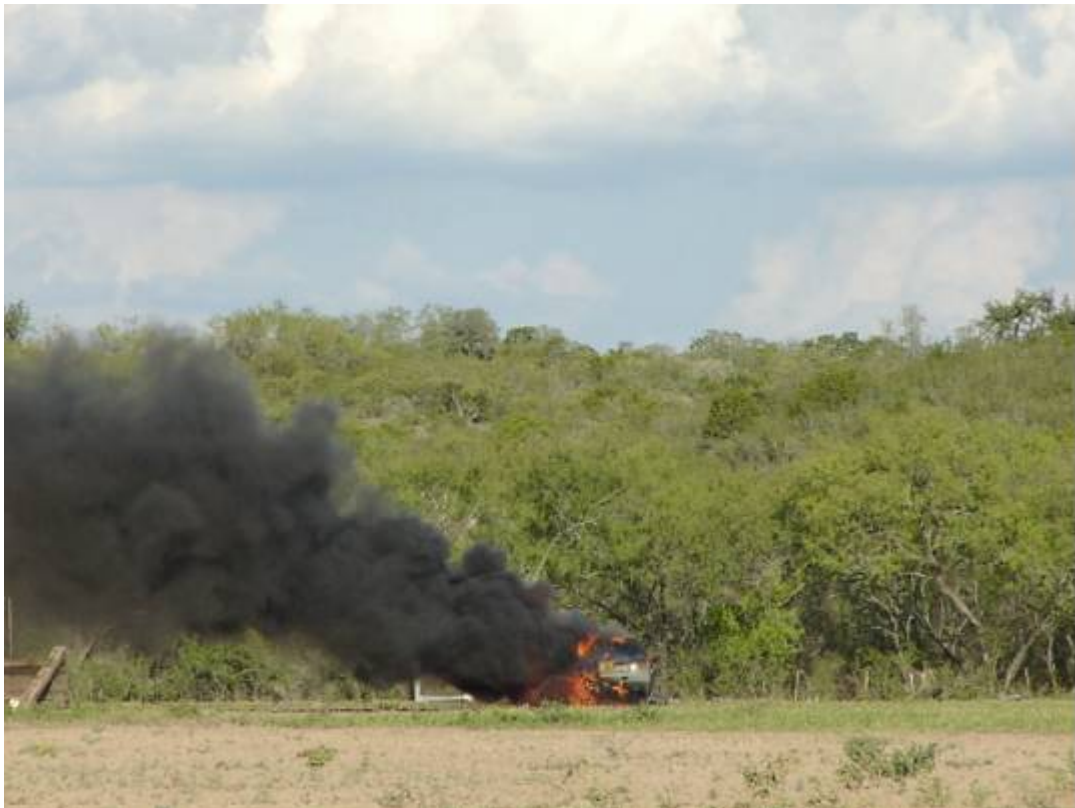
Figure B-6. Full Engulfment of Vehicle, Approximately 10 Min of Exposure.

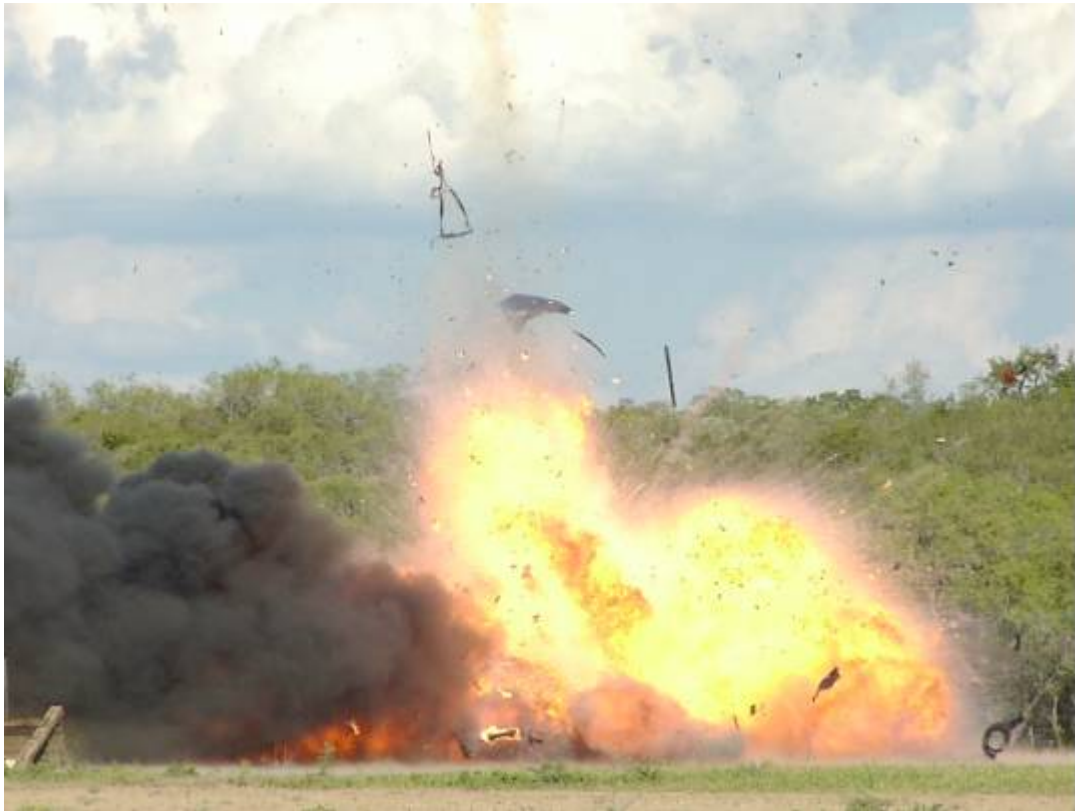
The hydrogen cylinder failed after 12 min 18 sec of exposure, destroying the burnt remains of the automobile. The rear of the vehicle projected upwards and twisted counter clockwise and over the front half of the vehicle. As the rear of the vehicle twisted, the cylinder projected horizontally (northward) out of the top of the vehicle. The vehicle rotated clockwise about 90 degrees. A trail of aluminum liner fragments of various sizes was left in the path of the cylinder to its final resting place, 132 ft north of the explosion.

Figure B-7. Explosion of Cylinder, After Approximately 12 Min of Exposure.

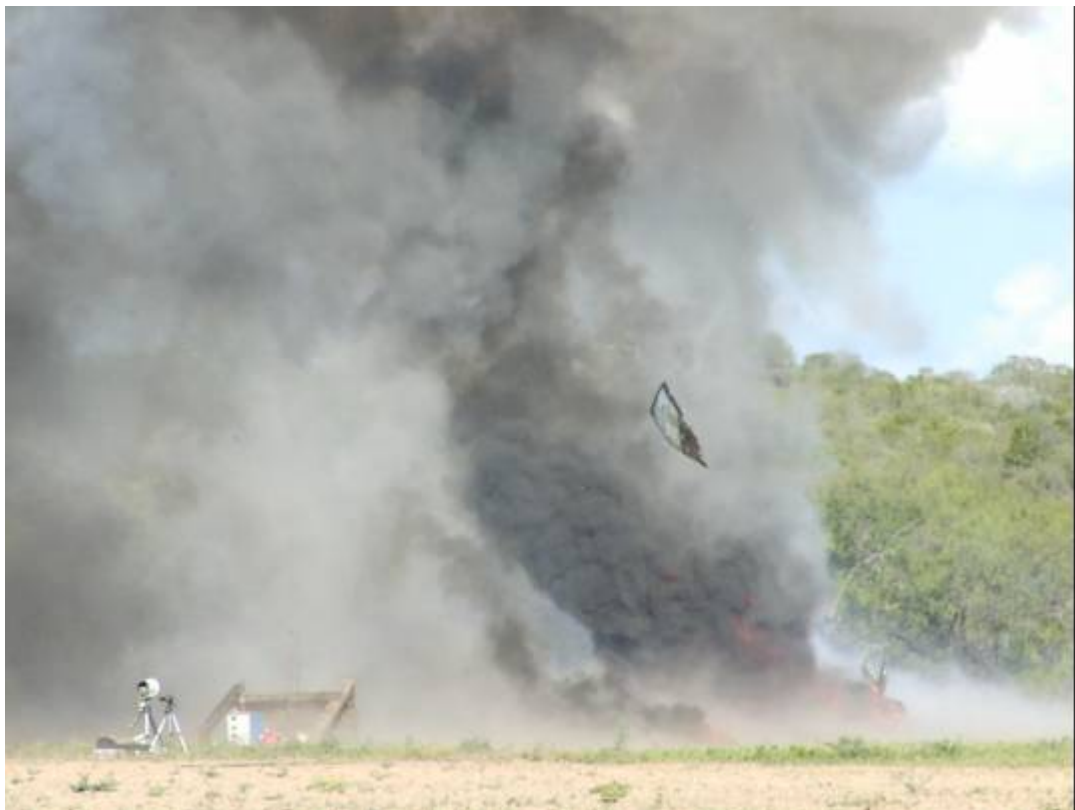
Figure B-8. Smoke Following Explosion, Parts Returning to Ground.

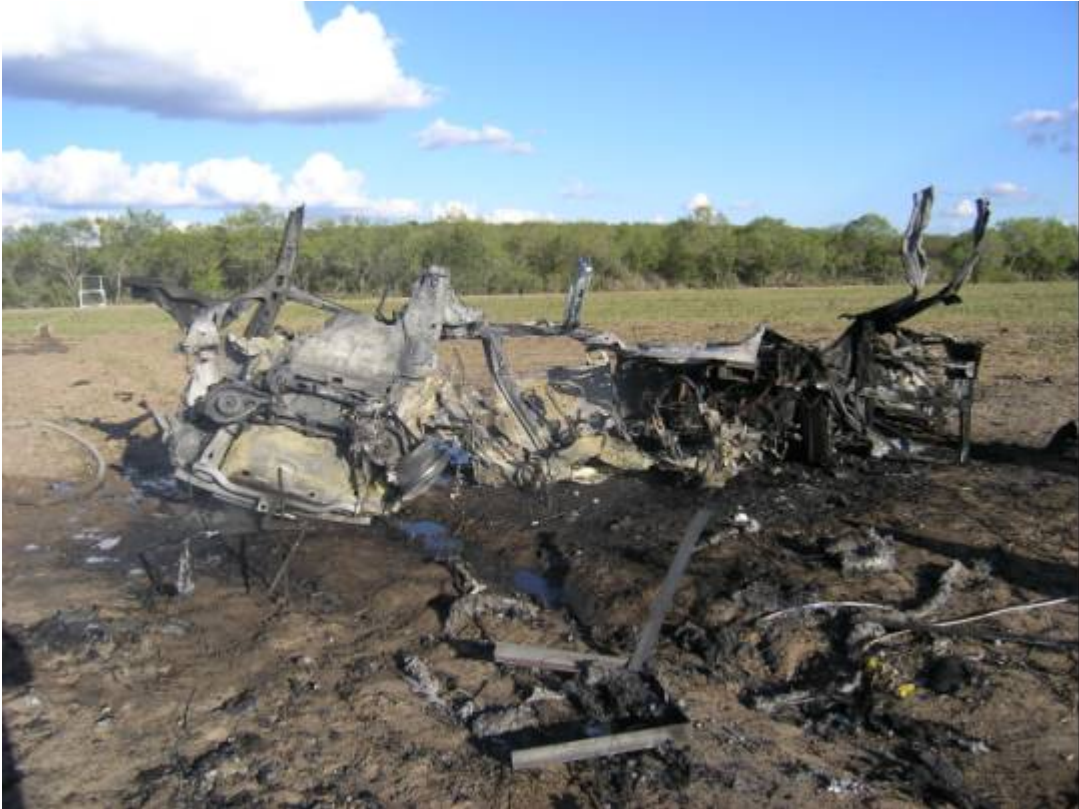
Figure B-9. Remains of Vehicle Following Explosion.

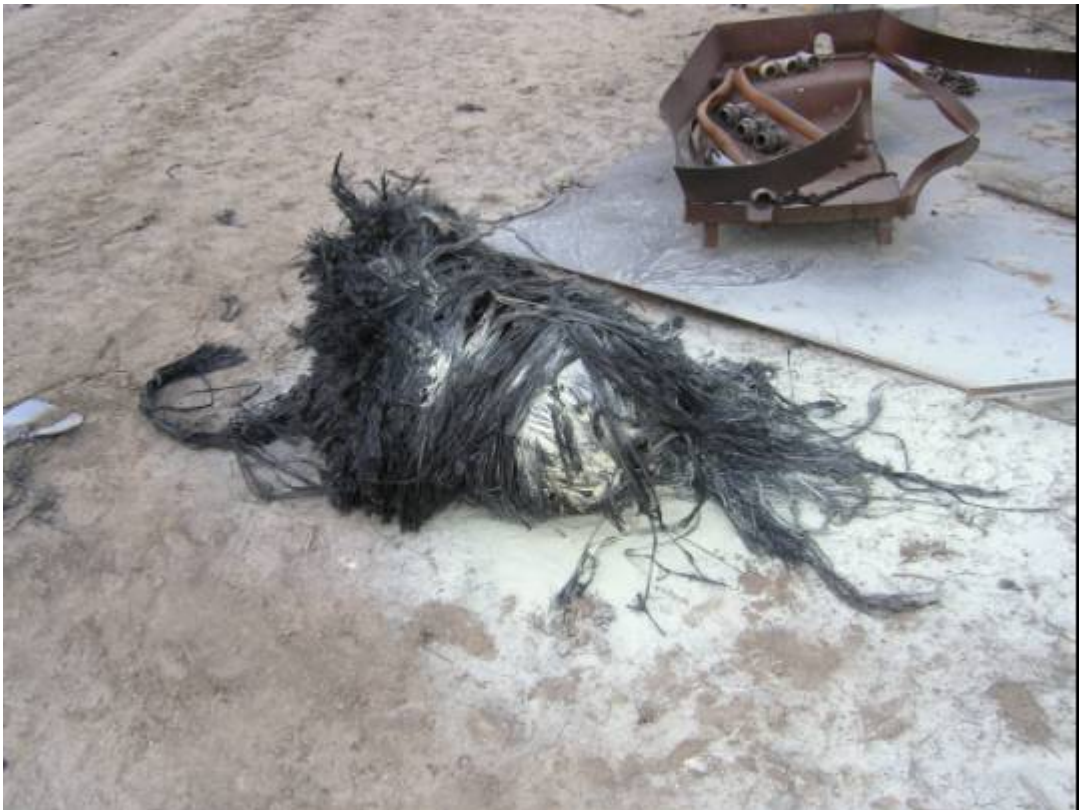
Cylinder failure was apparently due to deterioration of the carbon fiber layer directly in the exposure area. Once sufficiently weakened, the remaining carbon fiber and aluminum cylinder could not withhold the internal cylinder pressure. Post-test investigation found no evidence of melted aluminum prior to cylinder rupture.

Figure B-10. Remains of Cylinder.

In this experiment, a properly working temperature-activated pressure relief device located on the cylinder presumably would have been activated to prevent rupture. However, in the most extreme case, a pressure relief device might prove ineffective when a cylinder is exposed to a localized source of heat or flame, although more time may be required for catastrophic failure to occur. The incorporation of one or multiple layers of thermal insulation with a debris shield might delay or prevent catastrophic failure of a compressed hydrogen cylinder exposed to a flame source as observed in this test.

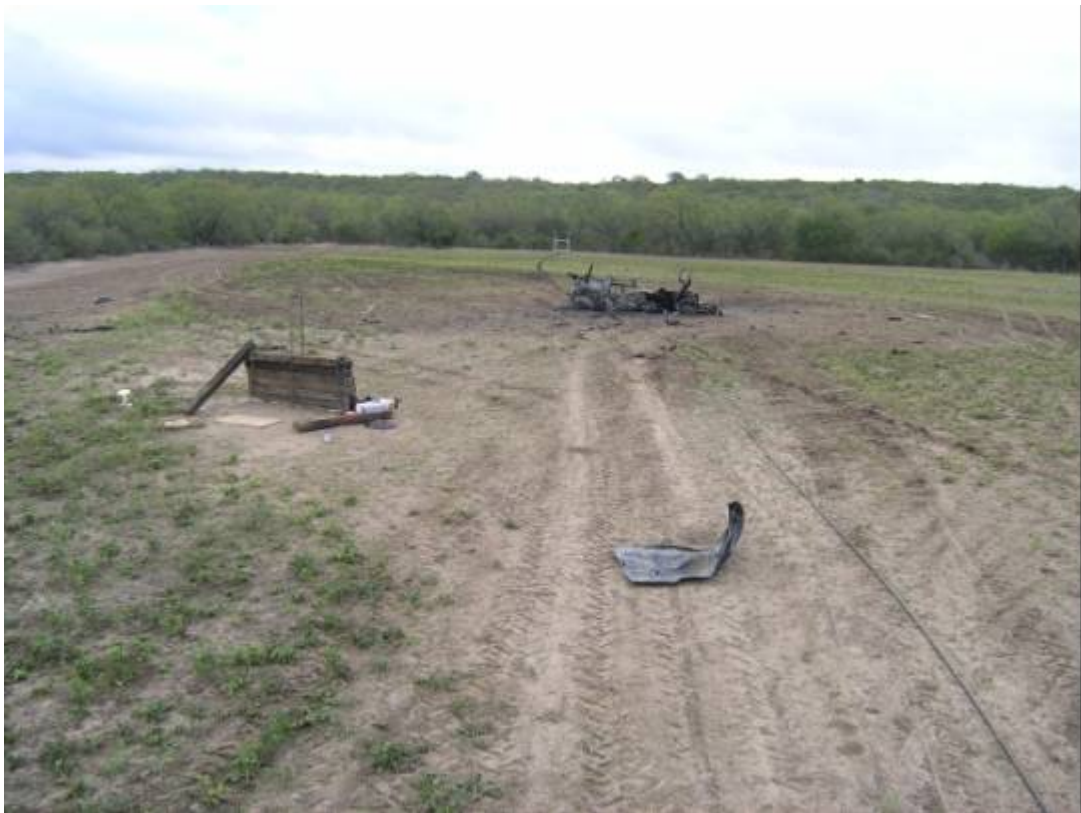
Figure B-11. Overall View of Test Site Following Explosion.

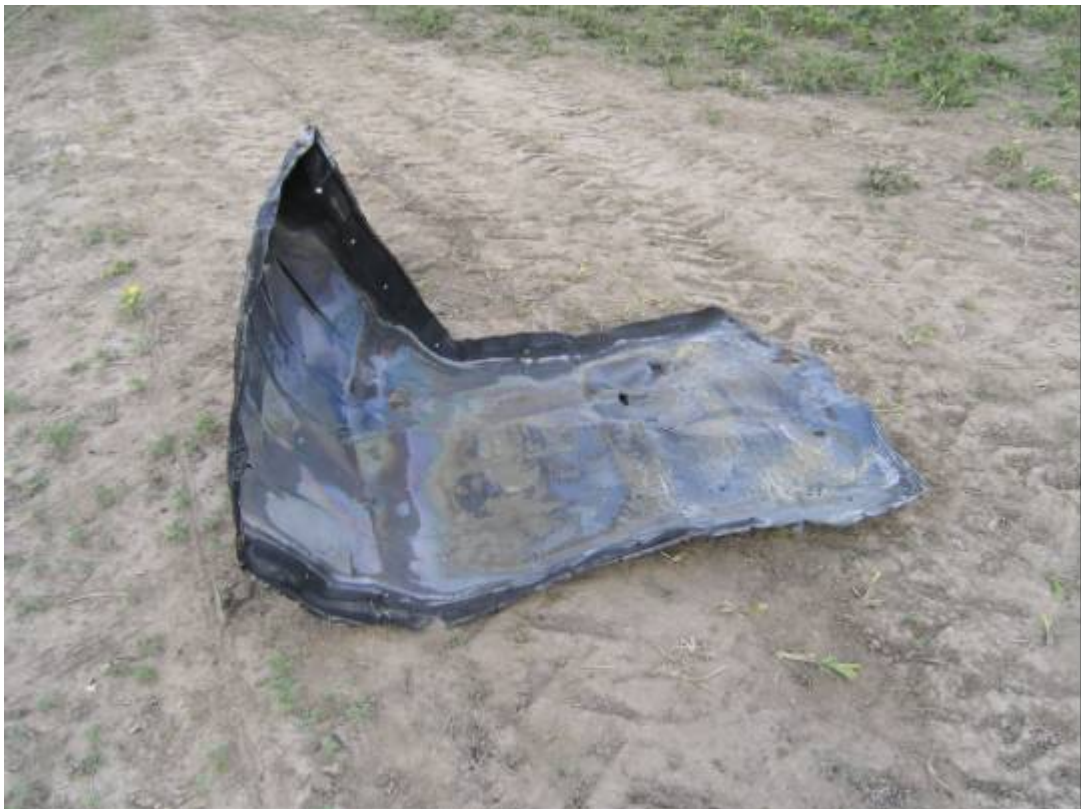
Figure B-12. Large Piece of Sheet Metal Found 112 ft From Test Site.

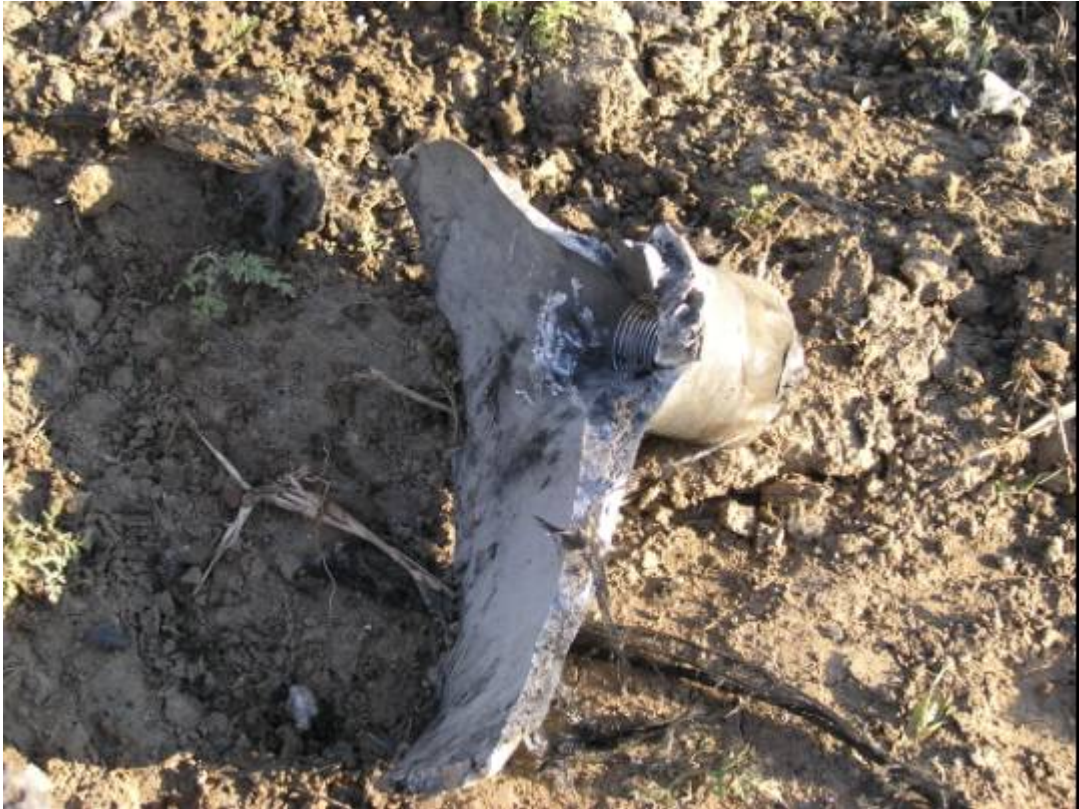
Figure B-13. Portion of Cylinder Found 35 ft From Test Site.

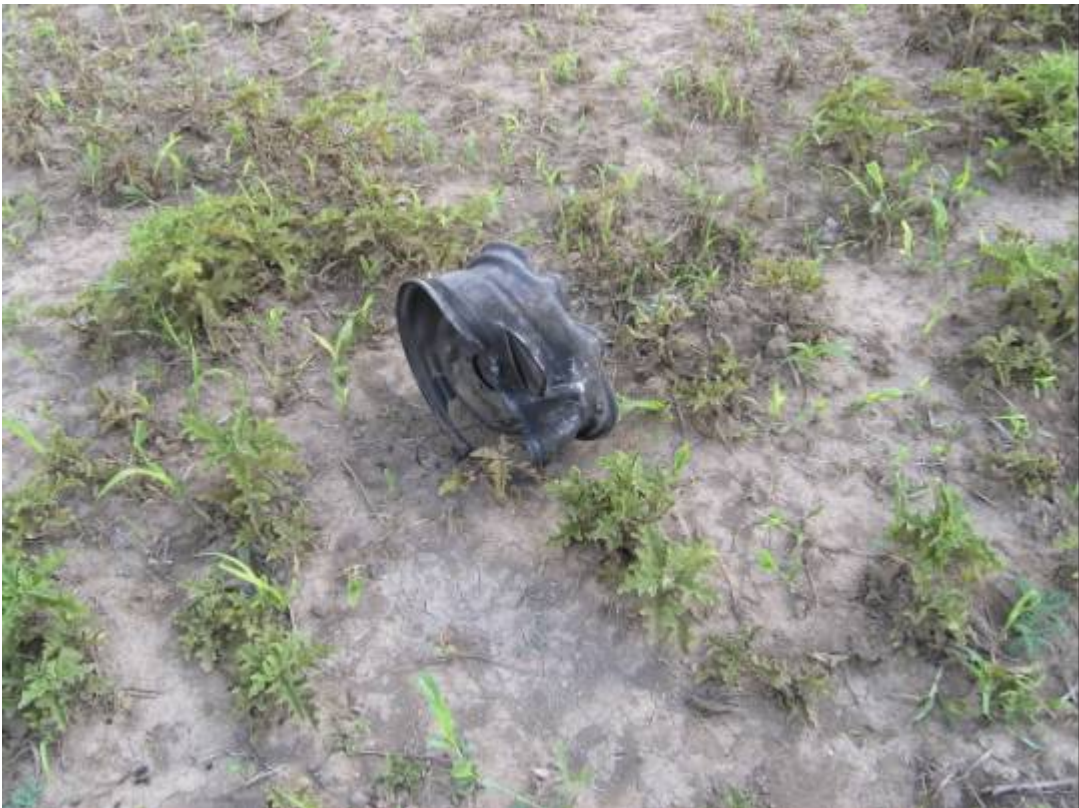
Figure B-14. Vehicle Rim Found 337 ft From Test Site.
