A Bed-Mounted Fuel Tank for GM C/K Pickup Trucks

Kennerly Digges

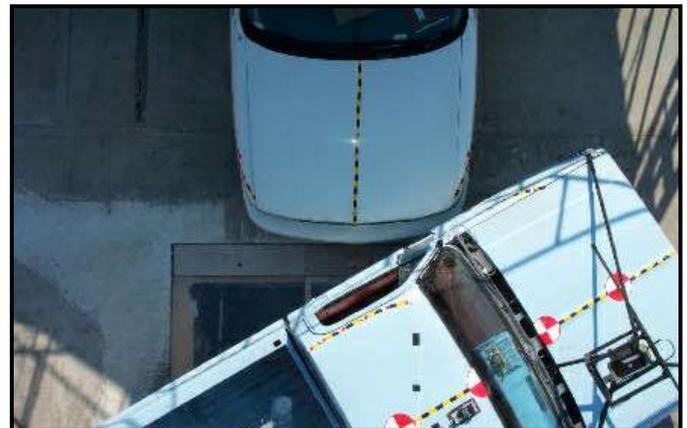
Figure 3: Typical vehicle alignment in side impact tests from a Caprice.

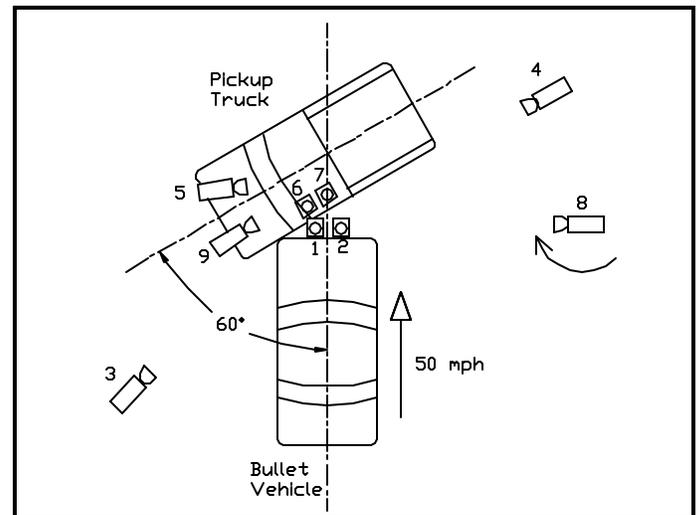
Figure 6: Vehicle orientation and camera positions for lateral impact tests (some tests are the mirror image of that shown).

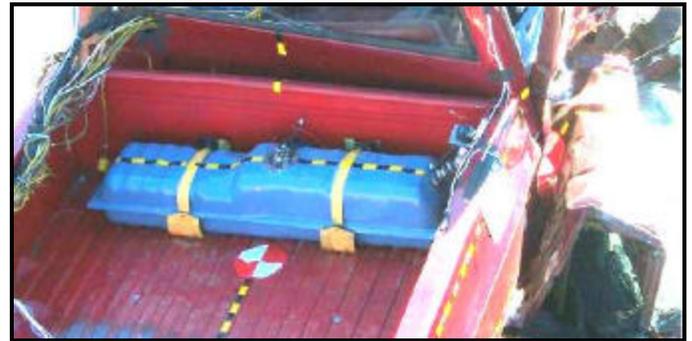
Figure 7: Post test view of bed mounted tank (test RP 01-036).

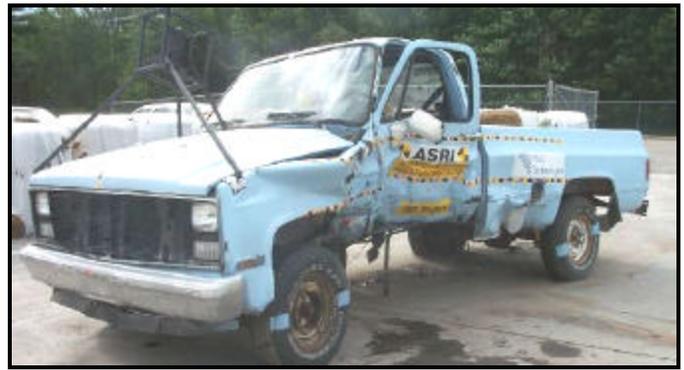
Figure 8: Typical damage to a GM pickup truck following a side impact from a Caprice.

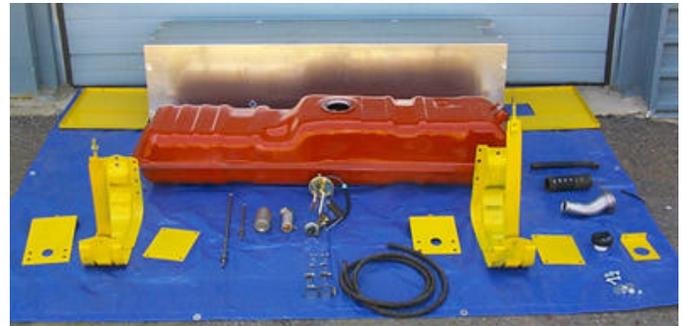
Figure 9: Bed mounted tank with components.
