JRS Dynamic Rollover Test  
1999 Toyota Camry

Sponsored By:  
**Automotive Safety Research Institute**

## Introduction

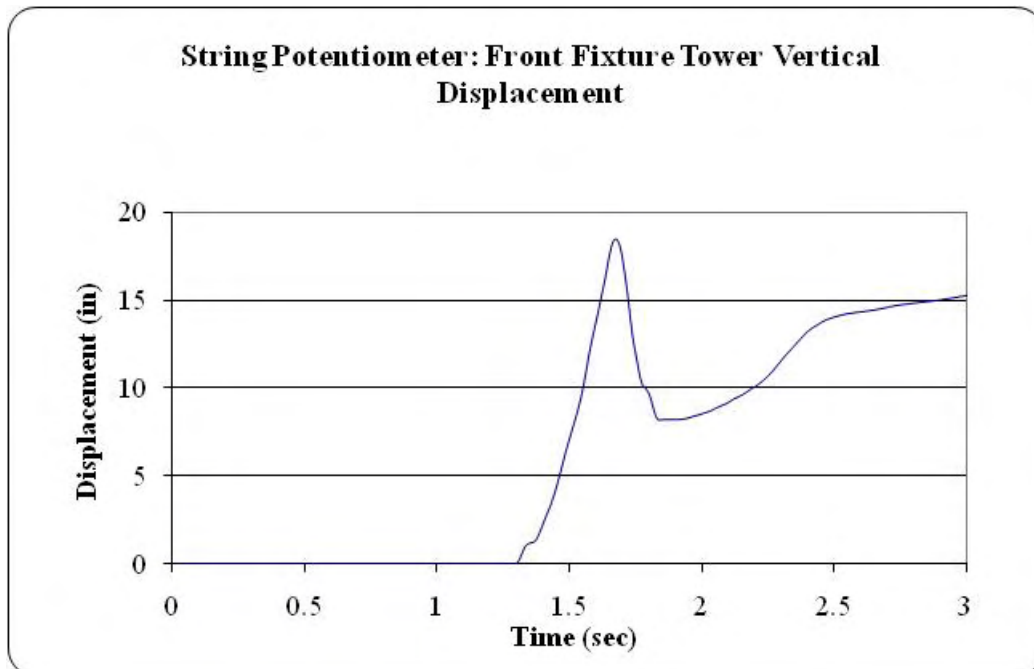
Plot 18: String Potentiometer Front Fixture Support Tower Displacement vs. Time

Data Sampling Rate: 1 kHz

The string potentiometers located on the fixture support towers show the vertical vehicle motion throughout the test. The front of the vehicle dropped 4.5 inches and the rear dropped 4.8 inches prior to initial touch down. The vehicle was pitched at 4.9 degrees at contact.

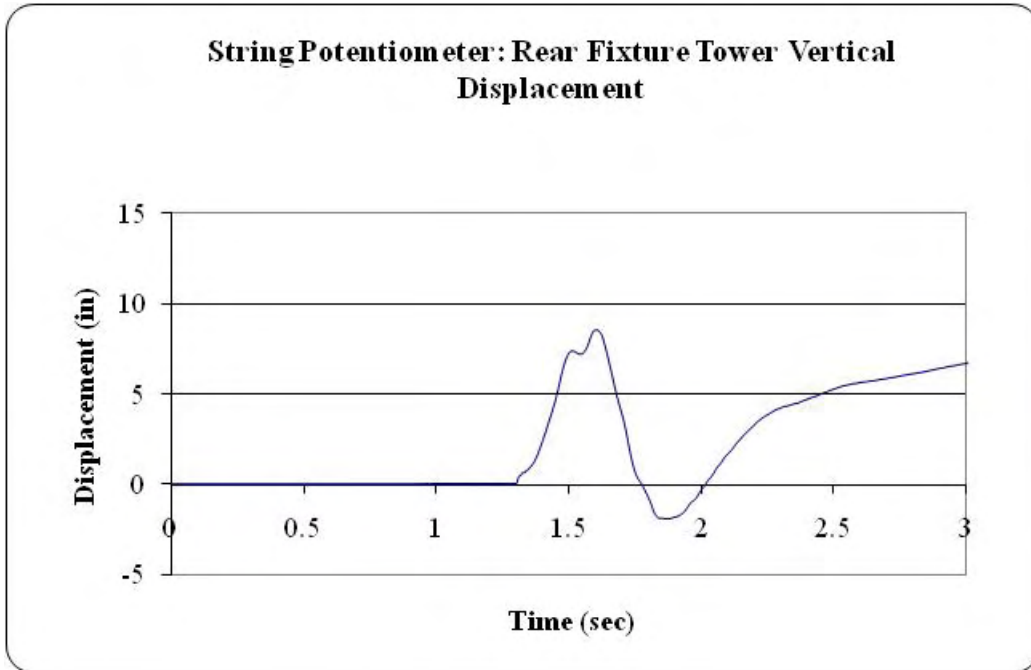
Plot 19: String Potentiometer Rear Fixture Support Tower Displacement vs. Time

Data Sampling Rate: 1 kHz

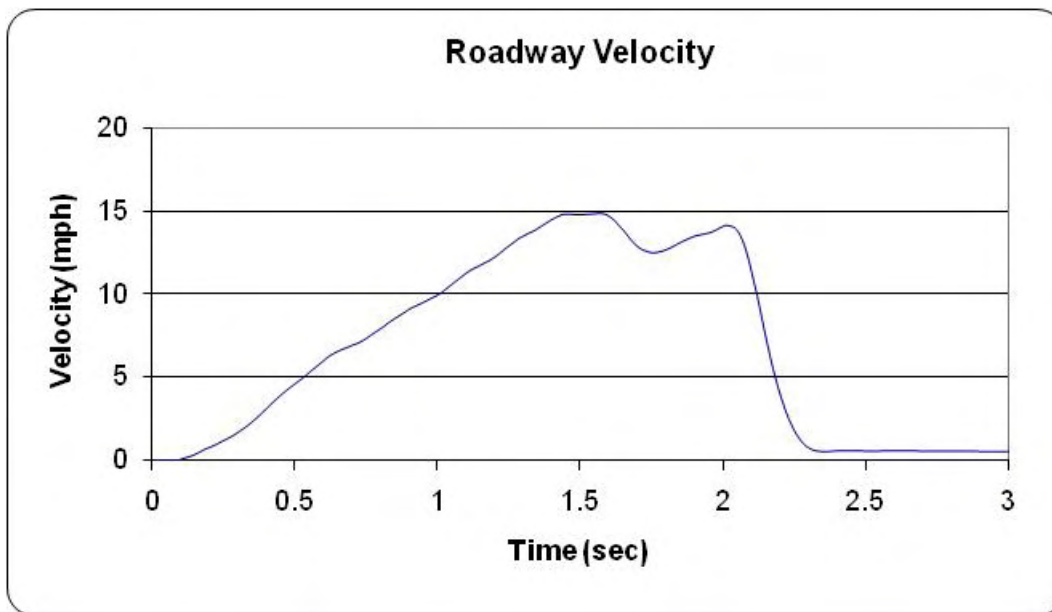
Plot 20: Roll Encoder on Roadway Velocity vs. Time

Data Sampling Rate: 1 kHz

The roll encoder located on the cable pulley shows the roadway velocity throughout the roll. The roadway was traveling at 14.9 mph at contact. A roll rate sensor in the vehicle was used to determine the roll angle and rate at impact. The roll angle of the vehicle was 132 degrees and the roll rate was 302 degrees per second at the roadway impact.

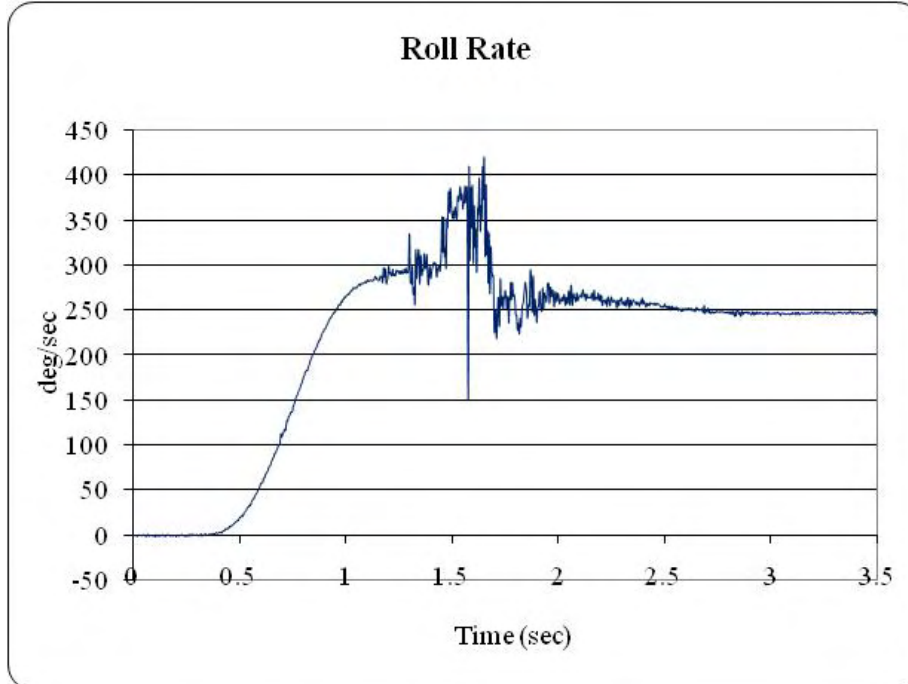
Plot 22: Roll Rate vs. Time

Data Sampling Rate: 10 kHz
