JRS Dynamic Rollover Test

2007 Toyota Camry
Hybrid Version

**Automotive Safety Research Institute
Charlottesville, VA.**

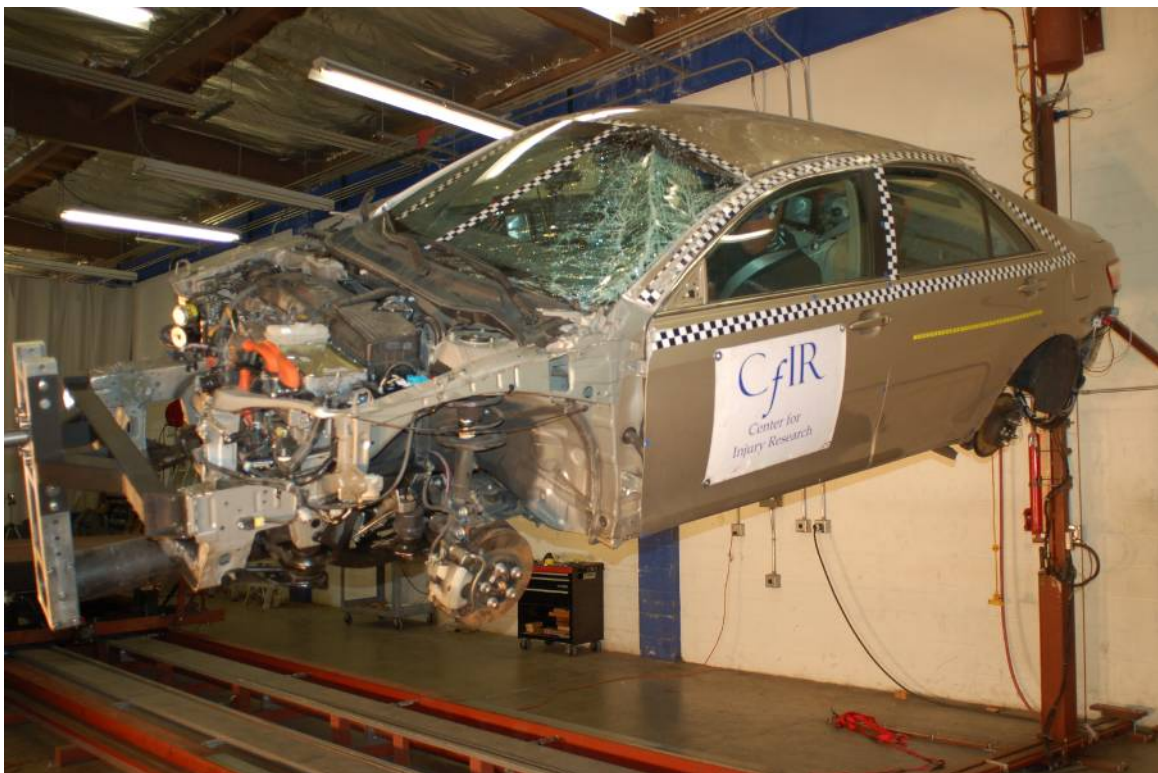
Figure 2: Vehicle Post Roll 1

During the first roll the windshield fractured and the rear window shattered. There was deformation of the far side C-pillar. There was no indication of fluid leakage from the Hybrid system.

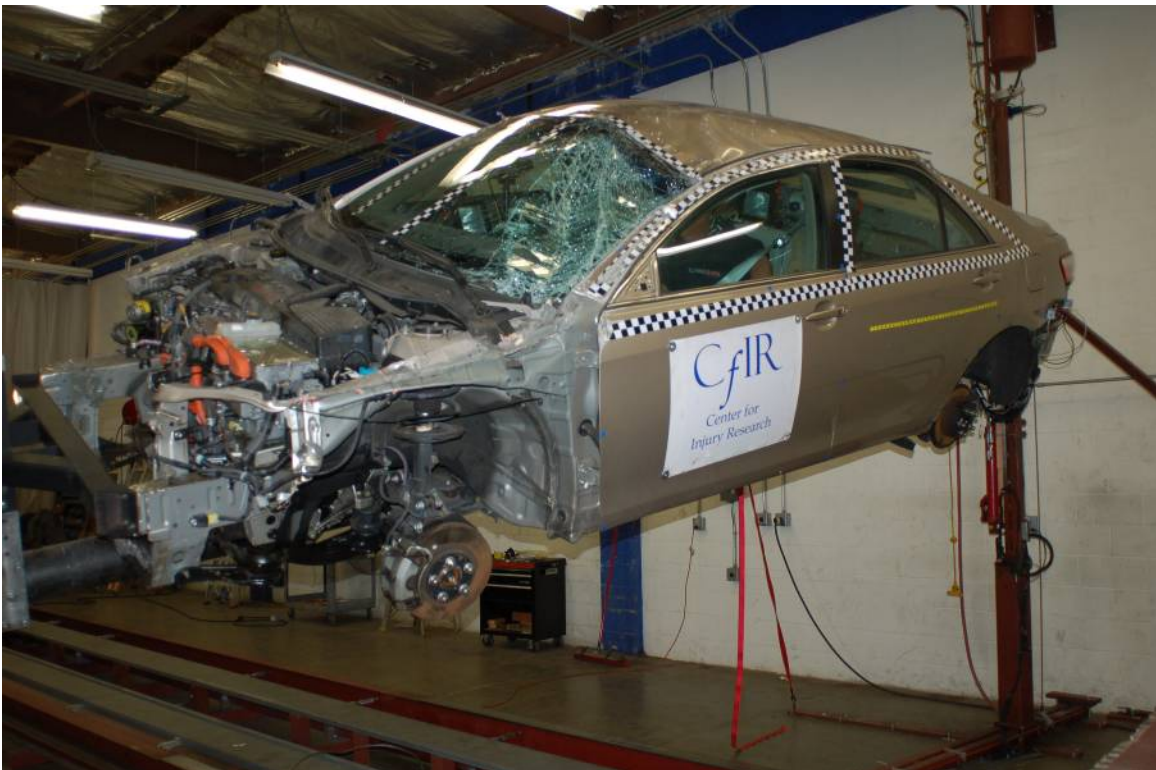
Figure 4: Vehicle Post Roll 2

During the second roll the windshield fractured further. There was minor additional deformation of the far side C-Pillar. There was no indication of fluid leakage from the Hybrid system. The front tower mount contacted the front stop during the roll at approximately 200 degrees. There was minimal deformation of the deformable stop indicating that the vehicle would not have dropped much more (if at all) if the stop was not there. The roof therefore would have had a minimal amount of additional roof crush on the far side.

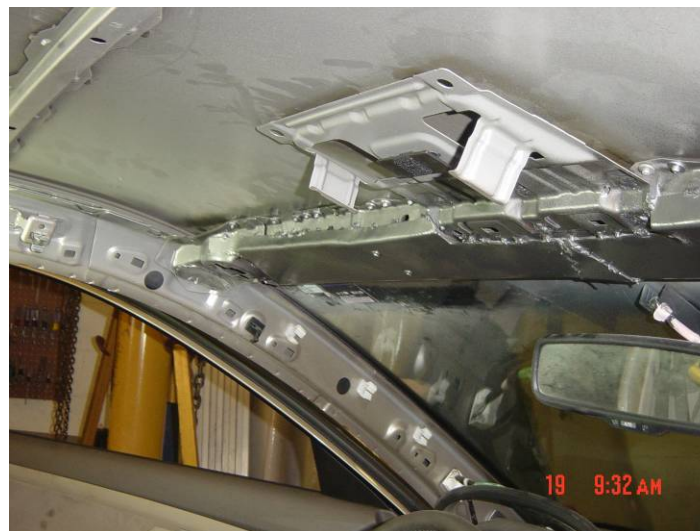
Figure 6. Driver side of header

The header was welded along the inboard edge every 2-2.5 inches. 20 rivets, with backup washers on the blind side, were also used along the 45 inch span of the header. See figure 6.

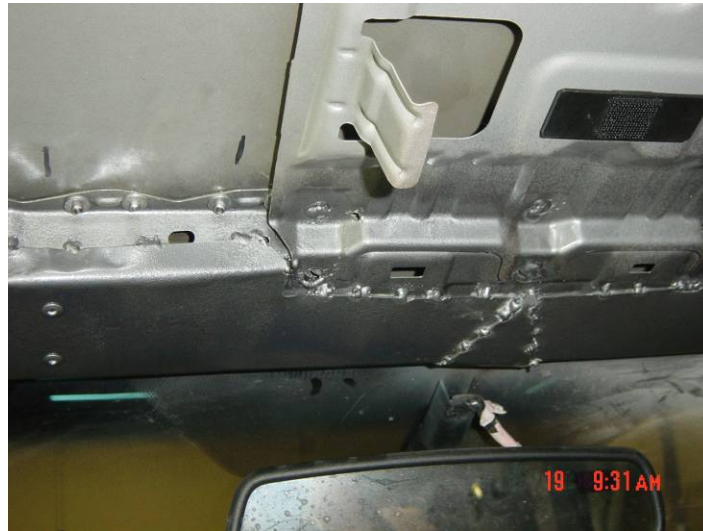
Figure 7. Junction at the center

The driver's side component was connected to the passenger's side component via a welded junction . See figure 7. The small triangular center piece wraps around towards the windshield.

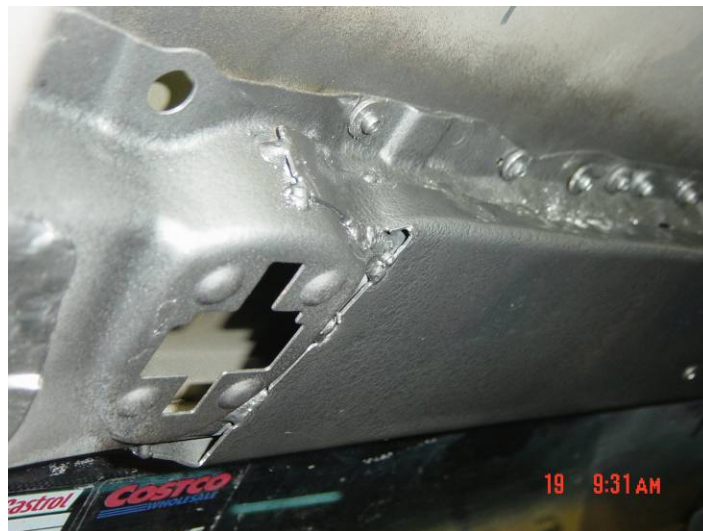
Figure 8. Driver side outboard attachment

Each end of the component was fabricated to allow for access to the visor attachment and to ease the transition from the stiffer reinforced section to the weaker corner without creating a connection prone to high stresses. See figure 8.

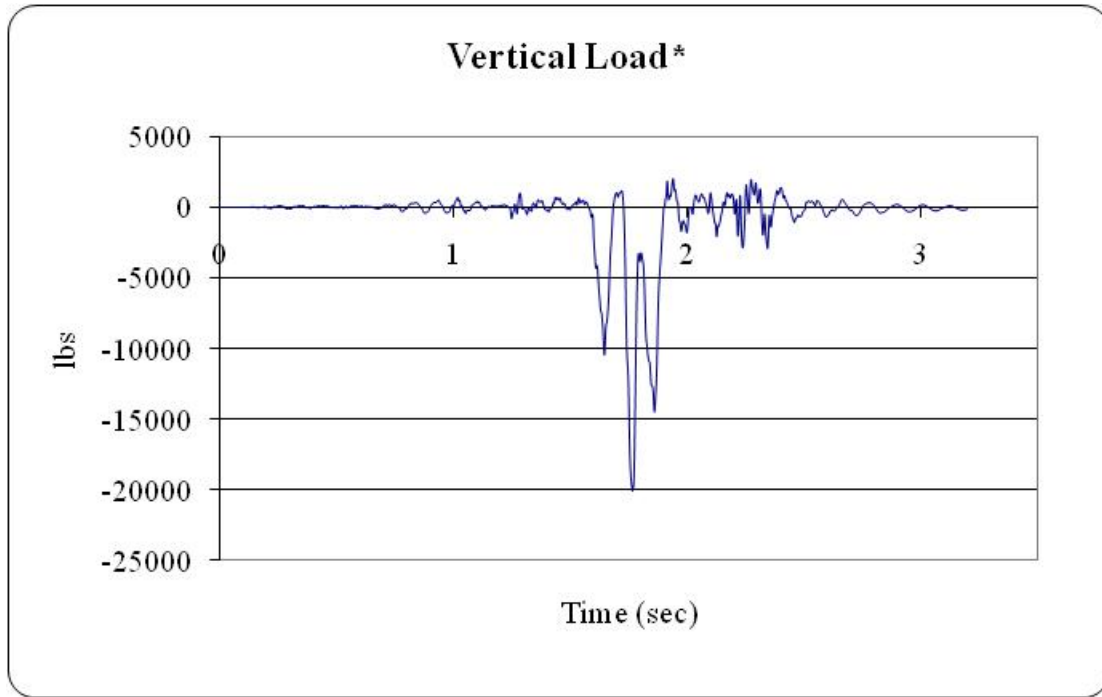
Plot 17: Total Vertical Load* v. Time

*Vertical load cell number 2 (out of 6) did not function properly and its data was excluded.
Data Sampling Rate: 10 kHz

The vertical load cells mounted on the roadway platform show the near and far side impacts. The vehicle struck the roadway on the near side at approximately 1.59 seconds. The entire roll sequence was completed by approximately 1.94 seconds.

Roadway vertical load cell number 2 recorded very large amounts of noise during the impact phase of the test. The data from number 2 was excluded from all charts and values concerning vertical roadway impact loads. The roadway load charts and values only contain the sum of the vertical load recorded by 5 of the 6 load cells. For reference, from an almost identical previous test with a non-hybrid 2007 Toyota Camry weighing about 10% less, we estimate that the peak value measured by load cell number 2 would have been approximately 3,300 lbs.
