JRS Dynamic Rollover Test

2008 Ford Escape Hybrid

Introduction

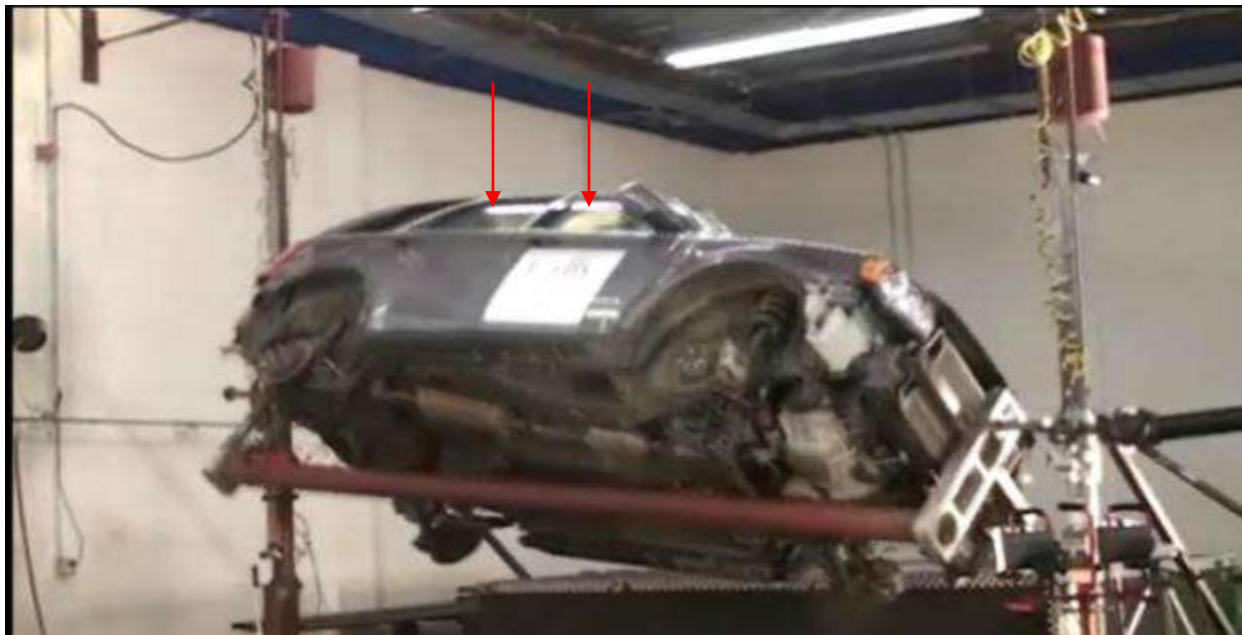
During the first roll the windshield fractured and peeled away from the driver side A-pillar. Due to the roof rack mounting location a buckle formed inside of the roof rail on the driver side. The hybrid battery in the rear of the vehicle was undamaged. No side windows failed during test. Figure 1 shows all the windows intact after the impact. A subsequent event following the testing event caused the driver rear window to fail, but did not affect the outcome of the test.

Figure 1. Photo Illustrating No Window Failures During Impact

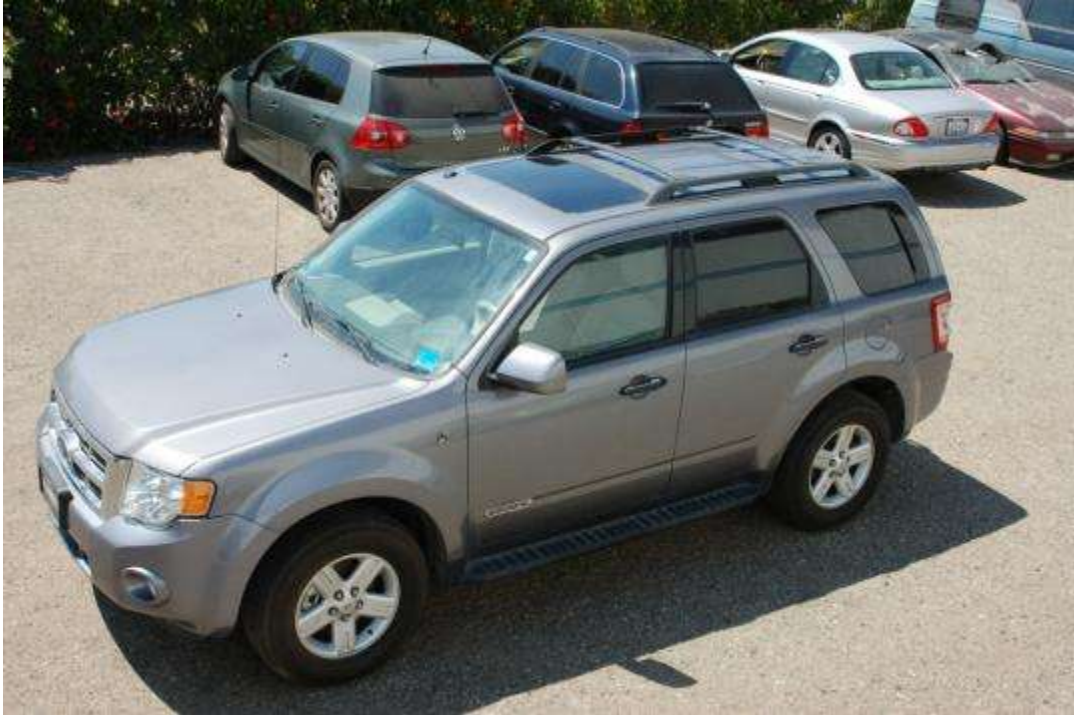
Figure 1: Vehicle Pre Roll 1

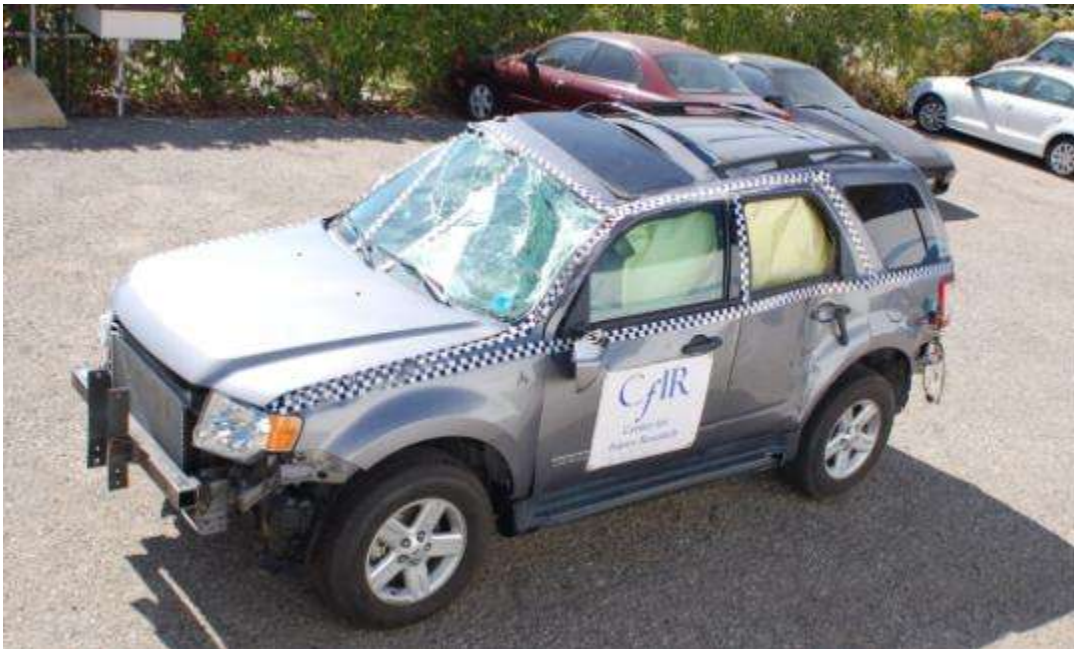
Figure 2: Vehicle Post Roll 1

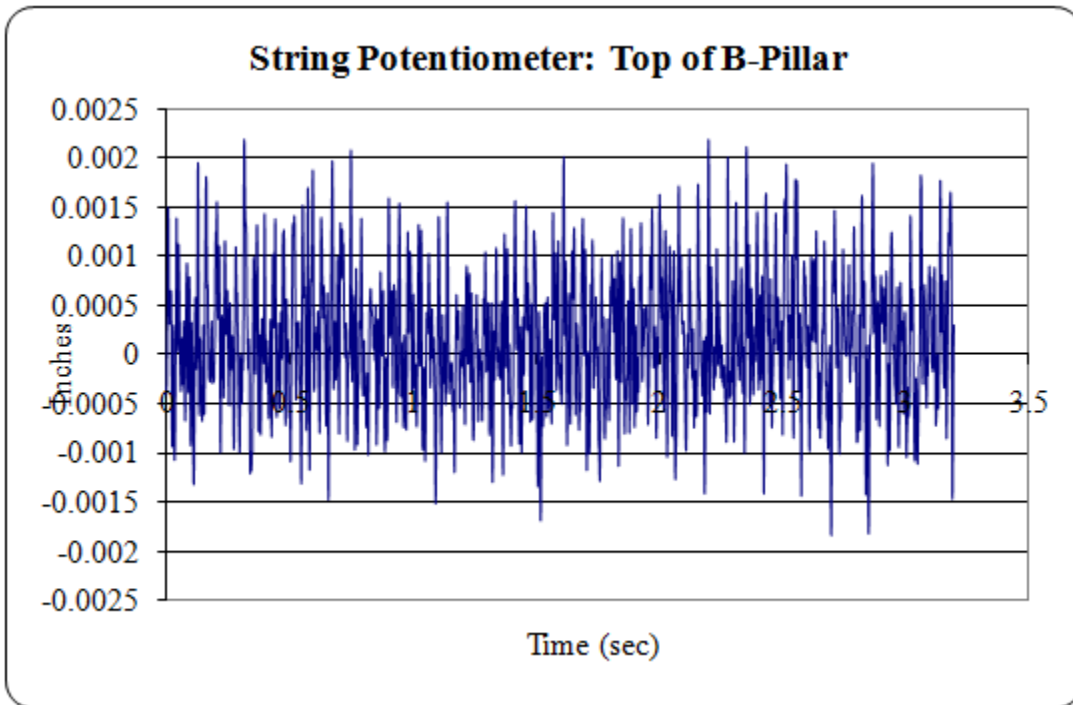
Plot 2: String Potentiometer Driver's Side B-Pillar Displacement v. Time*

*The B-pillar string pot was not used to allow full functionality of the side curtain airbag.

driver B-pillar string pot cable was not able to be mounted without interfering with functionality of the curtain airbag. Static measurements were taken to get the residual crush at the B-Pillar. An instrumented, restrained Hybrid III 50th percentile male test dummy was placed in the driver's seat. The dummy was instrumented with upper and lower neck load cells as well as a triaxial head accelerometer. In addition, seat belt load cells were utilized.

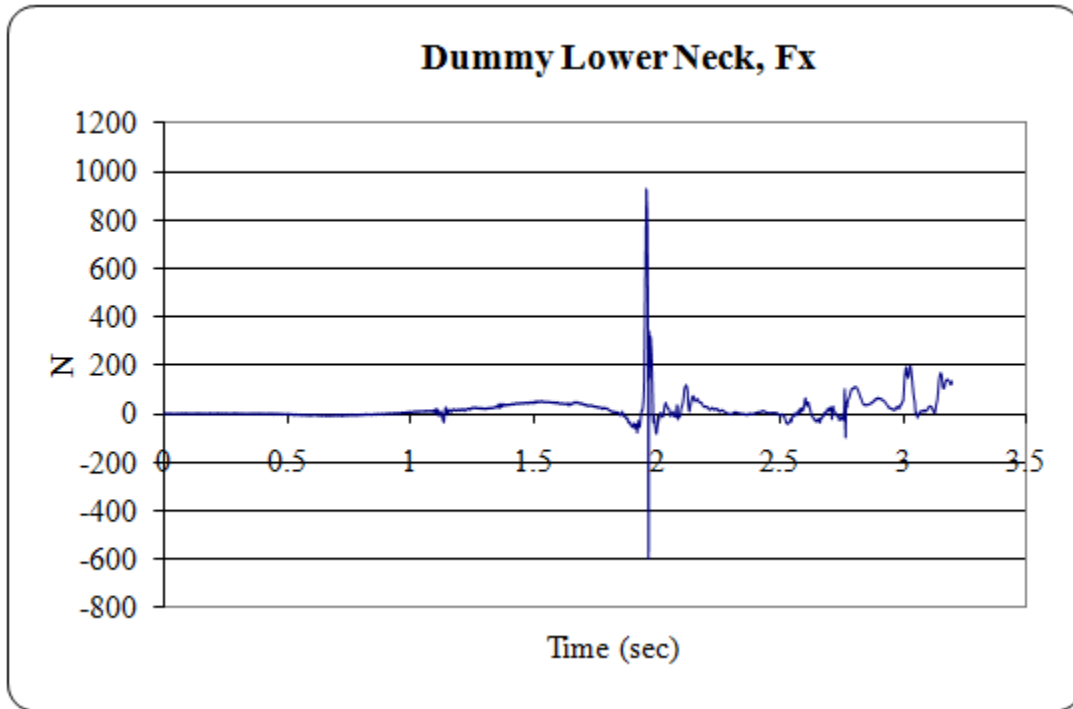
Plot 5: Lower Neck Load, Fx, v. Time

Instrument	Maximum Value	Minimum Value
Lap Belt Load	207 lb	-5 lb
Shoulder Belt Load	134 lb	-4 lb
Dummy Head Acceleration Ax	26 g	-27 g
Dummy Head Acceleration Ay	29 g	-17 g
Dummy Head Acceleration Az	7 g	-31 g
Lower Neck Load Cell Fx	926 N	-598 N
Lower Neck Load Cell Fy	96 N	-175 N
Lower Neck Load Cell Fz	164 N	-1,436 N
Lower Neck Load Cell Mx	11 Nm	-28 Nm
Lower Neck Load Cell My	161 Nm	-28 Nm
Upper Neck Load Cell Fz	92 N	-1,913 N
HIC	66	N/A

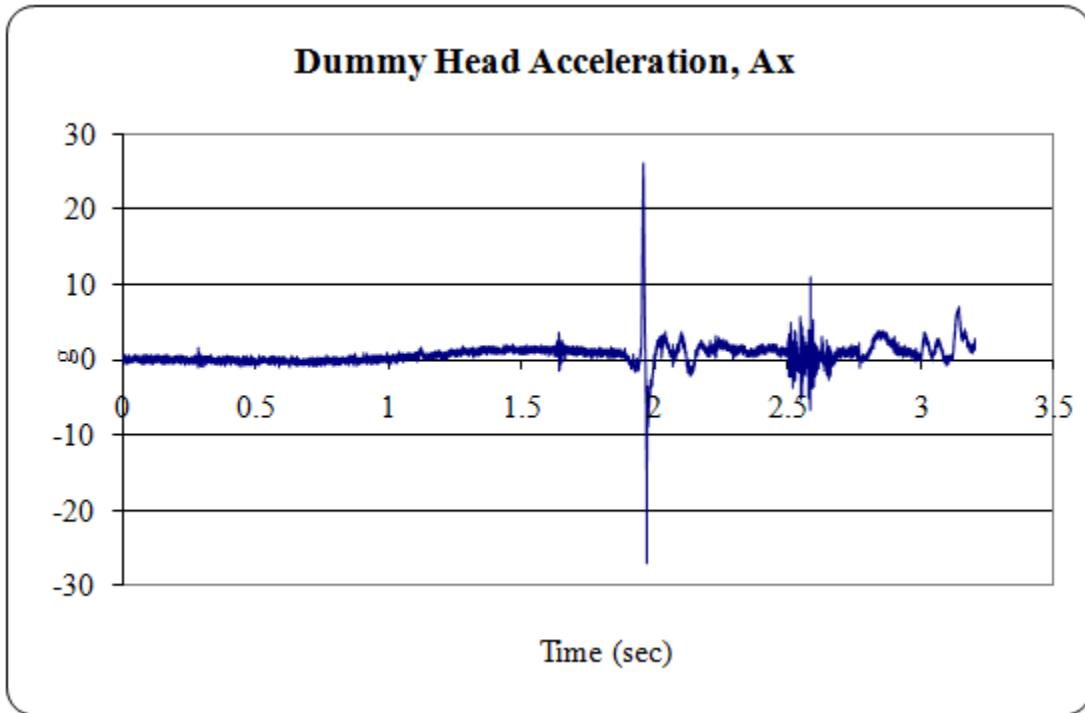
Plot 11: Head Acceleration, Ax, vs. Time

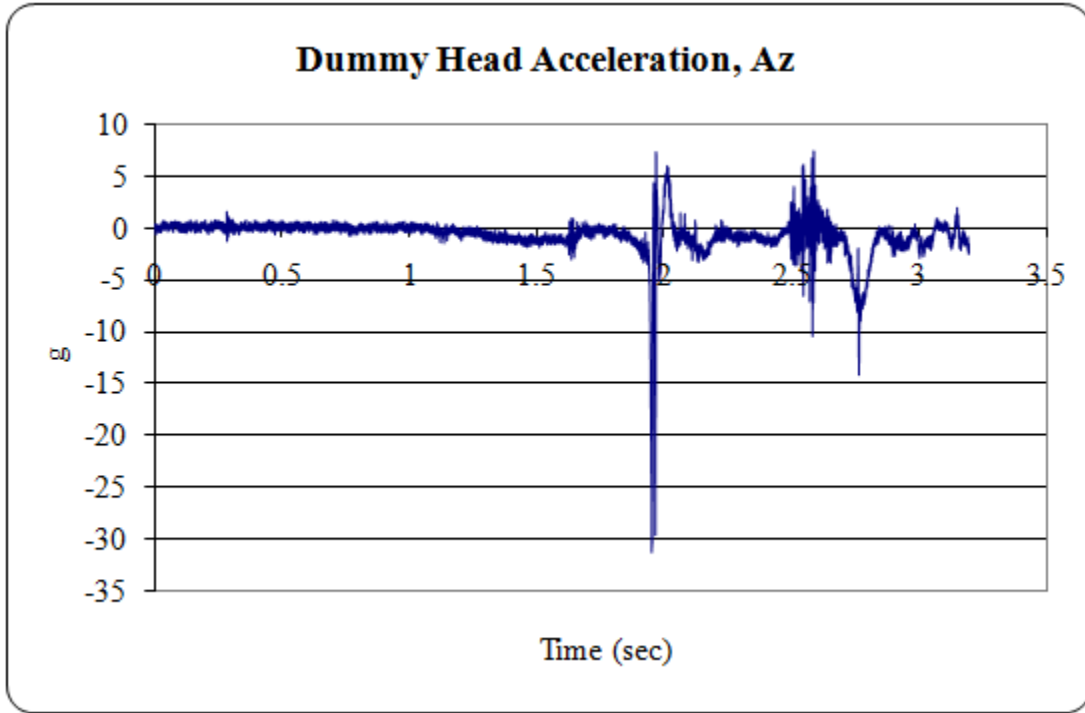
Plot 13: Head Acceleration, Az, vs. Time

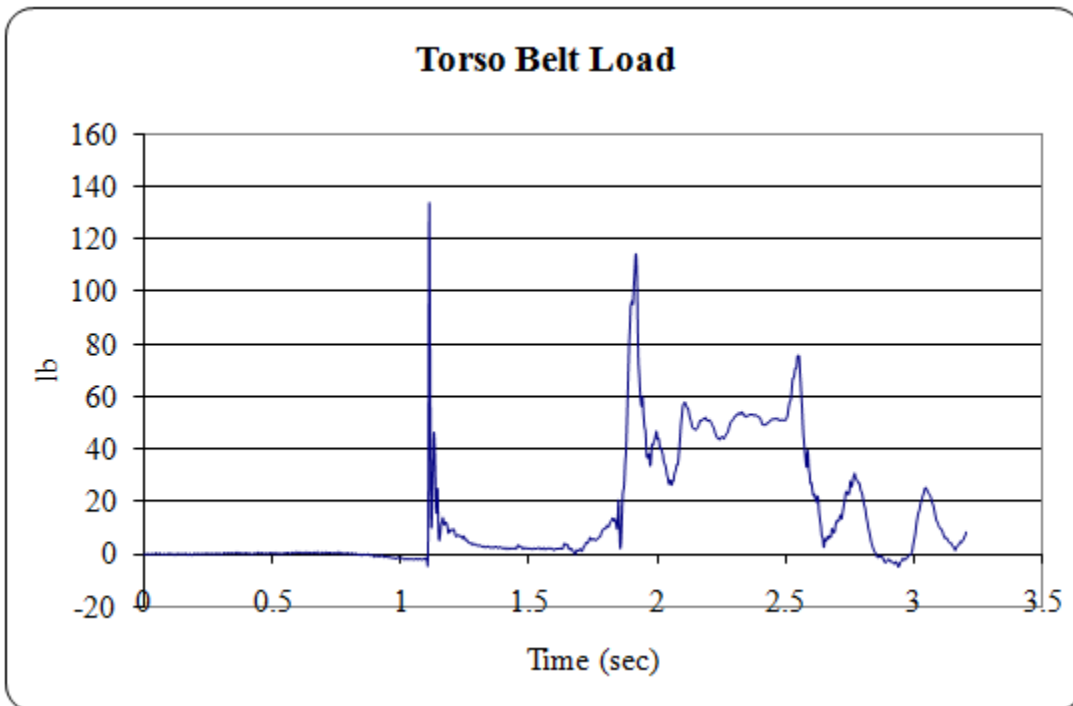
Plot 16: Torso Belt Load* vs. Time

*Measured on one side of the belt
Data Sampling Rate: 10 kHz

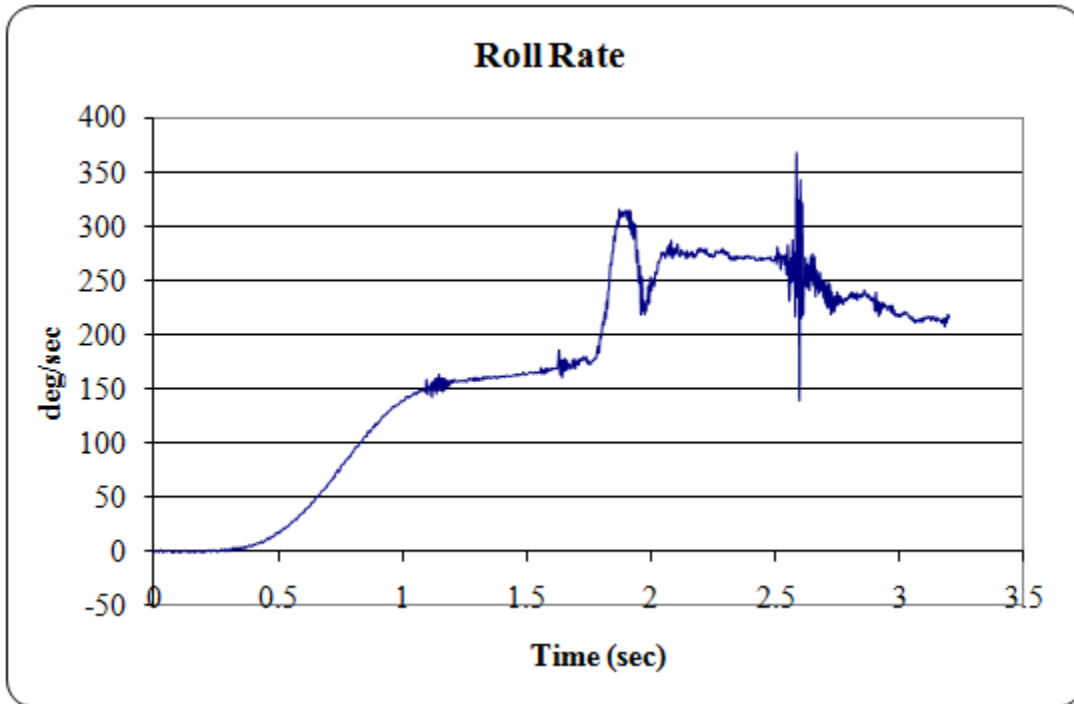
Plot 23: Roll Rate vs. Time

The roll encoder located on the cable pulley shows the roadway velocity throughout the roll. The roadway was traveling at 14.8 mph at contact. A roll rate sensor in the vehicle was used to determine the roll angle and rate at impact. The roll angle of the vehicle was 143 degrees and the roll rate was 176 degrees per second at the roadway impact.
