JRS Dynamic Rollover Test

2009 Chevrolet Malibu

Introduction

Center for Injury Research conducted a JRS dynamic rollover test consisting of two rolls of a 2009 Chevrolet Malibu on July 9 and 12, 2010. This test report is organized in sections containing test information, data tables and photographs as follows:

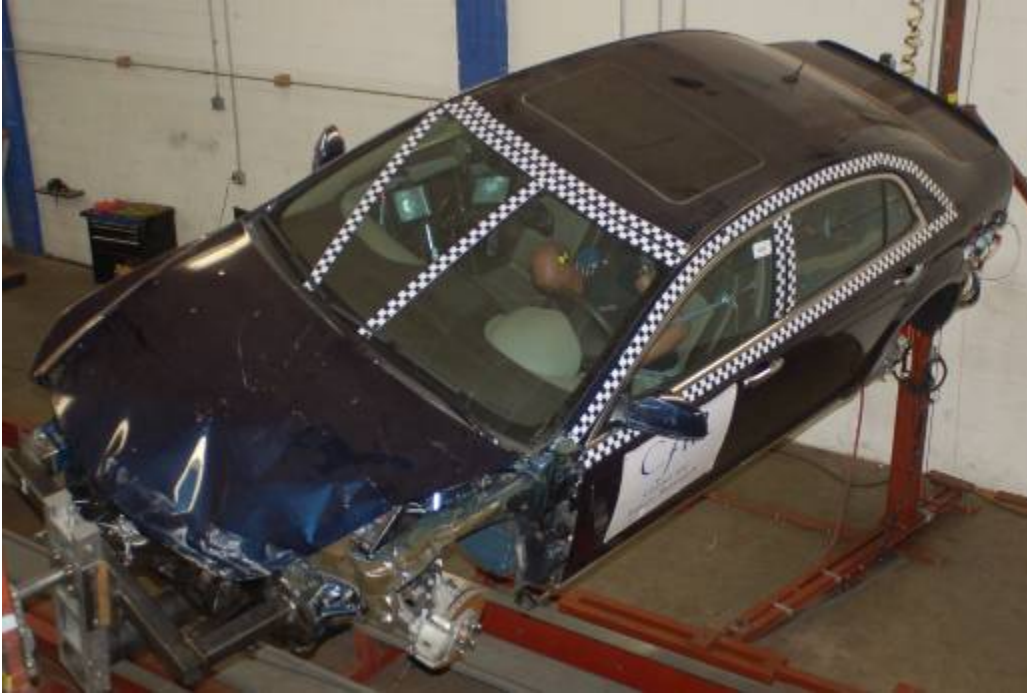
Figure 1: Vehicle Pre Roll 1

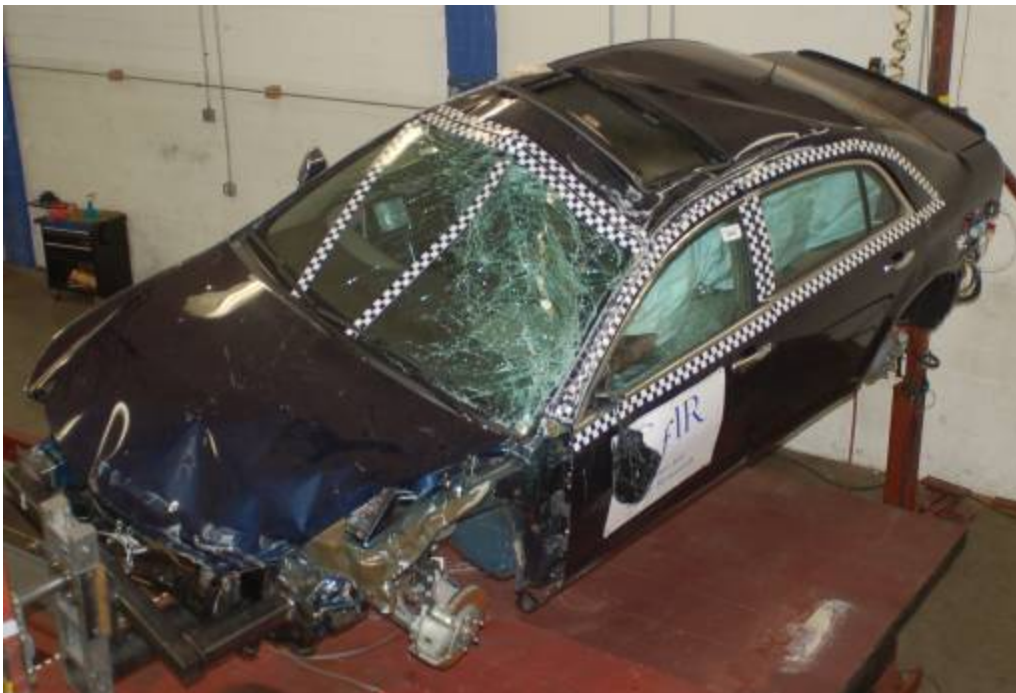
Figure 2: Vehicle Post Roll 1

During the first roll the windshield and driver side front laminated window fractured. A small buckle type deformation occurred in the far side C-pillar. The tempered glass from the sunroof shattered completely.

A pull test was conducted on the driver side doors of the vehicle after the first roll. The front door opened partially, but remained jammed, with 30 lb of force pulling at the door handle. The force was increased to 70 lb and the door remained stuck. It was clear that the top rear corner of the front door was pinned behind the top front corner of the rear door. The rear door took about 5 lb of force to open. The front door was able to open fully after the rear door was opened.

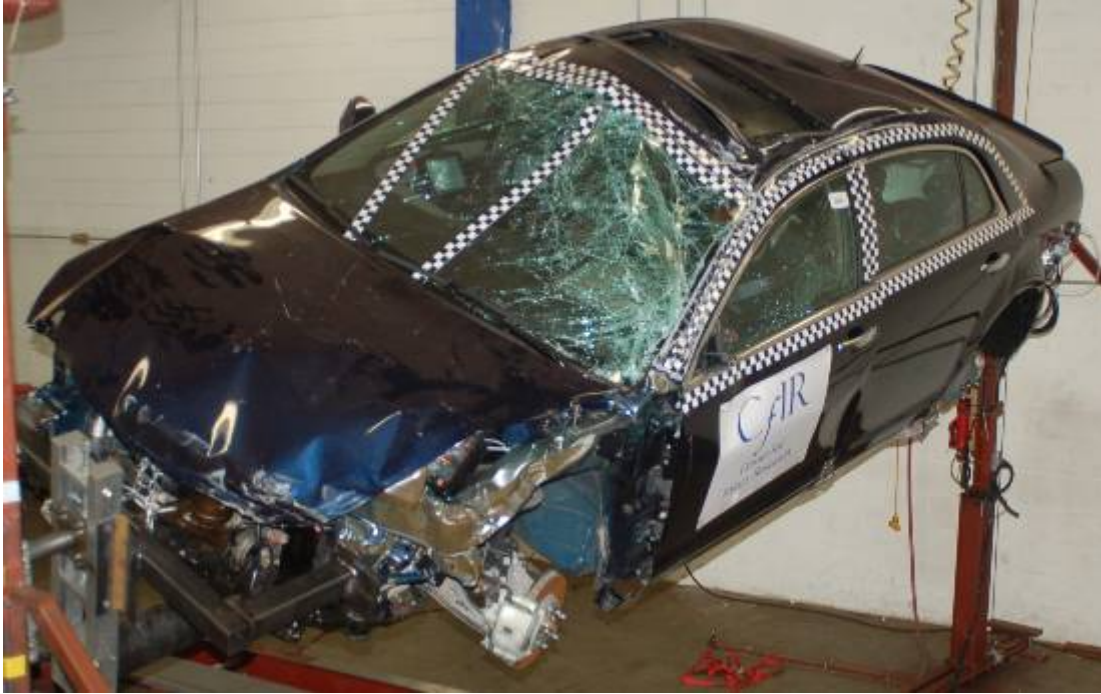
Figure 3: Vehicle Pre Roll 2

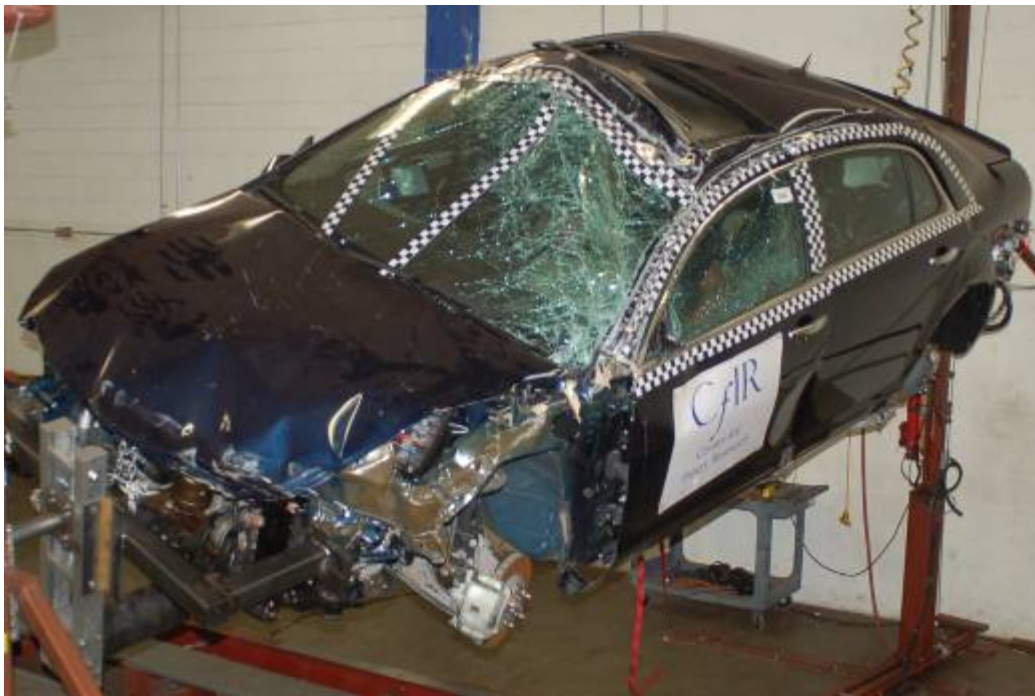
Figure 4: Vehicle Post Roll 2

During the second roll the windshield and driver side front window fractured further. The rear of the front driver side door was tucked behind the front of the rear driver side door and was unable to be opened. The rear door opened with approximately 5 lb of force. After the rear door was opened, the front door also opened with approximately 5 lb of force.

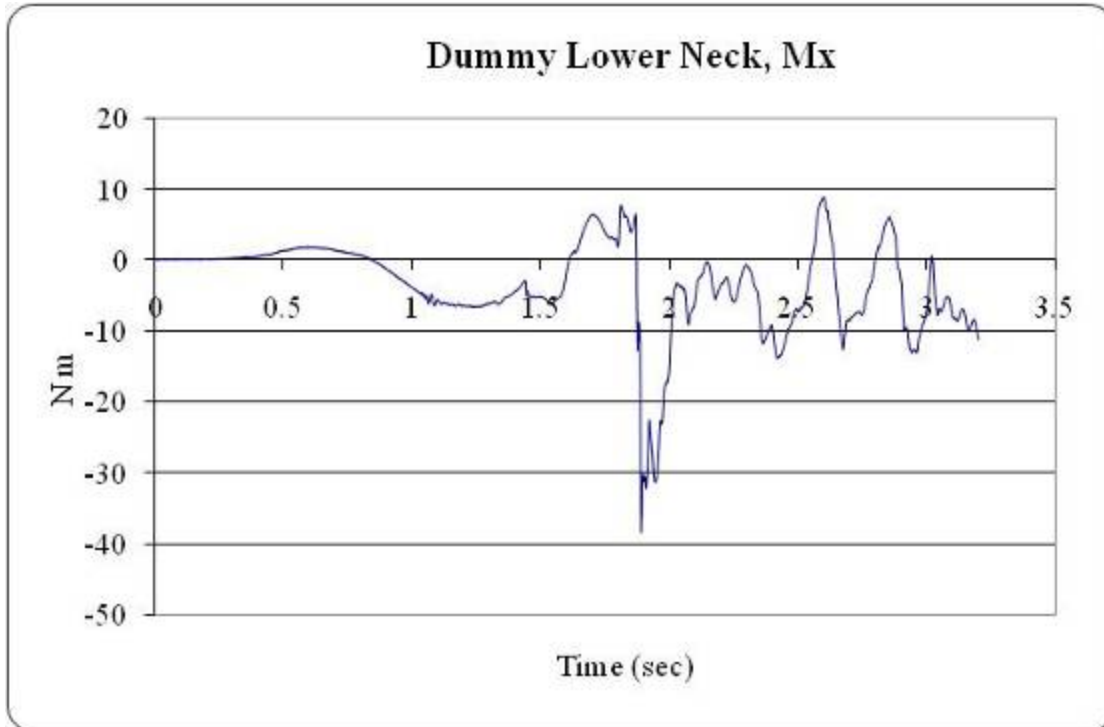
Plot 5: Lower Neck Load, Mx, v. Time

Data Sampling Rate: 10 kHz

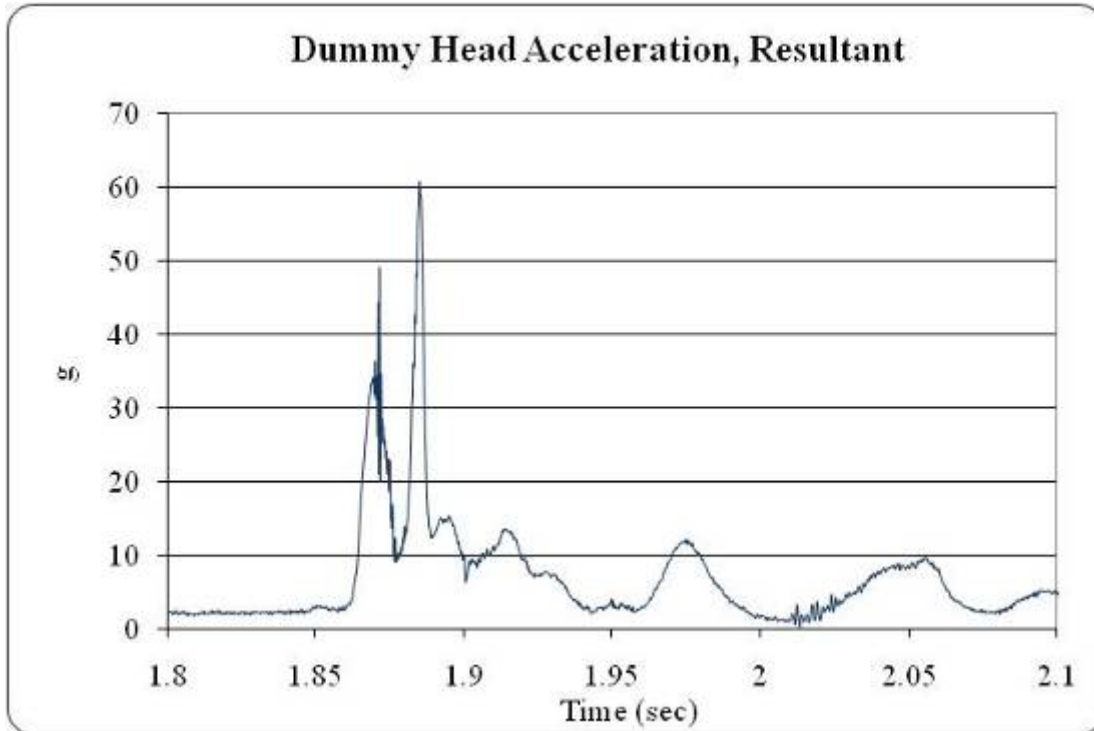
Plot 11: Resultant Head Acceleration vs. Time

HIC = 81

Data Sampling Rate: 10 kHz

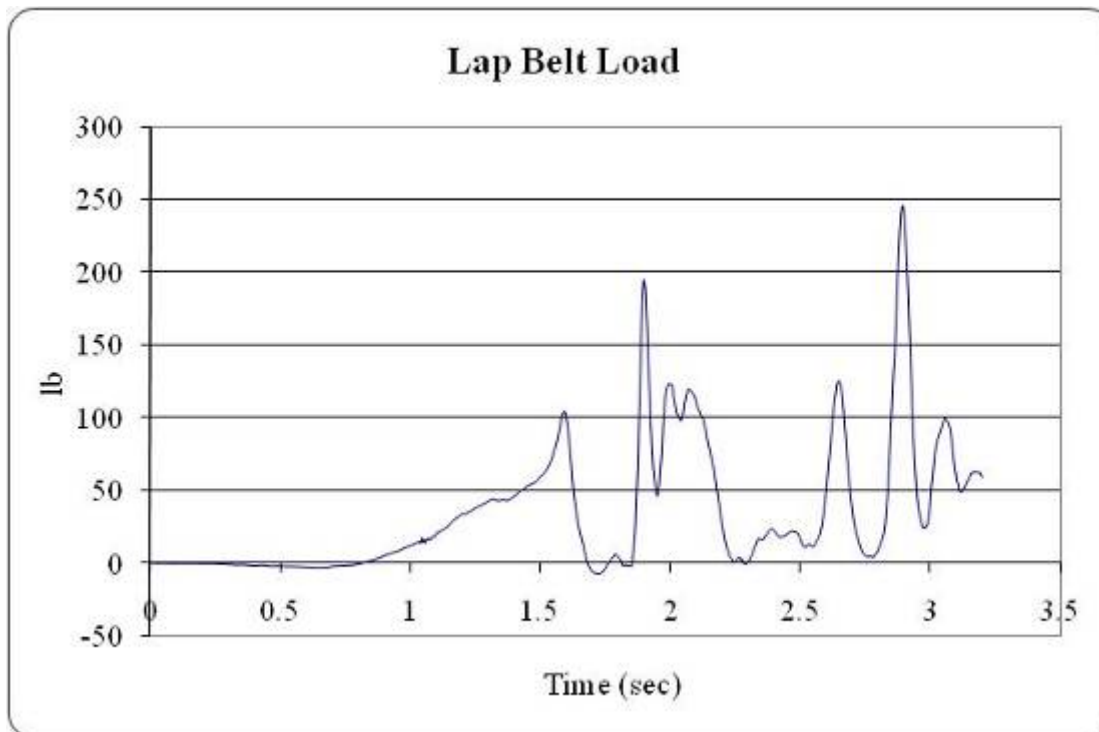
Plot 12: Lap Belt Load* vs. Time

*Measured on one side of the belt

Data Sampling Rate: 10 kHz

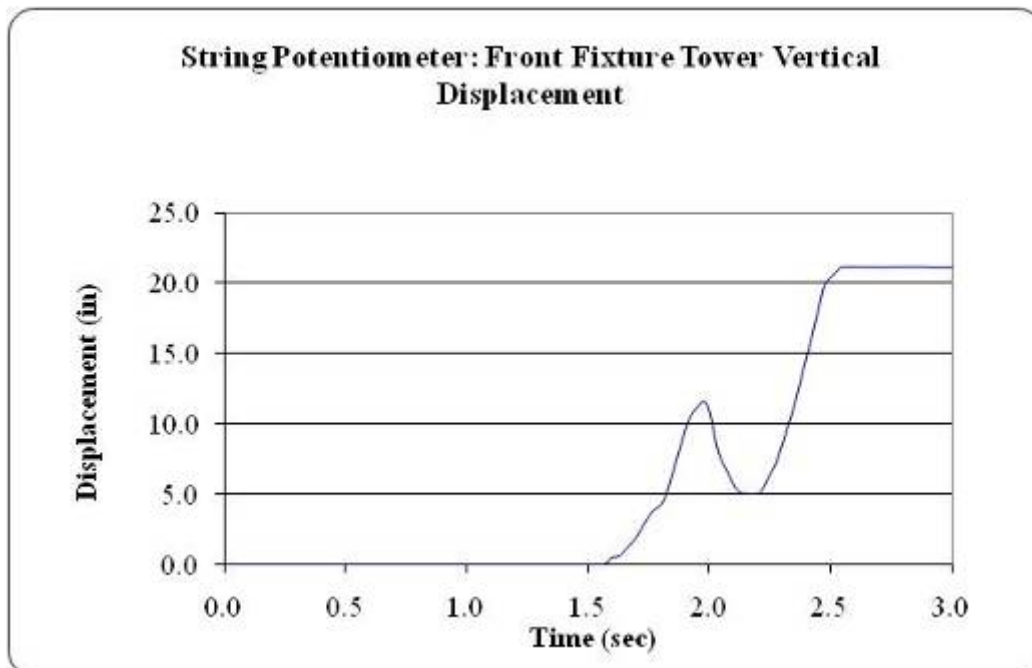
Plot 16: String Potentiometer Front Fixture Support Tower Displacement vs. Time

Data Sampling Rate: 1 kHz

The string potentiometers located on the fixture support towers show the vertical vehicle motion throughout the test. The front of the vehicle dropped 2.2 inches and the rear dropped 5.3 inches prior to initial touch down. The vehicle was pitched at 4.2 degrees at contact.

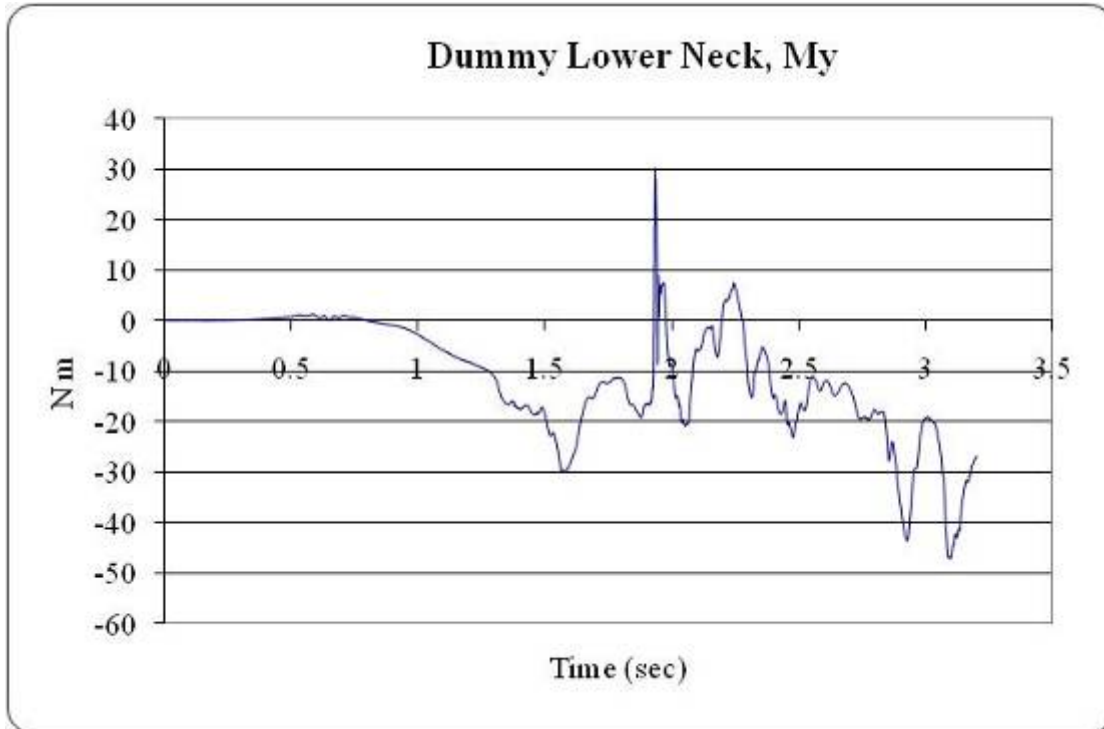
Plot 29: Lower Neck Load, My, v. Time

Data Sampling Rate: 10 kHz

In Roll 2, the peak lower neck compressive load was 889 N and the peak lower neck moment was 30 Nm in flexion and 30 Nm in extension. The peak intrusion speed at the top of the A-Pillar was 9.5 mph with a peak crush of 3.6 inches.

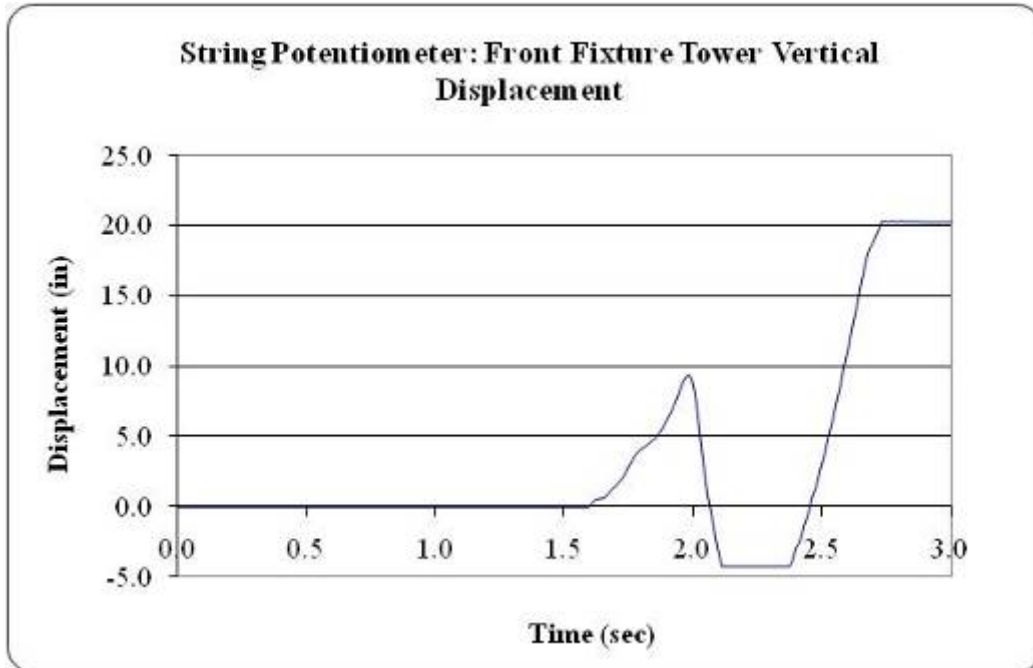
Plot 39: String Potentiometer Front Fixture Support Tower Displacement vs. Time

Data Sampling Rate: 1 kHz

The string potentiometers located on the fixture support towers show the vertical vehicle motion throughout the test. The front of the vehicle dropped 2.4 inches and the rear dropped 5.9 inches prior to initial touch down. The vehicle was pitched at 9.1 degrees at contact.

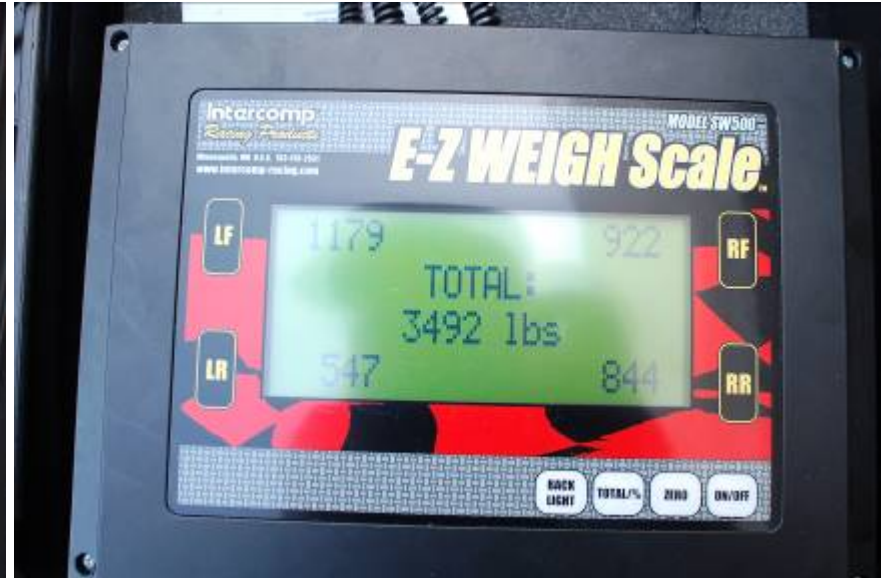
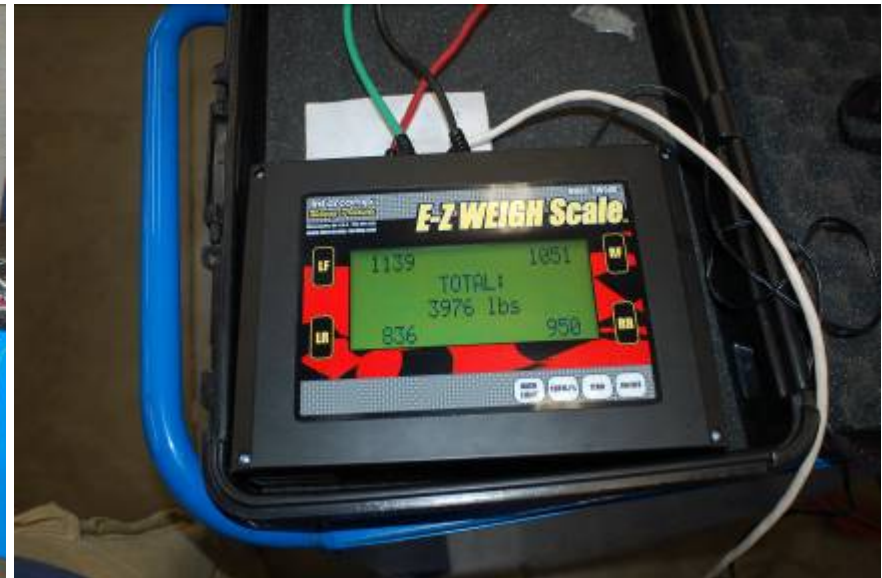
Test Setup and Vehicle Instrumentation
