JRS Dynamic Rollover Test

2010 Ford F-150 Supercab

The Center for Injury Research conducted a JRS dynamic rollover test consisting of two rolls of a 2010 Ford F-150 on April 11th and 12th. This test report is organized in sections containing test information, data tables and photographs as follows:

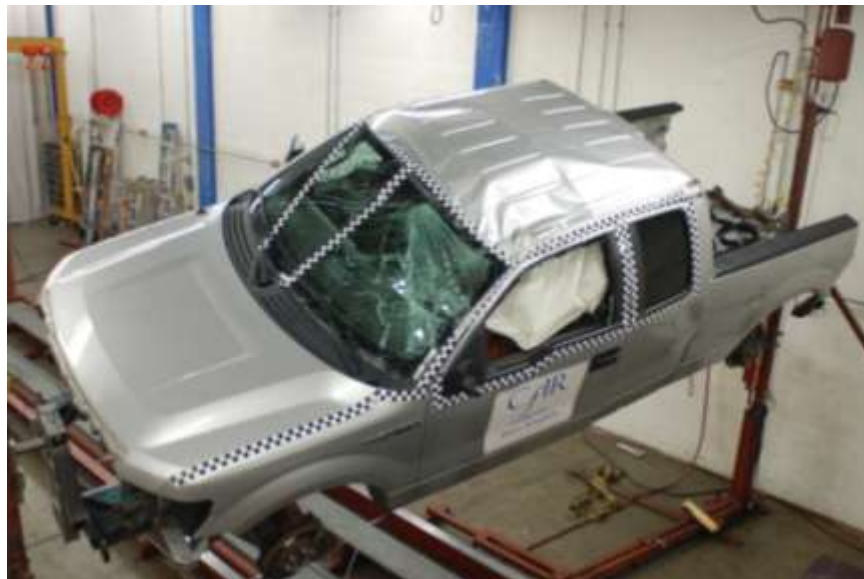
Figure 2: Vehicle Post Roll 1

There was moderate to high deformation beginning at the A-Pillar that traveled longitudinally down the vehicle nearly to the rear webbing. The driver side window shattered and there was significant damage to the windshield.

In Roll 1, the peak lower neck compressive load was 690 N and the peak lower neck moment was 22 Nm in flexion and 31 Nm in extension. The peak intrusion speed at the top of the A-Pillar was 6.0 mph with a peak crush of 6.7 inches.

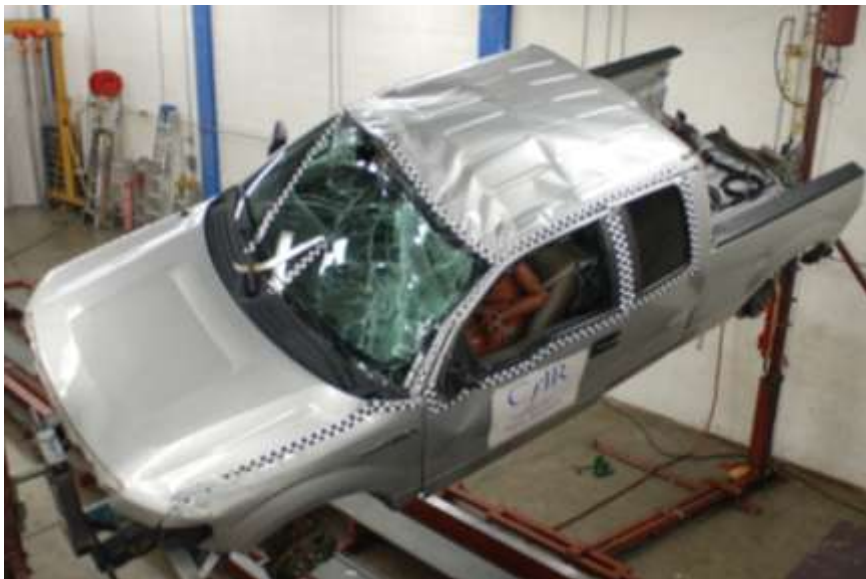
Figure 4: Vehicle Post Roll 2

During the second roll the roof header buckled and tented upward. The windshield suffered heavy damage but was held in place by the lamination.

In Roll 2, the peak lower neck compressive load was 1,751 N and the peak lower neck moment was 169 Nm in flexion and 34 Nm in extension. The peak intrusion speed at the top of the A-Pillar was 11.1 mph with a peak crush of 5.2 inches.

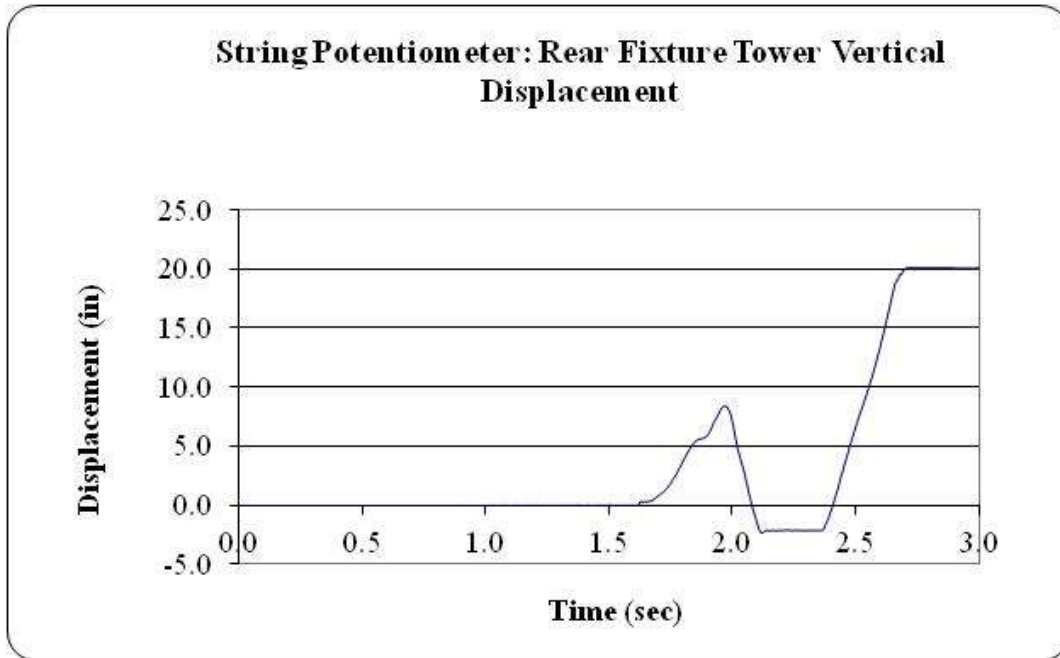
Plot 19: String Potentiometer Rear Fixture Support Tower Displacement vs. Time

Two string potentiometers were placed on the fixture support towers to record vehicle vertical motion characteristics during the test. One string potentiometer was located in the front drop tower and the other was located in the rear drop tower. The rear string potentiometer did not register data in this test and the vehicle pitch was calculated using high speed camera data.

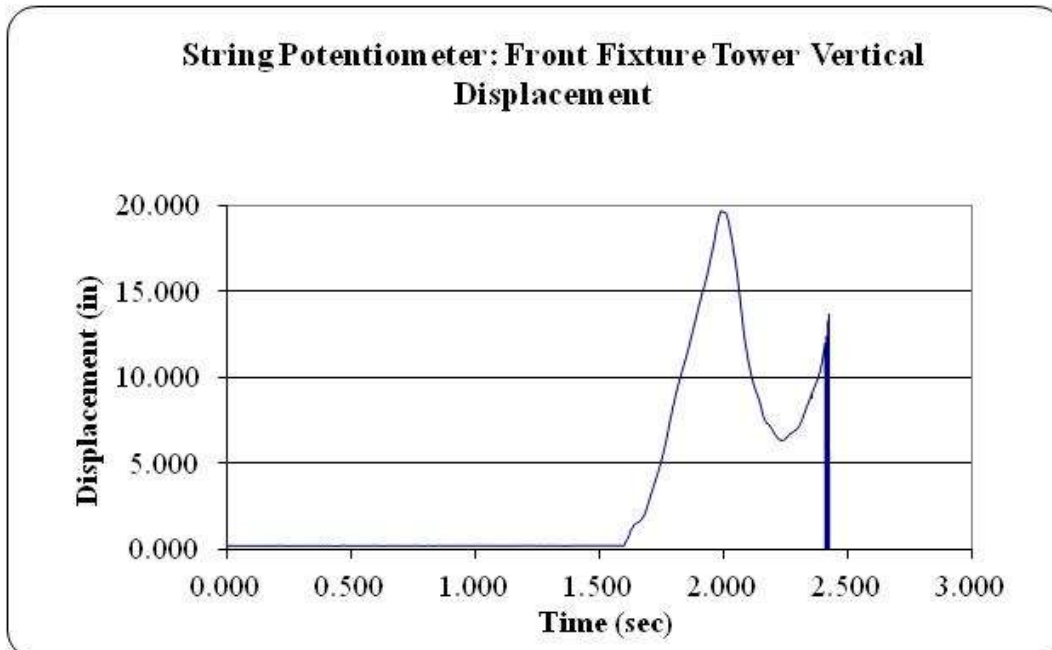
Plot 40: String Potentiometer Front Fixture Support Tower Displacement vs. Time

The string potentiometers located on the fixture support towers show the vertical vehicle motion throughout the test. The front of the vehicle dropped 4.54 inches and the rear did not function during the test. The vehicle was estimated to be at approximately 10 degrees of pitch from the high speed camera data.
