# JRS Dynamic Rollover Test

## 2010 Toyota Prius

Center for Injury Research conducted a JRS dynamic rollover test consisting of two rolls of a 2010 Toyota Prius on August 11 and 12, 2010. This test report is organized in sections containing test information, data tables and photographs as follows:

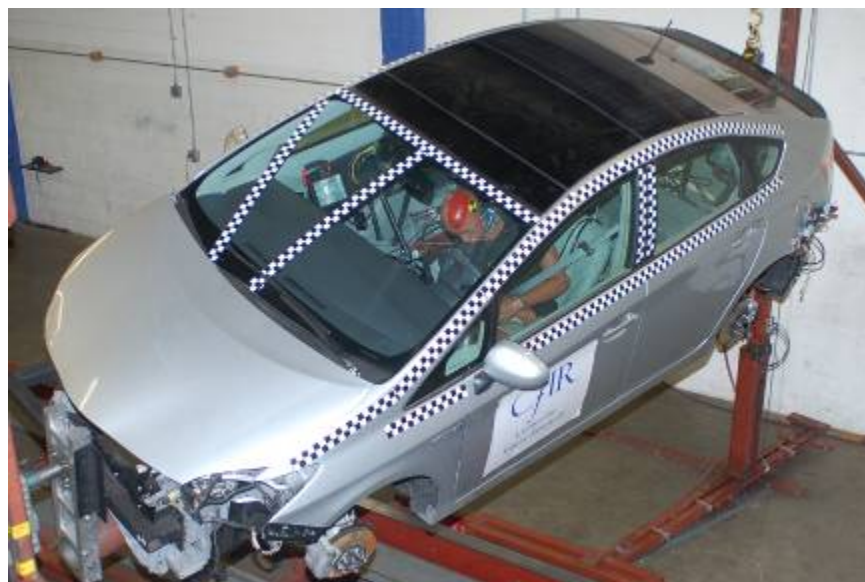
Figure 1: Vehicle Pre Roll 1

During the first roll the windshield fractured and peeled away from the driver side A-pillar. A small buckle type deformation occurred in the far side C-pillar. The Hybrid battery in the rear of the vehicle was undamaged.

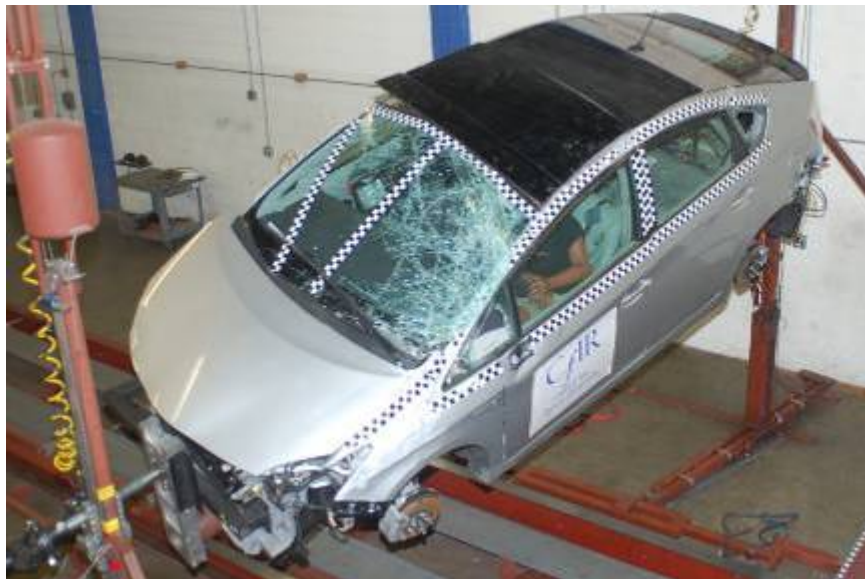
Figure 4: Vehicle Post Roll 2

During the second roll the windshield fractured further. The small quarter windows in front and rear of the driver side broke.

Pull tests were conducted on both the driver side doors of the vehicle after the second roll. Each door required less than 15 lb-f to open.

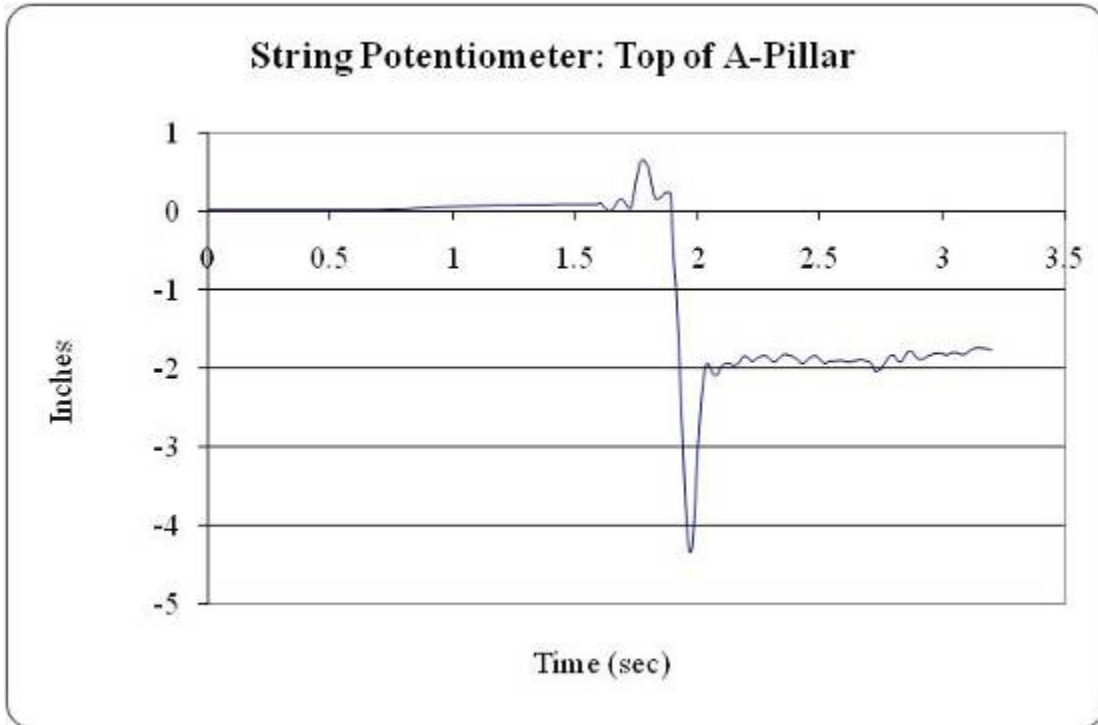
Plot 1: String Potentiometer Driver's Side A-Pillar Displacement v. Time

In Roll 1, the peak lower neck compressive load was 315 N and the peak lower neck moment was 19 Nm in flexion and 40 Nm in extension. The peak intrusion speed at the top of the A-Pillar was 4.3 mph with a peak crush of 4.4 inches.

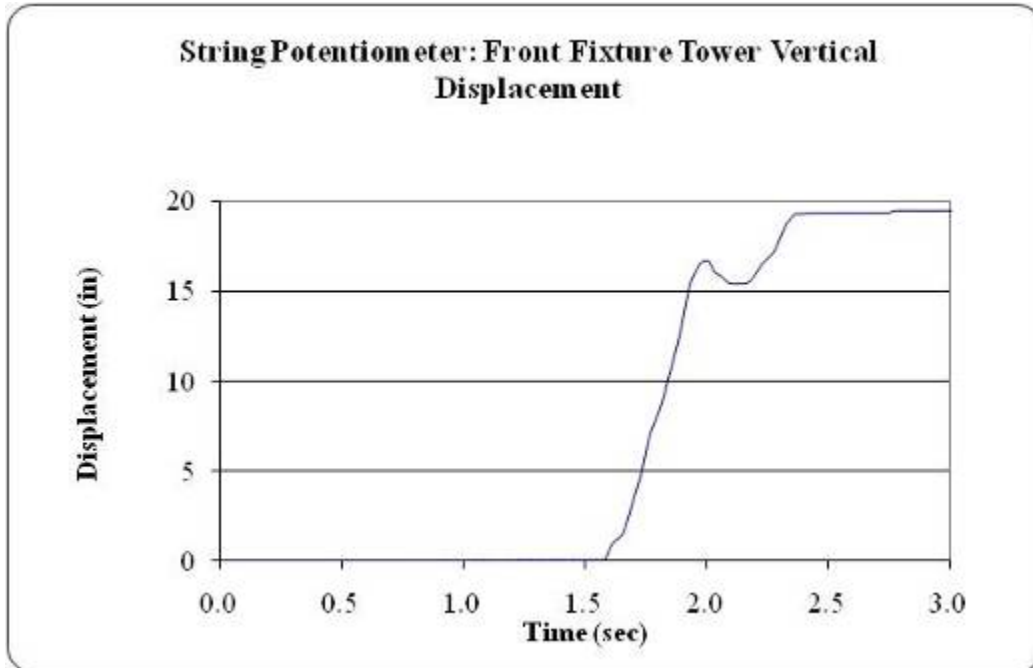
Plot 19: String Potentiometer Front Fixture Support Tower Displacement vs. Time

The string potentiometers located on the fixture support towers show the vertical vehicle motion throughout the test. The front of the vehicle dropped 4.4 inches and the rear dropped 4.3 inches prior to initial touch down. The vehicle was pitched at 5.0 degrees at contact.

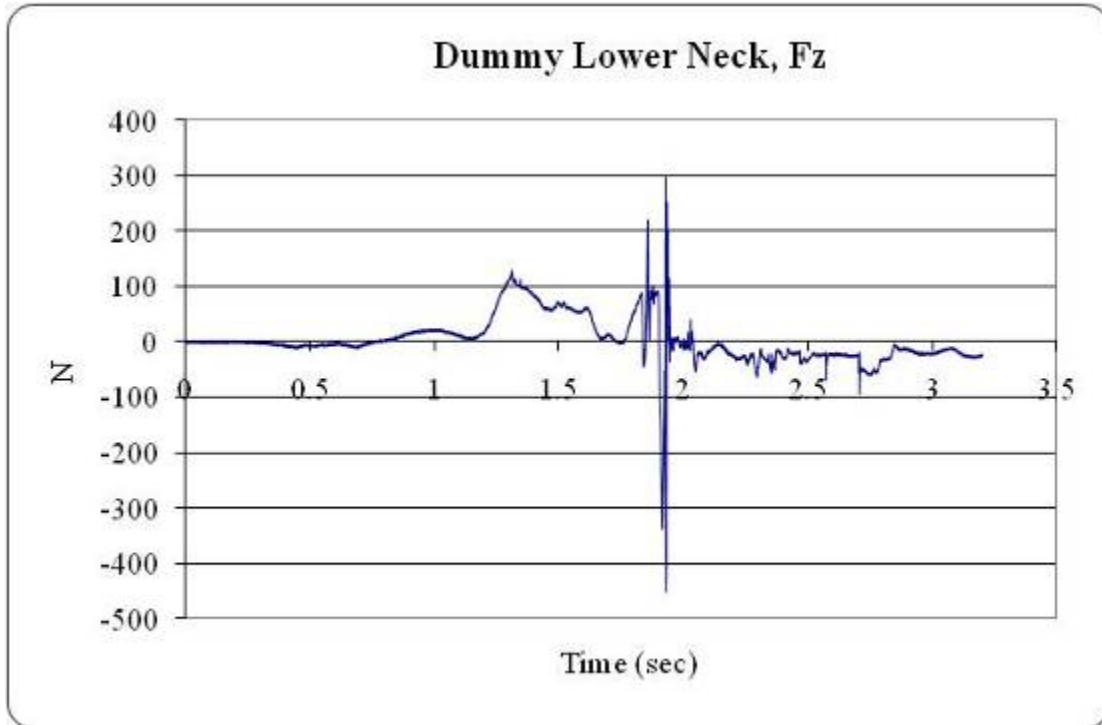
Plot 30: Lower Neck Load, Fz, v. Time

In Roll 2, the lower neck mount failed during the test. Data from the neck was recorded, but the peak values cannot be validated. The peak lower neck compressive load was 451 N and the peak lower neck moment was 14 Nm in flexion and 95 Nm in extension. The peak intrusion speed at the top of the A-Pillar was 8.2 mph with a peak crush of 6.6 inches.

\*The lower neck mount failed during the test, which resulted in peak values that cannot be validated.
