JRS Dynamic Rollover Test

2011 Kia Soul

The Center for Injury Research conducted a JRS dynamic rollover test consisting of two rolls of a 2011 Kia Soul on June 6^h and 7th. This test report is organized in sections containing test information, data tables and photographs as follows:

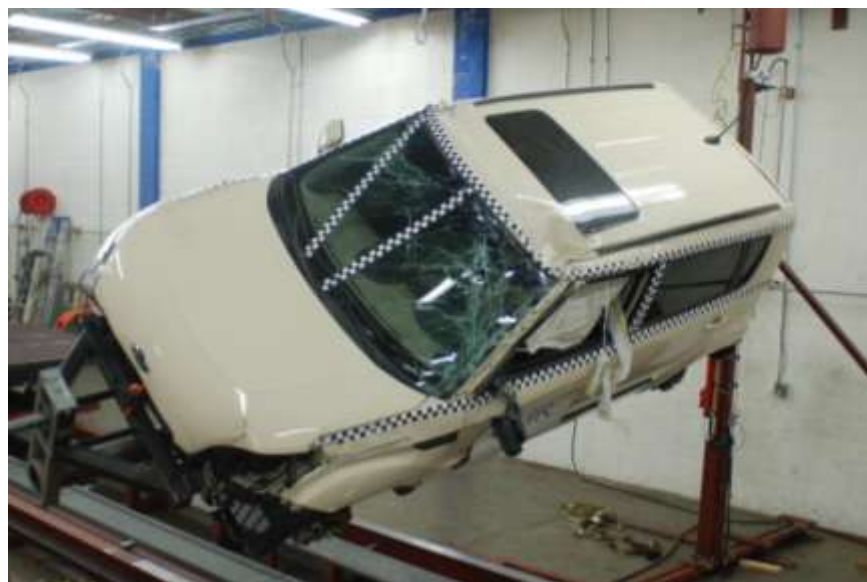
Figure 3: Vehicle Pre Roll 2

During the second roll the roof header buckled and tented upward. The deformation on the near side was similar to the residual crush on the far side, with similar levels of intrusion at both pillars.

A pull test was conducted on the doors after Roll 2. The driver side door and both rear doors opened with less than 20 lbf. The passenger door however, would not open with a force of 56 lbf applied to it. It opened easily after the passenger side rear door was opened first. This was due to the fact that deformation had caused the front door to be wedged behind the rear door.
