# Potential Thoracic Injuries in a Rollover Crash Reproduction

F J Tahan\*, K Digges\*\*, Cing-Dao Kan\*, Raphael Grzebieta\*\*\*, and Mike Bambach\*\*\*

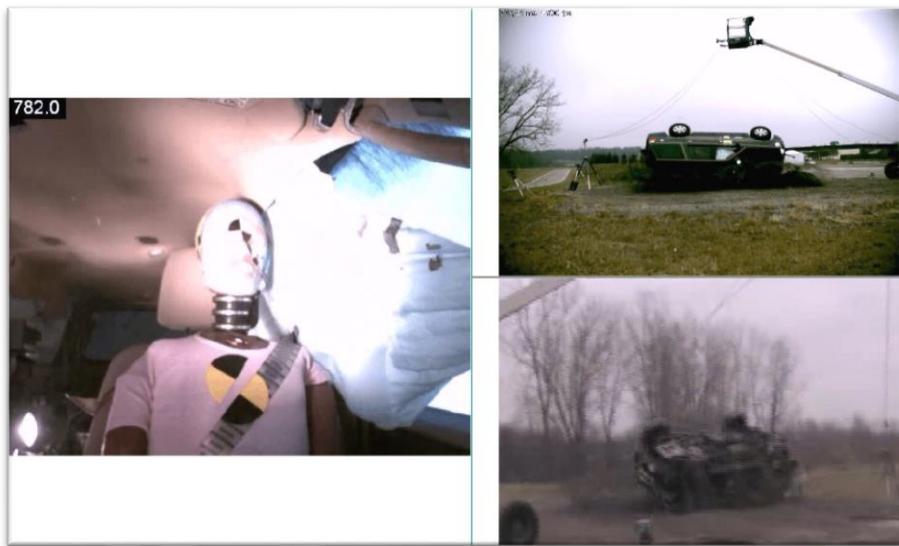
Figure 2. NHTSA Test No. 6960 Vehicle initial conditions contact (superimposed and synchronized video)

Regarding the Hybrid III dummy position at the initial rollover condition when the roof contact the ground (when the simulation starts), several tests were reviewed. From these tests, the videos of NHTSA Test No. 6960 were of interest to this paper and were examined closely (TRC 2010) [16]. Three videos from the rollover test were superimposed and synchronized in order to examine the driver dummy motion at various times of the rollover. Figure 2 shows the images of different views at the same time. The left image shows the dummy in the vehicle, in the vehicle coordinate system. The upper right image shows the rear view and the lower image shows the oblique view of the vehicle, in the earth-based inertial coordinate system. Figure 2 shows the vehicle when the roof is contacting the ground at an initial roll angle similar to the FE simulation of the reproduction NASS-CDS case (between  $125^\circ$  and  $180^\circ$ ). The left image in Figure 3, which is the same as the left image in Figure 2, shows the dummy has moved slightly upward and outboard of the center during the initial  $145^\circ$  of the rollover, since the dummy chest and seat belt marker are less than an inch apart. Therefore, the Hybrid III dummy position in the simulation at the beginning of the roof contact, as shown in Figure 3, is in agreement with the Hybrid III dummy in the test.

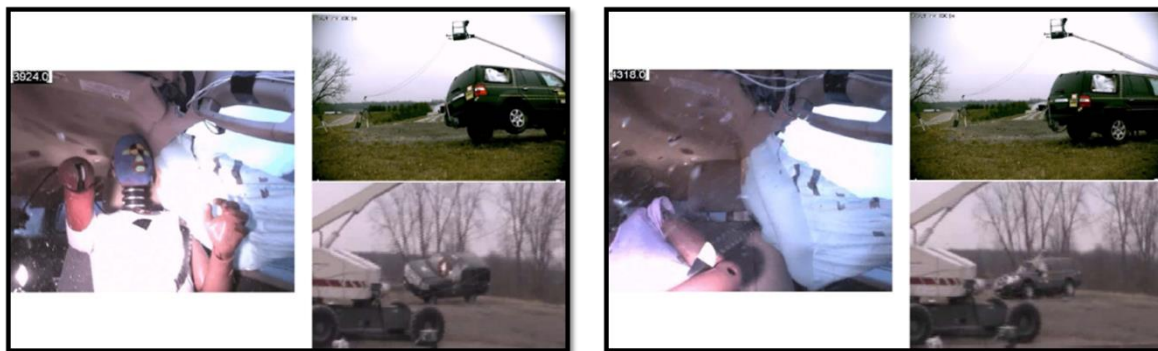
Figure 7. NHTSA Test No. 6960 8th quarter-turn left wheel contact the ground at 3924 and 4318 ms

A review of the NHTSA Test No. 6960 videos shows additional interesting findings. Figure 7 shows three superimposed and synchronized videos from the rollover test at 2 different times. When the vehicle in the test is in its final (8th) quarter-turn, the left tires contact the ground first as shown in Figure 7 at 3924 milliseconds. The Hybrid III dummy in the test as shown in Figure 7 is initially to the left, contacting the outboard side of the vehicle at the curtain airbag. Figure 7 shows the same sequence of the test at 4318 milliseconds when right tires contact the ground to complete the final (8th) quarter-turn. Figure 7 shows the Hybrid III dummy position to the right, as the torso extends past the center of the vehicle. This motion, as previously explained, is due to the abrupt reduction in the vehicle rotational speed as shown in the FE simulation during the final (4th) quarter-turn in Figure 5. The dummy is thrown from the extreme left to the extreme right (Figure 7) in less than 200 milliseconds. Since the center console was removed from the vehicle in NHTSA Test No. 6960, the Hybrid III dummy does not stop by contact, but rather by the seatbelt, which constrains the right side of the dummy. NHTSA Test No. 6960 demonstrates the validity of the rollover FE simulations that were able to identify the inboard chest injury, its timing during the rollover, and a previously undocumented contact source.
