JRS Dynamic Rollover Test

2009 Volkswagen Tiguan

Automotive Safety Research Institute
Charlottesville, VA.

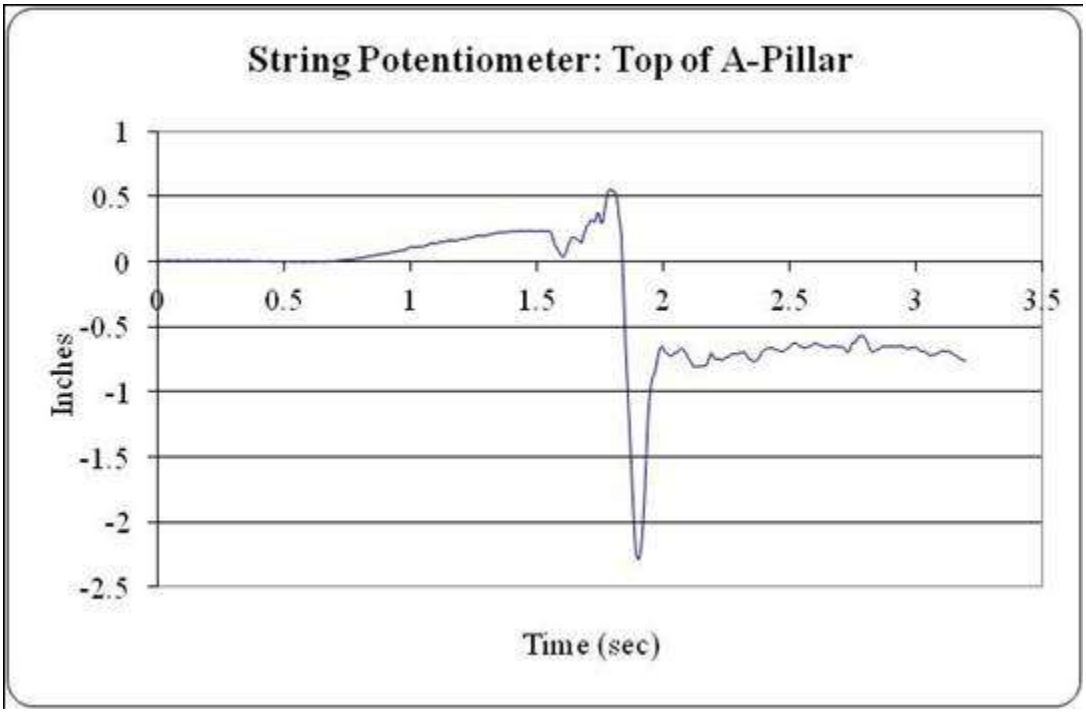
Plot 1: String Potentiometer Driver's Side A-Pillar Displacement v. Time

In Roll 1, the peak lower neck compressive load was 210 N and the peak lower neck moment was 26 Nm in flexion and 33 Nm in extension. The peak intrusion speed at the top of the A-Pillar was 3.2 mph with a peak crush of 2.3 inches.

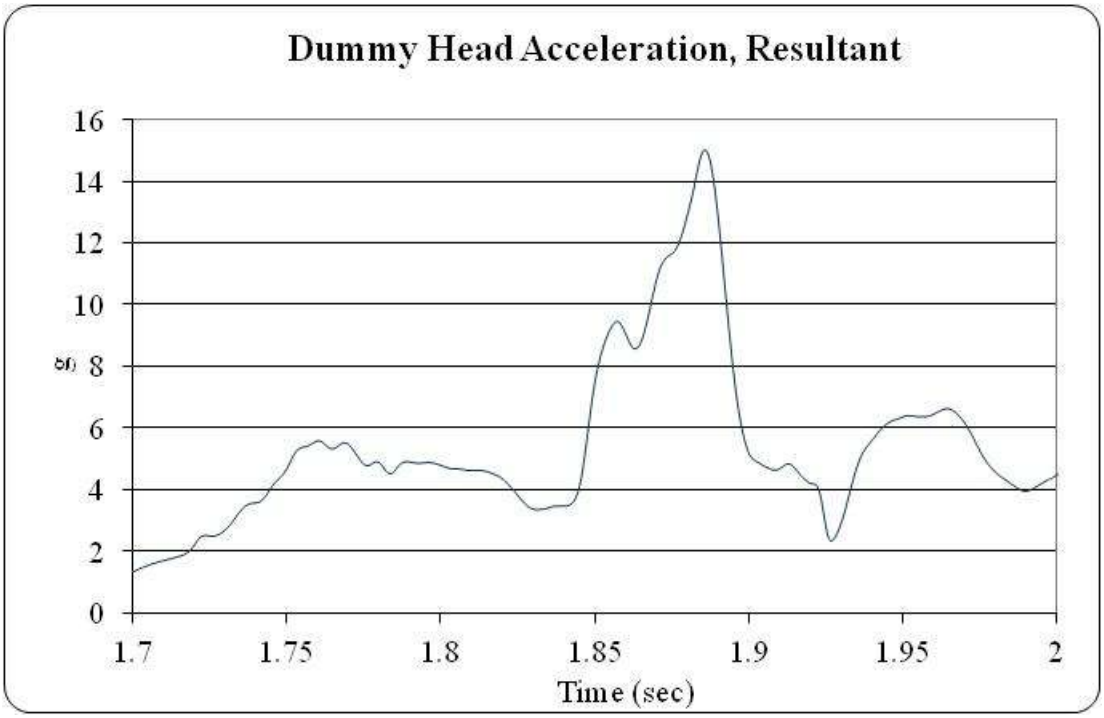
Plot 13: Resultant Head Acceleration vs. Time

HIC = 16

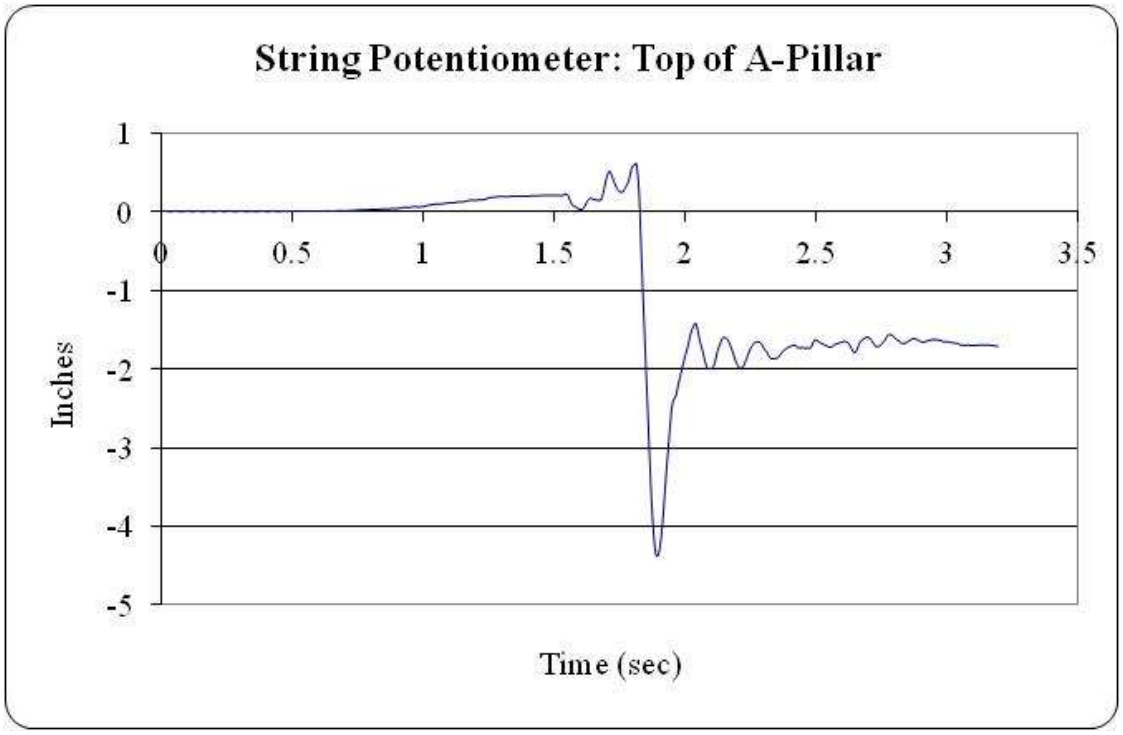
Plot 20: String Potentiometer Driver's Side A-Pillar Displacement v. Time

In Roll 2, the peak lower neck compressive load was 1,787 N and the peak lower neck moment was 96 Nm in flexion and 27 Nm in extension. The peak intrusion speed at the top of the A-Pillar was 5.7 mph with a peak crush of 4.4 inches.

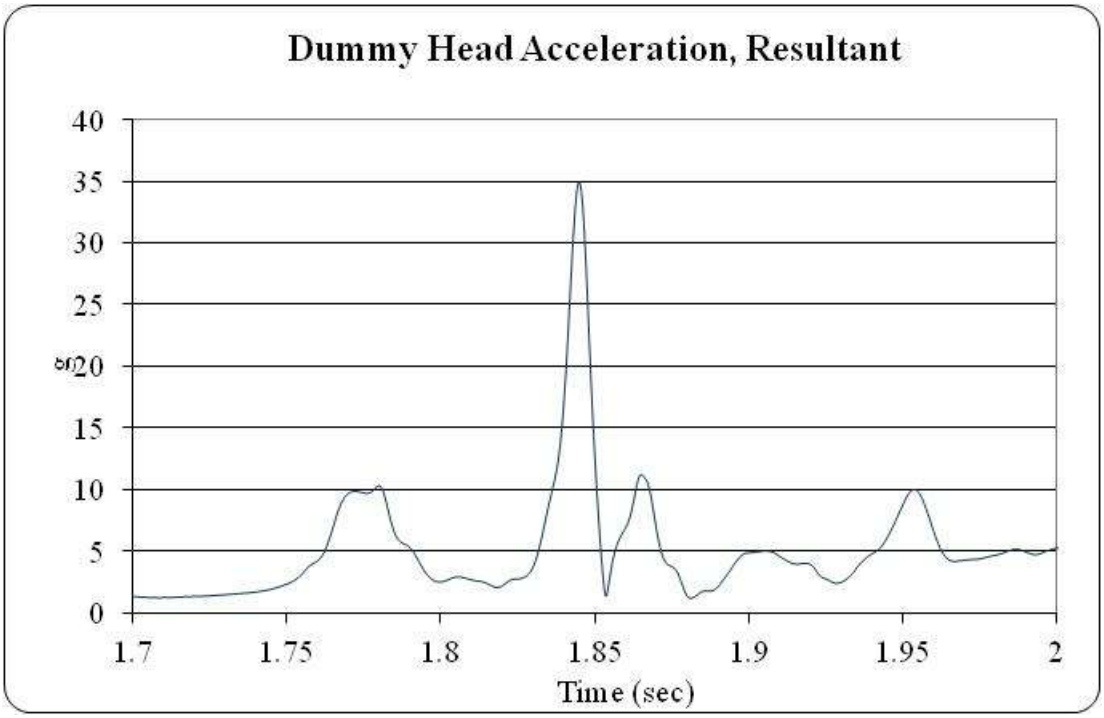
Plot 32: Resultant Head Acceleration vs. Time

HIC = 37

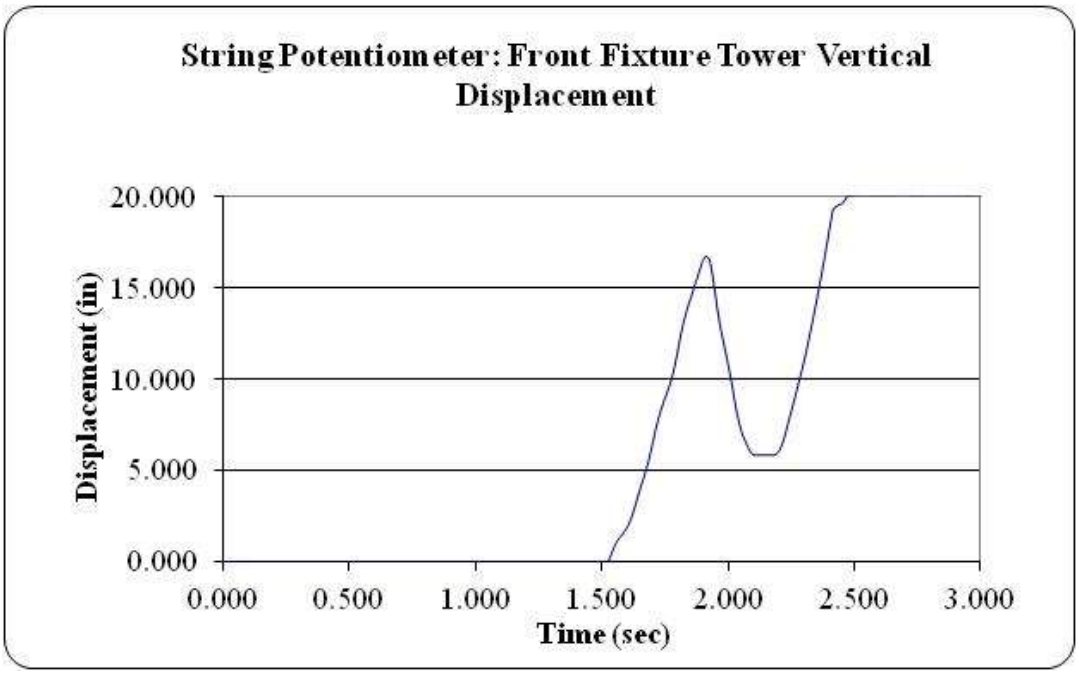
Plot 37: String Potentiometer Front Fixture Support Tower Displacement vs. Time

The string potentiometers located on the fixture support towers show the vertical vehicle motion throughout the test. The front of the vehicle dropped 5.1 inches and the rear dropped 4.8 inches prior to initial touch down. The vehicle was pitched at 10 degrees at contact.

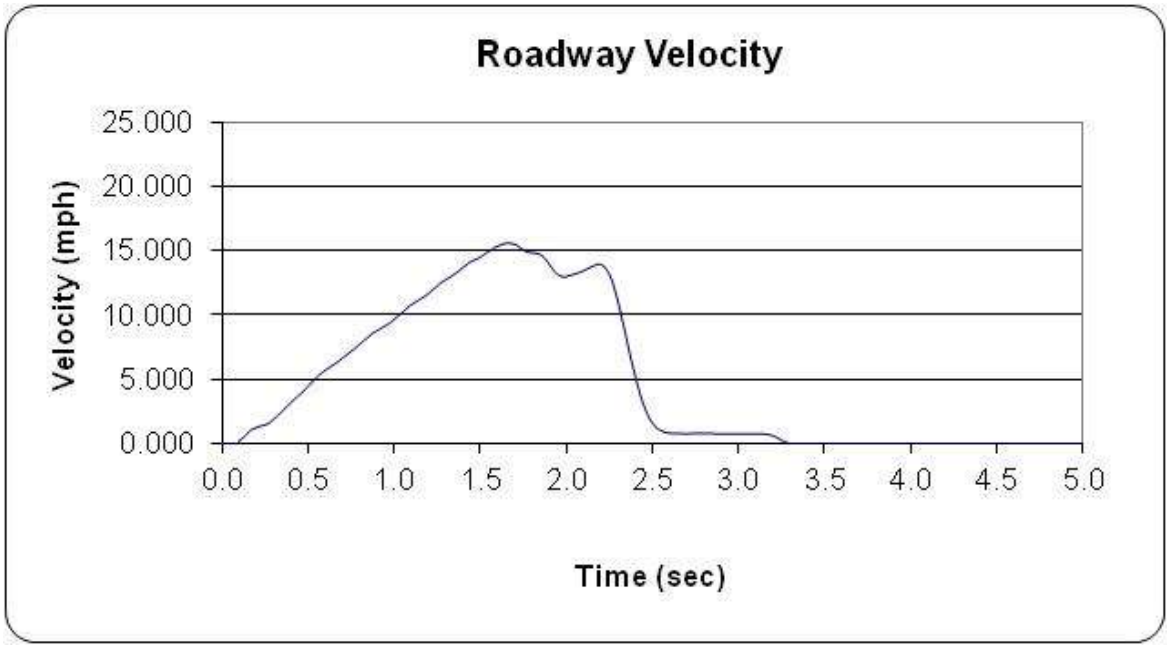
Plot 39: Roll Encoder on Roadway Velocity vs. Time

The roll encoder located on the cable pulley shows the roadway velocity throughout the roll. The roadway was traveling at 15.6 mph at contact. A roll rate sensor in the vehicle was used to determine the roll angle and roll rate at impact. The roll angle of the vehicle was 146 degrees and the roll rate was 188 degrees per second at the roadway impact.
