RESEARCH TO EVALUATE SAFETY TECHNOLOGIES FOR VULNERABLE FUEL TANKS

Kennerly Digges
Automotive Safety Research Institute
USA
Edmund Fournier
Matthew Keown
Jim Kot
Nicholas Shewchenko
Biokinetics & Associated, Ltd.
Canada
Paper Number 230

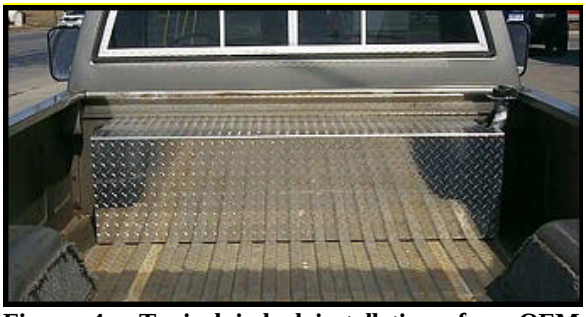
The tank was covered by a 3 mm thick aluminum checker plate shield for protection from shifting cargo. The shield installation is shown in Figure 4. The shield weighed 15.8 kg and cost approximately $215. Other miscellaneous hardware required for the bed installation cost $40. The installation time for the bed tank and shield was 3 hours. Installation procedures for this tank were documented in a report [Fournier et al, January, 15 2003].

Figure 4. Typical in-bed installation of an OEM tank with shield

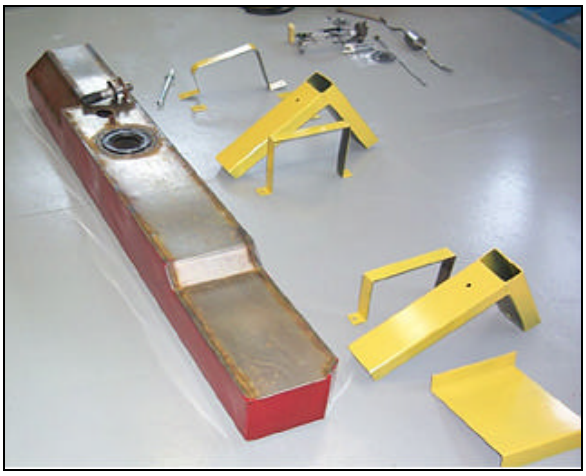
Figure 5. Center-mounted with mounting brackets

Figure 6. Typical center-mounted tank installation – Rear View

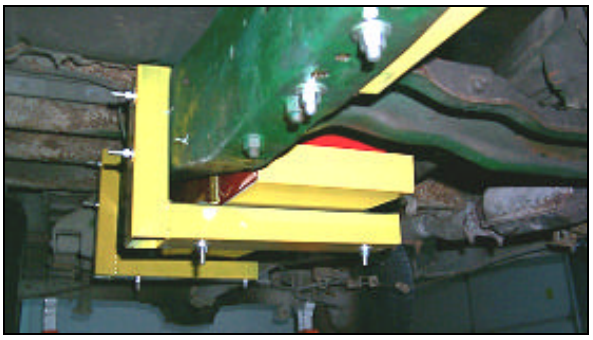
Figure 7. Typical center-mounted tank installation – Front View

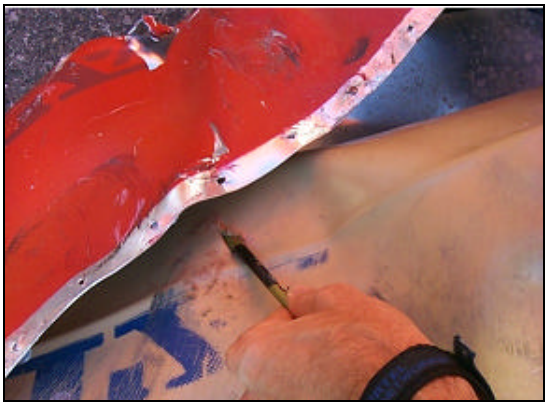
Figure 8. Damage to the fuel cell aluminum housing (a) cut in fuel cell caused by sharp aluminum surface (b)

With the aluminum container ruptured, the fuel cell inside was ejected from the truck. In the process, all the fuel lines connected to the tank were severed. The filler tube was disconnected from the tank, but a reverse flow flapper valve in the tank prevented spillage at the filler spud. Additionally, a rollover valve on the vent line prevented fuel leakage from the severed vent hose. There were no provisions in the fuel supply line to prevent fluid loss in the event that the line was severed and consequently it leaked fuel. However, the majority of fuel spillage stemmed from a tear in the bladder that was discovered along its lower inside edge. The damage was caused by the rear mounting bracket/strap that failed during the impact and perforated the aluminum outer housing creating sharp edges on the inside of the housing that cut or punctured the bladder. The damaged aluminum cover and fuel cell puncture are shown in Figure 8.

A second fuel cell system was assembled addressing the shortcomings identified by the results of the first test. Enhancements to the second fuel cell included fabricating the outer housing from steel rather than aluminum with through bolts instead of rivets to secure the hosing cover and the end plates of the container. The mounting brackets, which previously supported the tank from underneath, were replaced with brackets from which the tank was suspended. The intent of the new bracket arrangement was to allow the tank to deform without being restricted by the mounting brackets. To prevent fuel leakage from severed fuel lines, self-sealing breakaway connectors were installed on the fuel delivery and returns lines. As with the previous fuel cell, the vent line relied on an internal rollover valve.

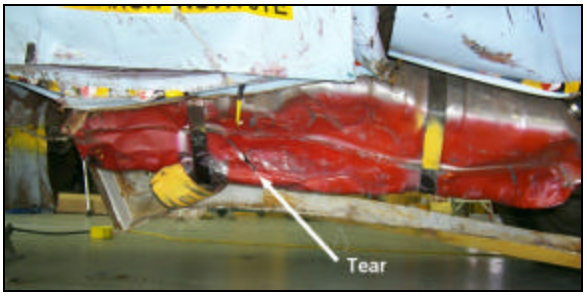
Notwithstanding the additional bracing of the rear support, neither the protective frame nor the vehicle structure to which it was bolted were capable of resisting the severe downward torque applied by the impacting vehicle, thereby, leaving the tank exposed and vulnerable to direct loading by the bullet vehicle. A significant tear in the tank resulted in excessive fluid loss. Damage to the tank and frame are shown in Figure 10.

Figure 10. Damage to the tank protective frame

A retest of the tank protection system was performed with a second system based on the initial frame except with two additional attachment points to specifically counteract the downward moment applied by the impacting vehicle. The front end of the guard was fastened vertically to the cab floor and

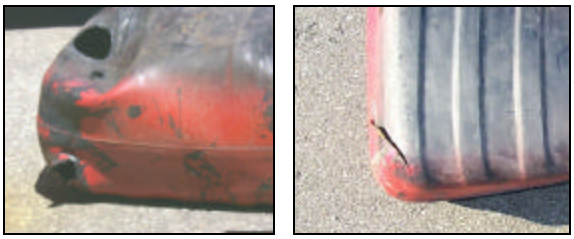
Tears in the tank, as a result of excessive deformation, were only one of the failure modes. Punctures and cuts from aggressive components on the truck itself or on the bullet vehicle were also prevalent. Damage to the tanks is shown in Figure 12. The available aftermarket plastic tank did not offer any improvements over the existing OEM steel tank. Considerable additional development appeared necessary for significant improvements. This approach was discontinued.

Figure 12. Puncture and slash damage to plastic tank

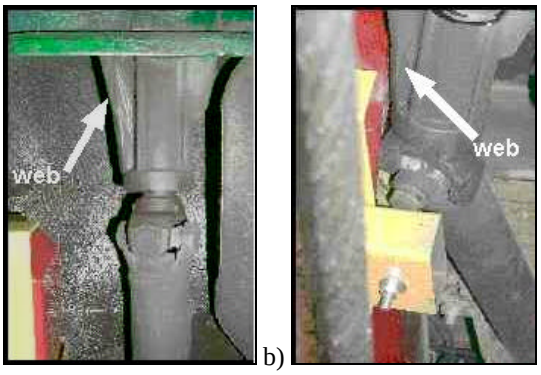
Relocating the tank between the frame rails reduces its vulnerability to side impact, but may increase vulnerability in some other crashes. In severe crashes into a rigid frontal barrier the engine and transmission move rearward. An aggressive web on one of the alternative transmission produced a leak in one frontal barrier test. In addition, the drive shaft may buckle in the direction of the tank causing damage. Figure 14 shows the location of the aggressive transmission web and the drive shaft relative to the tank before and after a frontal crash test.

Figure 14. Drive shaft and transmission clearance in severe frontal crash – before (a) and after (b)

The final center-mounted tank design addressed both of these undesirable loadings. The transmission contact was mitigated by increasing the tank to transmission clearance and by chamfering the corner of the tank to reduce the stress concentration when contact occurs. The drive shaft contact was addressed by maintaining OEM drive shaft clearance for center-mounted tanks and by positioning the tank brackets to resist drive shaft loading. The tank thickness of 1.52 mm. provided added protection compared with 0.86 mm. in the OEM tank.

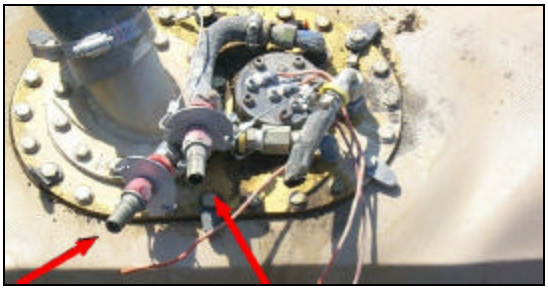
Self-sealing breakaway connectors were installed on the fuel delivery and returns lines on the racing fuel cell. In a Caprice test, the fuel lines connectors disengaged and no leakage occurred. The self-sealing breakaway connectors are shown in Figure 17 before and after the test.

Figure 17. Self-sealing break-away couplings in fuel line before test (a) and after test (b)
