RESEARCH TO EVALUATE SAFETY TECHNOLOGIES FOR VULNERABLE FUEL TANKS

Kennerly Digges

Paper Number 230

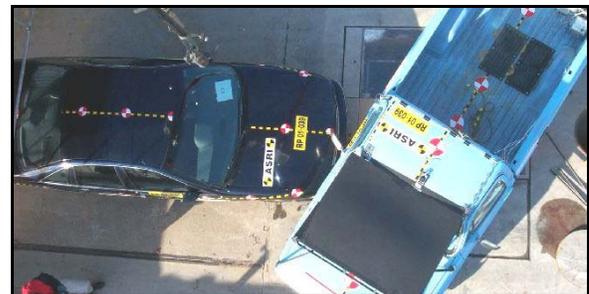
Figure 1. Typical vehicle alignment in side impact tests with a Caprice as the bullet vehicle

The side impact test with the Chevrolet Caprice as the bullet vehicle, as shown in Figure 1 did not challenge the tank in the bed location. The pickup damage was located below the bed of the truck, and the tank was well protected. To provide a more challenging test, an FMVSS 301 rigid faced moving barrier was used, as shown in Figure 2. However, the barrier speed was increased from 32 km/h (20 mph) to 64 km/h (40 mph). The bed-mounted tank passed this test.

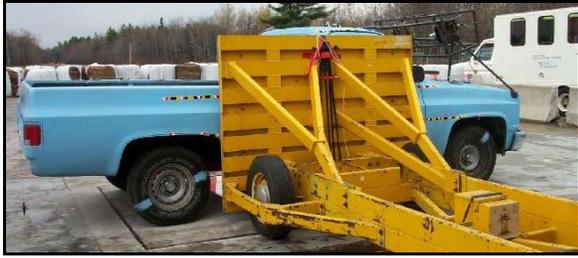
Figure 2. Alignment of the FMVSS 301 barrier for side collision

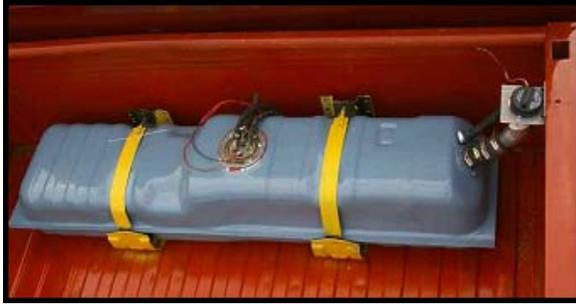
The bed-mounted system consisted of relocating a standard OEM steel tank and brackets, normally installed in the sidesaddle position, into the bed of the truck. Standard mounting brackets were used with additional holes drilled in the brackets such that they could be bolted vertically into the floor of the truck bed. A typical installation is shown in Figure 3.

Figure 3. OEM bed tank installation with OEM brackets

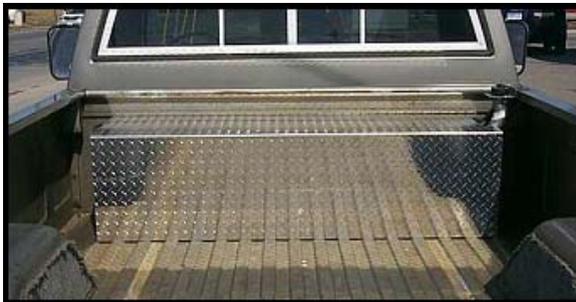
The tank was covered by a 3 mm thick aluminum checker plate shield for protection from shifting cargo. The shield installation is shown in Figure 4. The shield weighed 15.8 kg and cost approximately \$215. Other miscellaneous hardware required for the bed installation cost \$40. The installation time for the bed tank and shield was 3 hours. Installation procedures for this tank were documented in a report [Fournier et al, January, 15 2003].

Figure 4. Typical in-bed installation of an OEM tank with shield

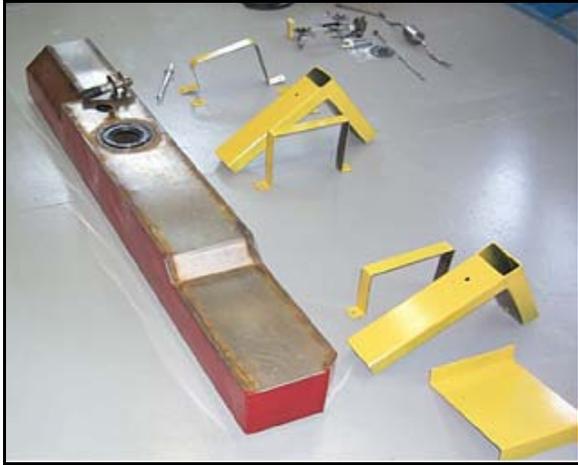
Figure 5. Center-mounted with mounting brackets

The center-mounted tank was custom fabricated at a welding shop specializing in fuel tanks. It comprised a box shaped container fabricated from 1.52 mm thick sheet steel. This steel is thicker than that used in the original equipment manufacturer's (OEM) mass produced tanks, which were nominally 0.86 mm thick. The reasons for the thicker steel were two fold: first, the thicker steel simplified the manual welding process and second it offered improved resistance to damage. The tank was held in place at three locations. The front and center of the tank were strapped down to a substantial "L" shaped bracket that bolted directly to a frame rail and supported the tank from underneath (See Figure 6 and Figure 7). A strap that attached to the frame rail and a cross member supported the rear of the tank. The weight of the straps, brackets and miscellaneous components was 12.1 kg. Approximately three hours of labor was required to install the tank. . Installation procedures for the center-mounted tank were documented in a report [Fournier et al, January 29, 2003].

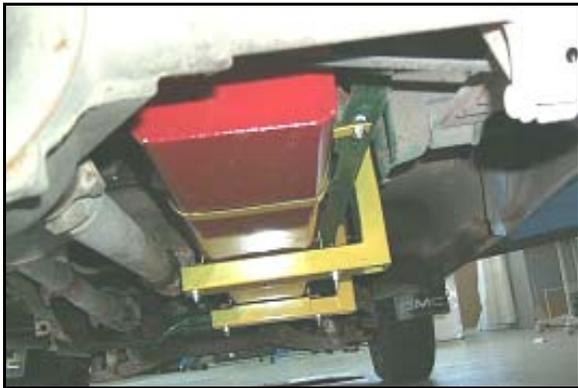
Figure 6. Typical center-mounted tank installation – Rear View

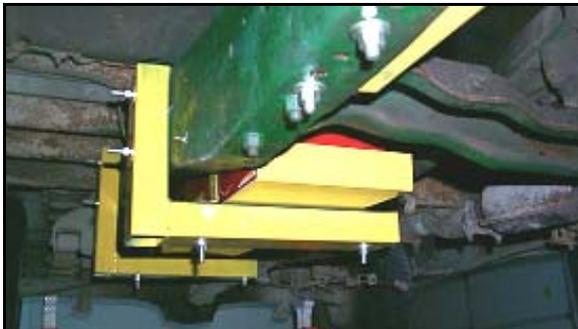
Figure 7. Typical center-mounted tank installation – Front View

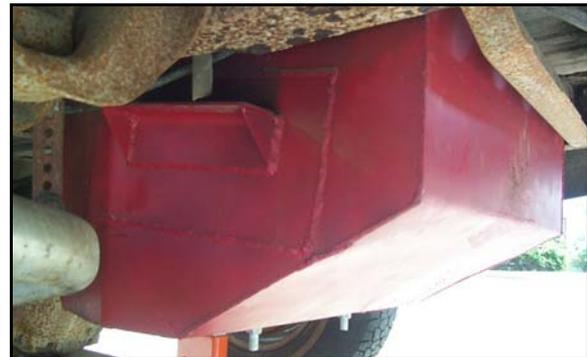
An aftermarket rear mounted tank was installed on one truck and subjected to the 80km/h (50 mph) Caprice test and it performed satisfactorily. However, due to its potential vulnerability to a Caprice test in a rear impact, this approach was not continued. The cost of the tank kit was \$400. The configuration is shown in Figure 13.

Figure 13. After market rear mounted tank
