VEHICLE BONFIRE TO INDUCE CATASTROPHIC FAILURE OF A 5,000-PSIG HYDROGEN CYLINDER INSTALLED ON A TYPICAL SUV

FINAL REPORT
Consisting of 28 Pages

SwRI® Project No. 01.06939.01.005
Test Date: September 14, 2006
Report Date: December 14, 2006

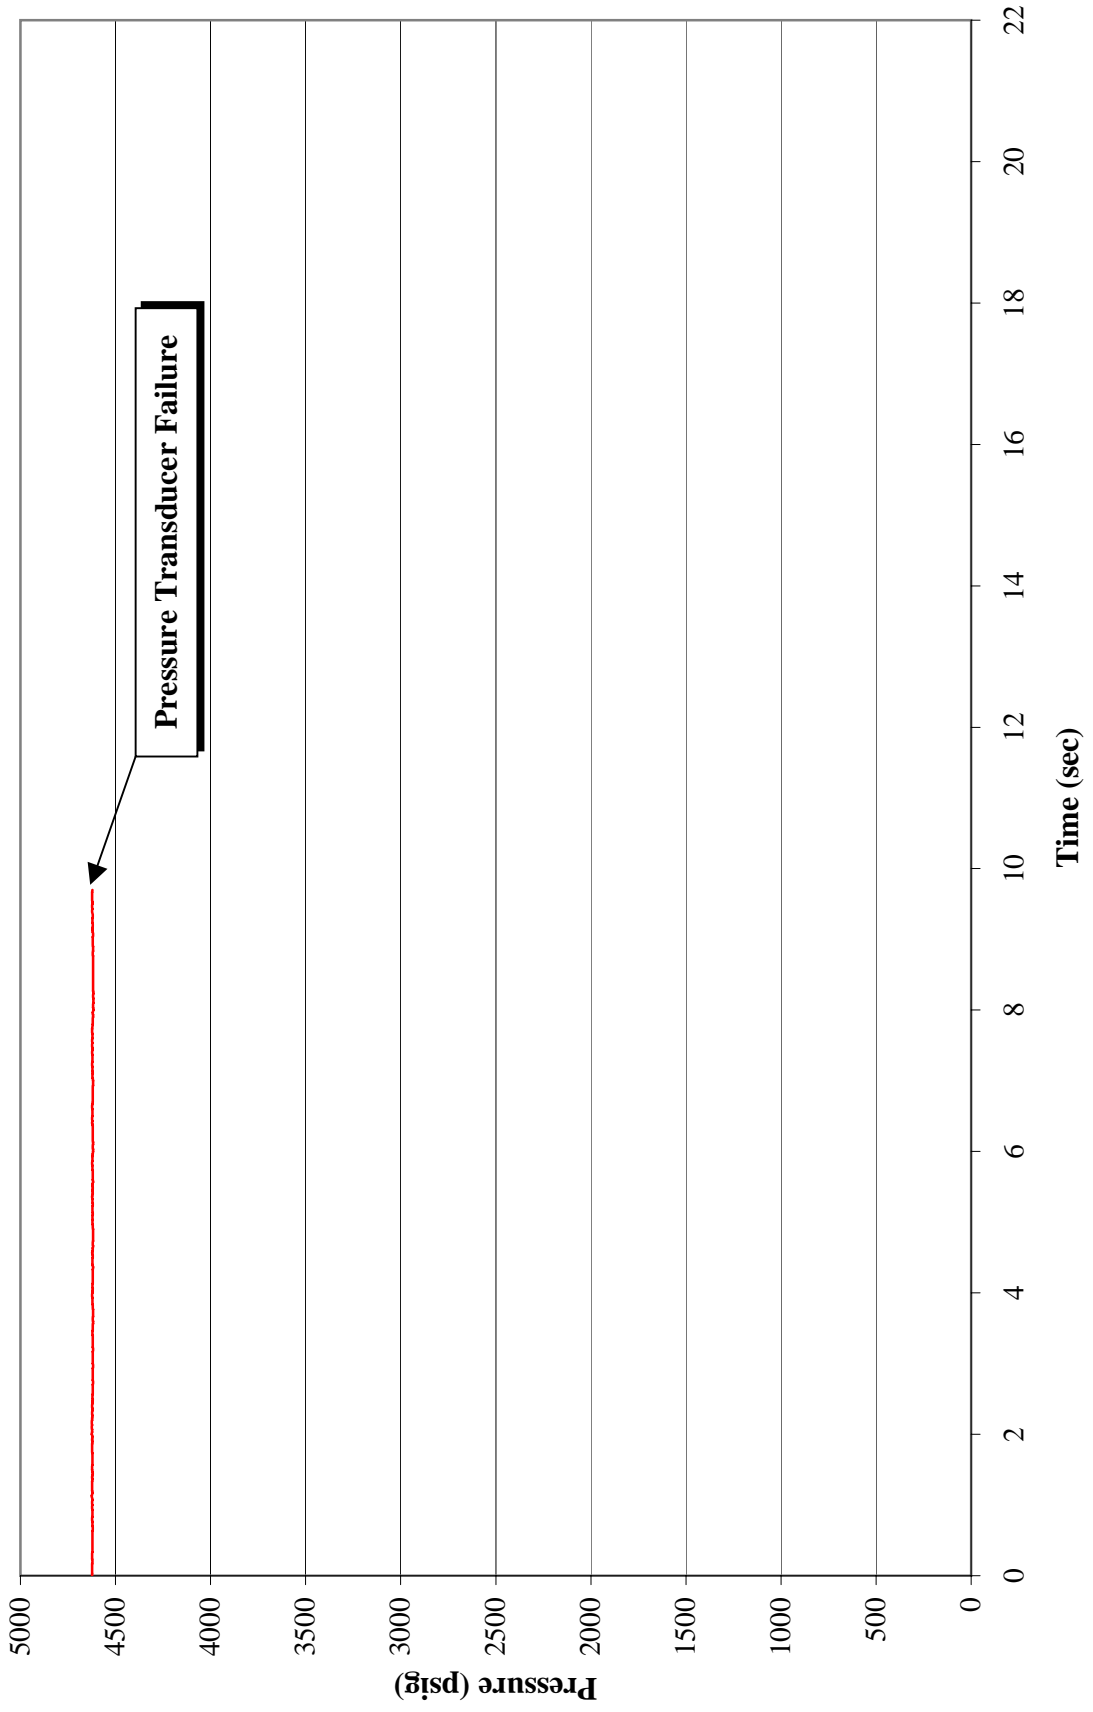
Hydrogen Cylinder Internal Pressure

Combustion of the composite material and plastic vehicle components began within 20 sec of ignition, as evidenced by the appearance of black soot. The internal pressure of the hydrogen cylinder remained fairly constant during the exposure. The pressure transducer failed at approximately 1 min 24 sec into the test, at which time the cylinder pressure had not changed from its initial value.

The cylinder had been exposed to the fire for 12 min 18 sec when it lost its integrity and failed catastrophically. Graphical depiction of the test data is provided in Appendix A. Photographic documentation of the test is provided in Appendix B.

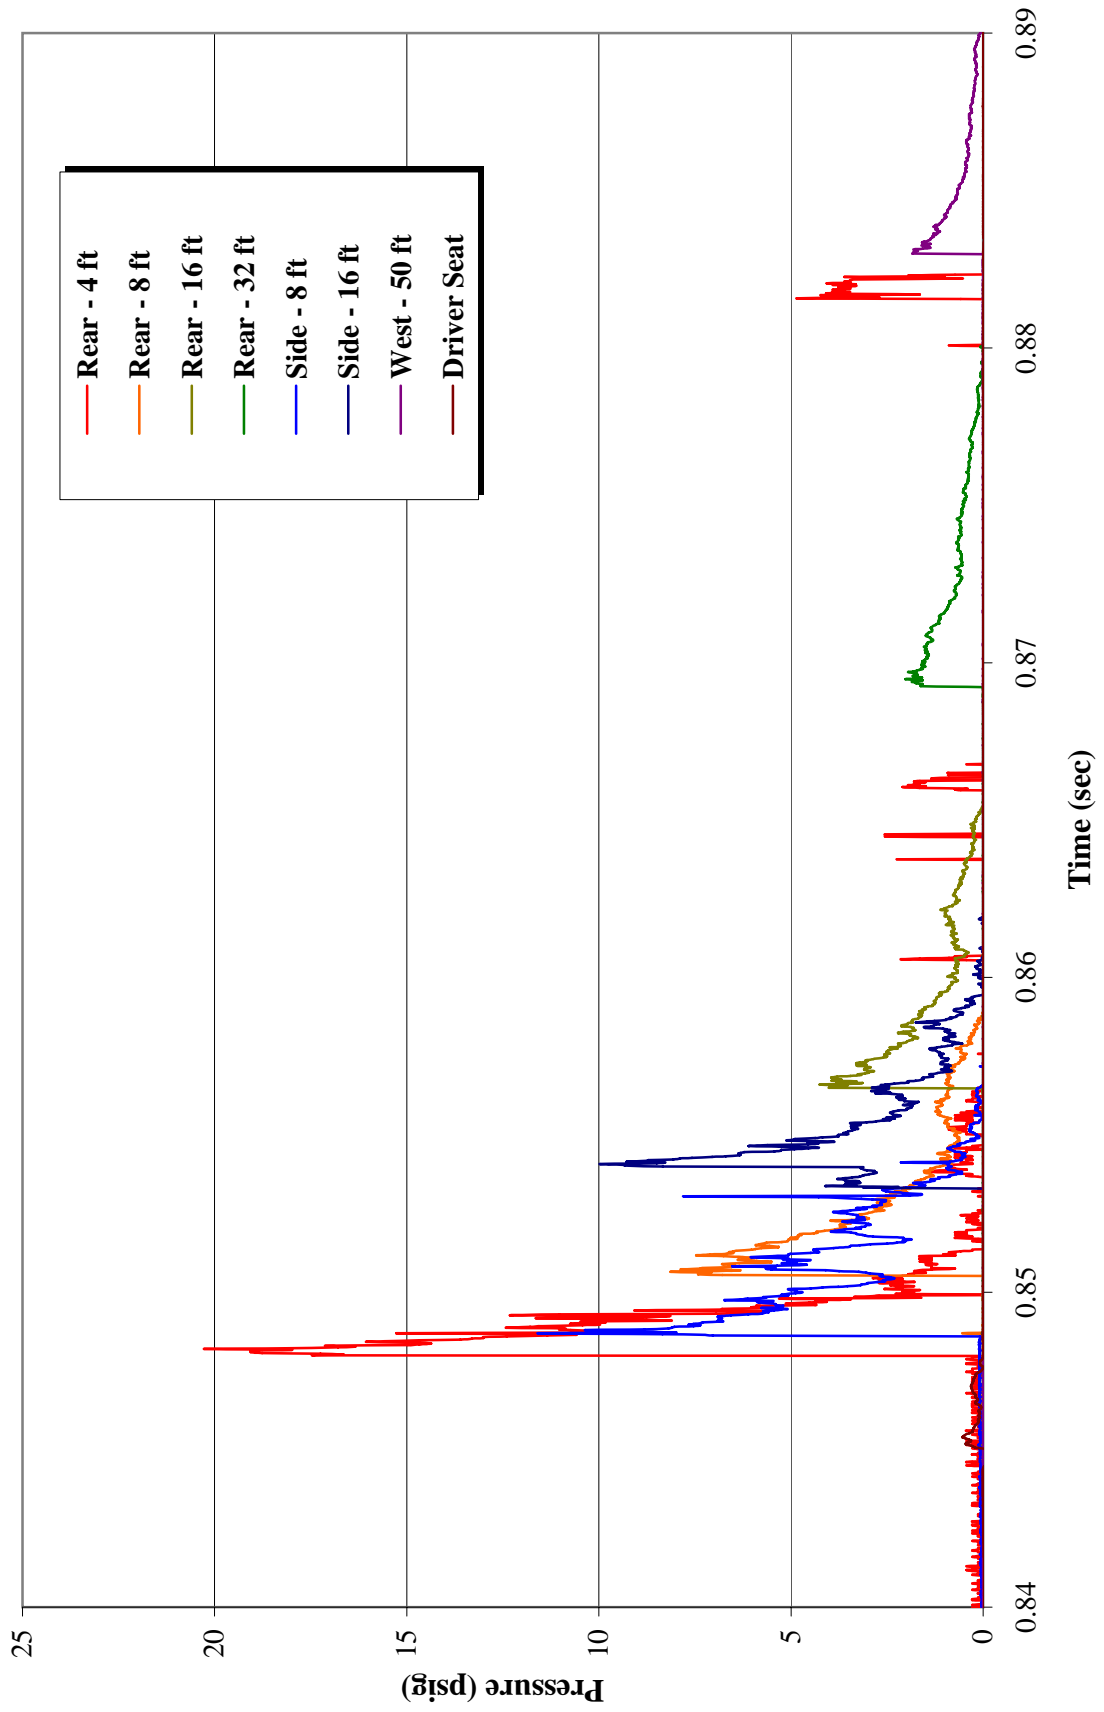
Blast Wave Pressures

Rear 4 ft	Rear 8 ft	Rear 16 ft	Rear 32 ft	Side 8 ft	Side 16 ft	West 50 ft	Driver Seat
Pressure - psig (kPa)	20.3 (140)	8.1 (56)	4.3 (30)	2.0 (14)	11.6 (80)	10 (69)	1.8 (12)	0.5 (3)
Arrival Time (s)	0.848000	0.850550	0.856500	0.869250	0.848625	0.853325	0.883000	0.845050

The pressure obtained at 16 ft on the driver side of the vehicle, oriented on the longitudinal axis of the cylinder, was 2.3 times higher than the respective location to the rear of the vehicle, oriented on the cylinders radius. This is likely due to the manner in which the cylinder failed, projecting itself to the north, above where the “side” pressure transducers were located.

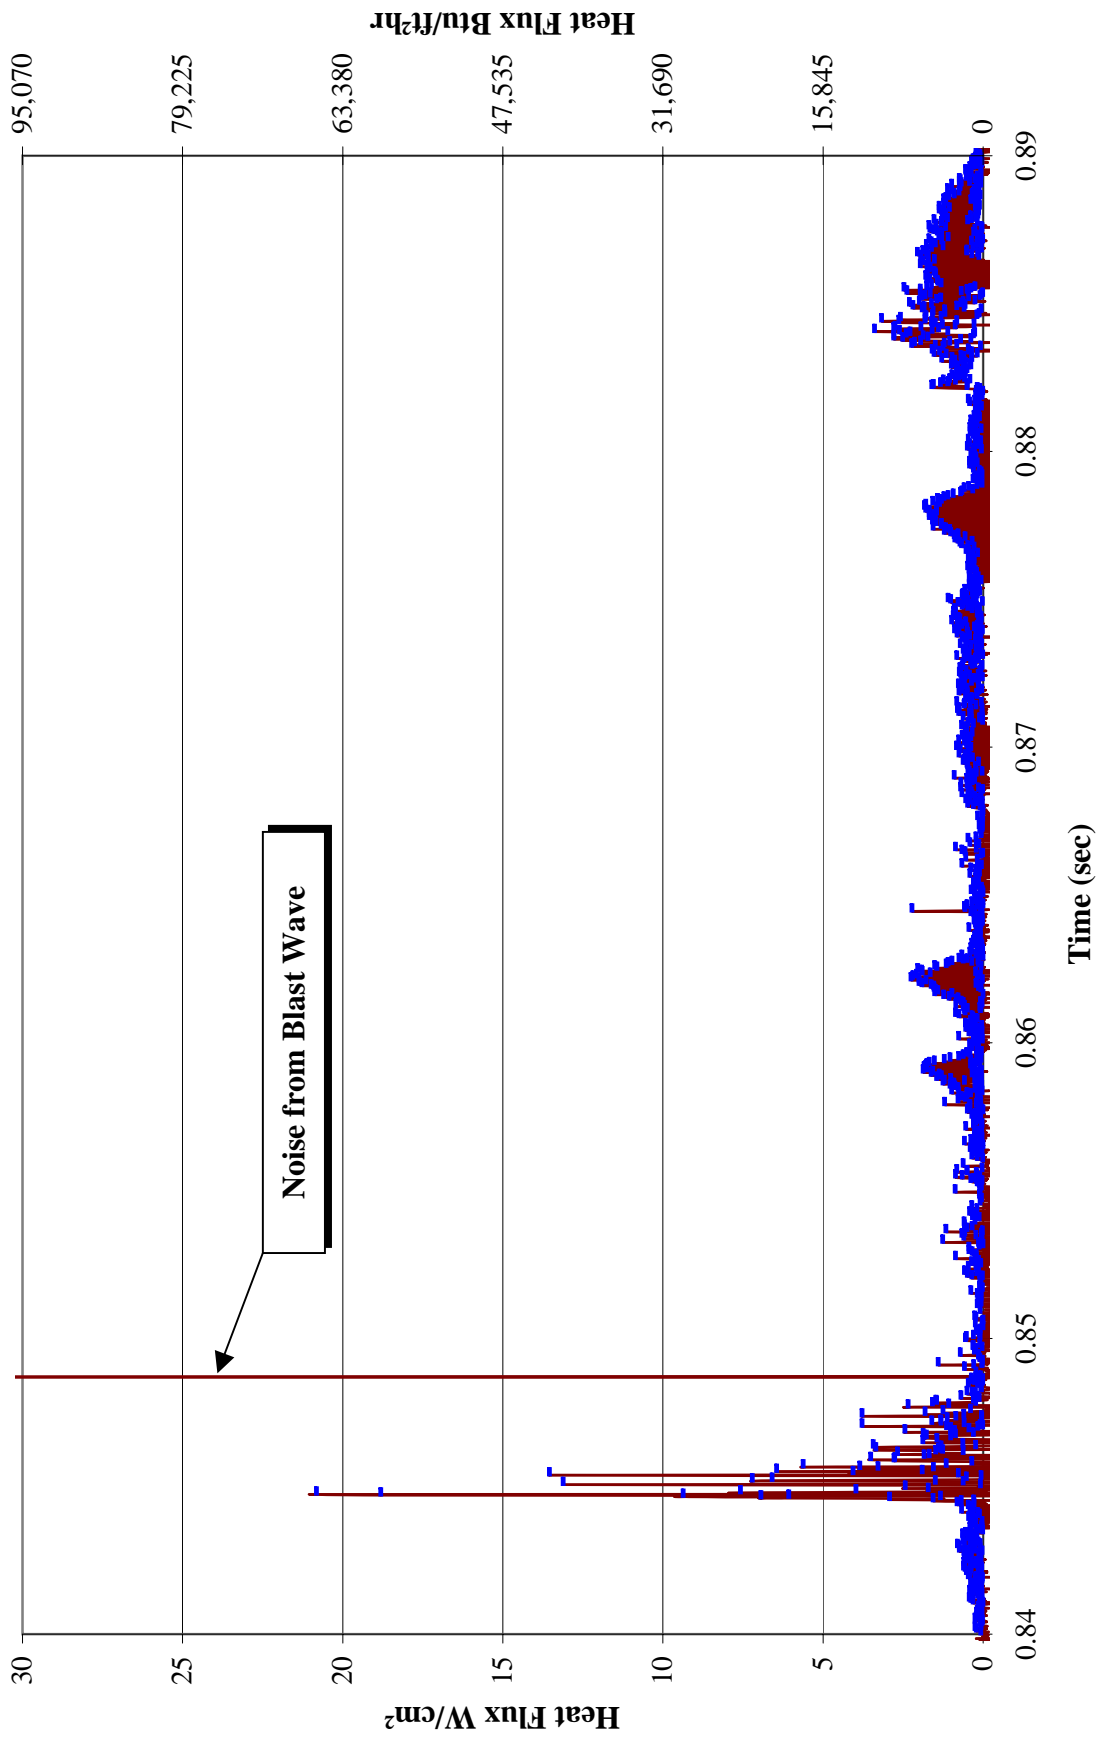
Blast Wave Heat Flux

Heat flux data peaked at approximately 66,000 Btu/ft²hr (21 W/cm²), followed by a rapid decrease to zero in 0.003 sec. An unreasonably large, single-point peak that followed, is presumed to be the noise caused by the blast wave.
