**CALSPAN/CHRYSLER
RESEARCH SAFETY VEHICLE
PHASE III
FINAL TECHNICAL REPORT**

**VOLUME I
EXECUTIVE SUMMARY**

April 1980
Contract No. DOT HS-7-01551

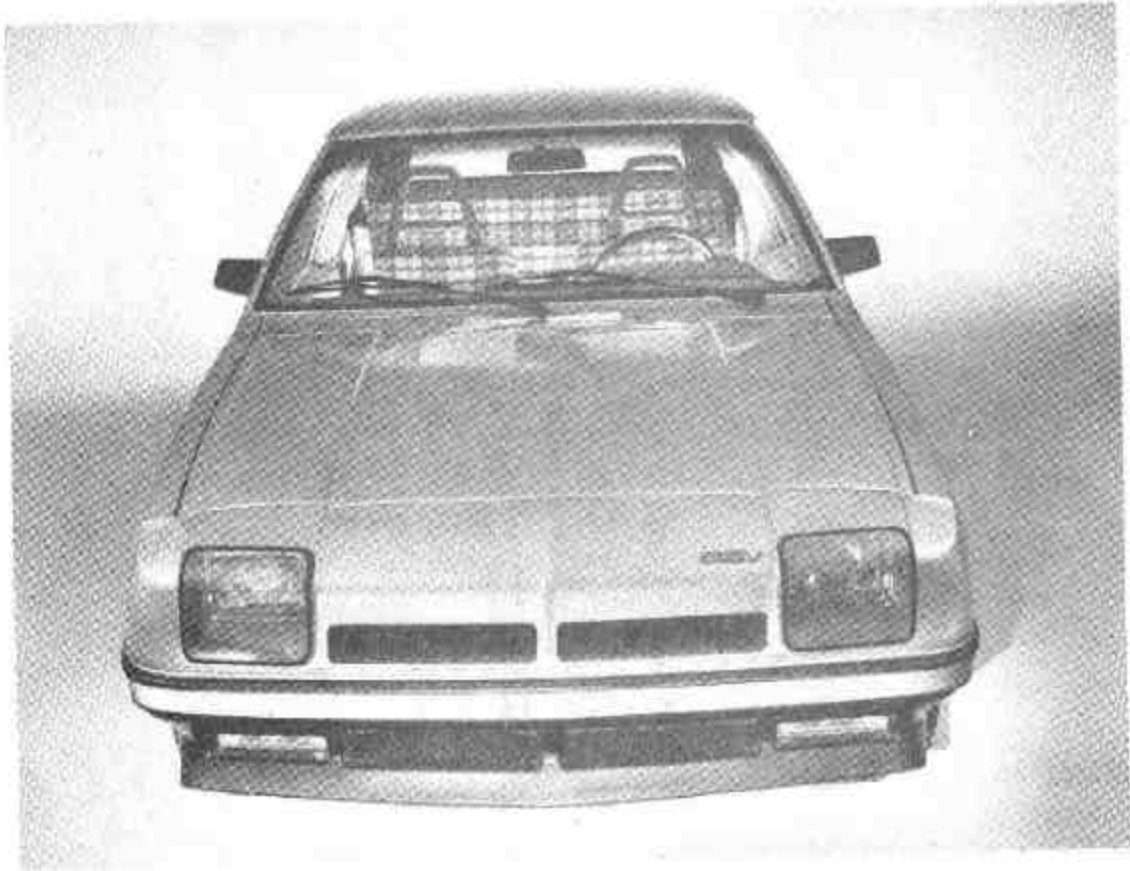
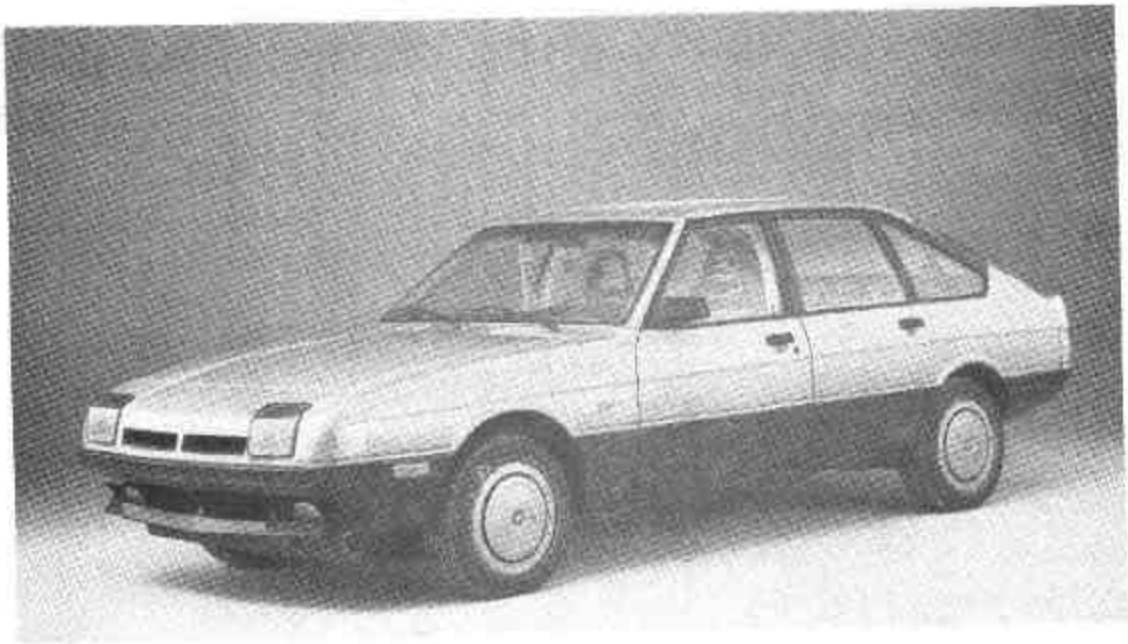
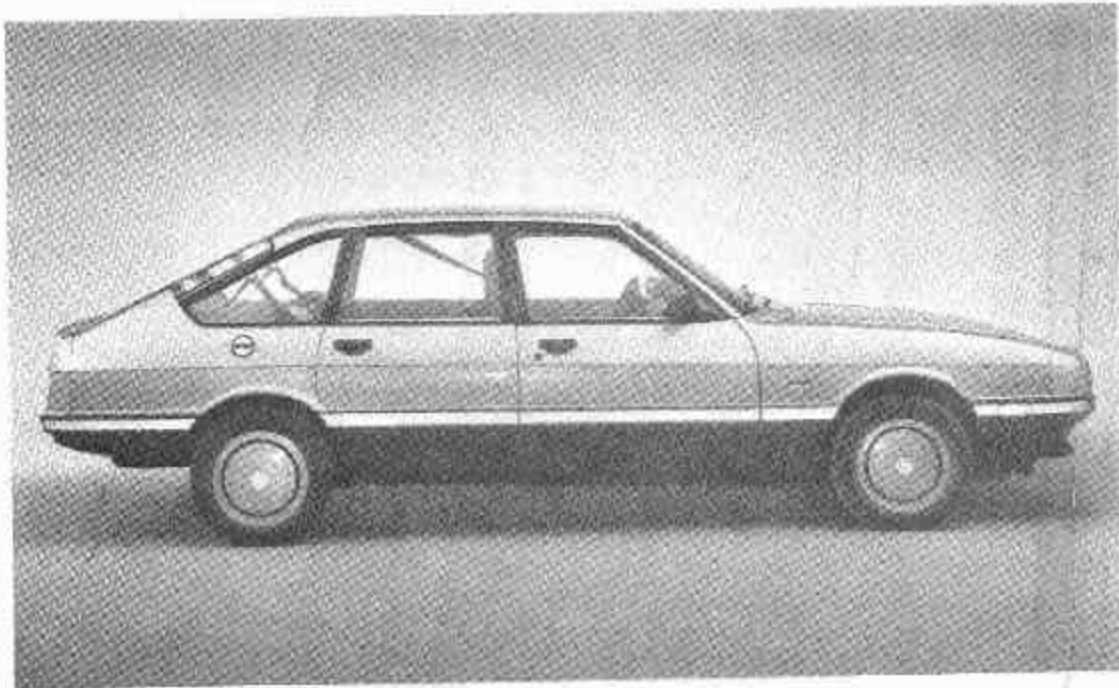
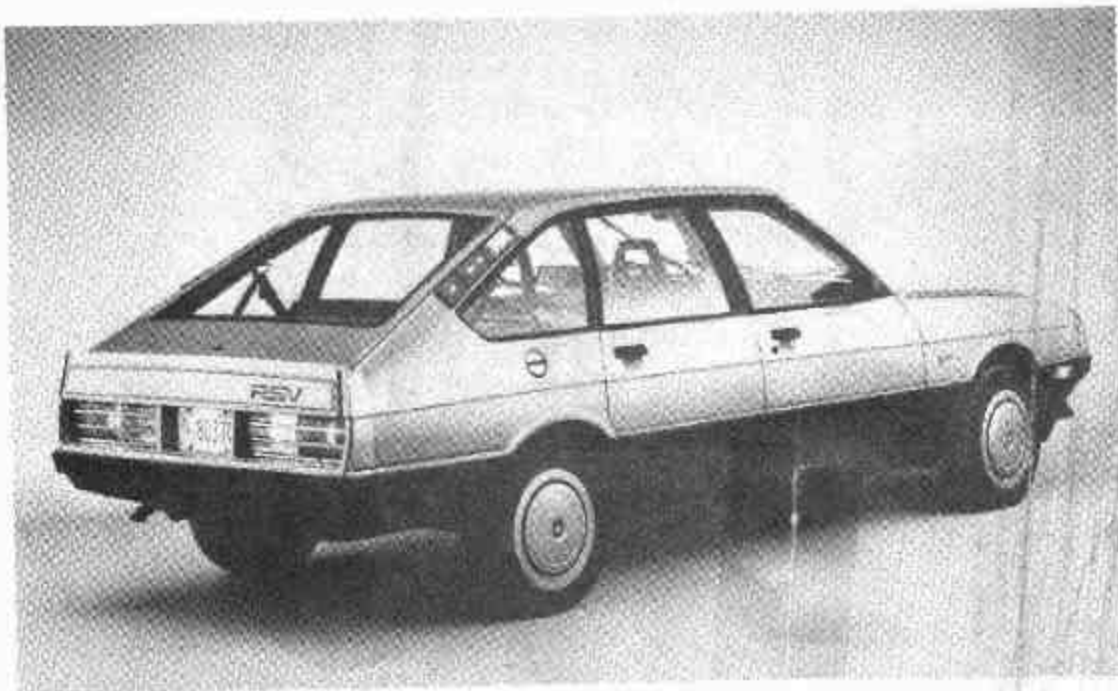
Figure 1. Calspan/Chrysler RSV

Figure 2. Calspan/Chrysler RSV

Figure 3. Calspan/Chrysler RSV

Figure 4. Calspan/Chrysler RSV

Although the RSV resembles the Simca 1308 from which it was derived, the shape forward of the windshield is all new and the wheel base almost three inches longer. In addition, the RSV has a new rear bumper and hatch lid. Wind tunnel testing led to the rounded front shape that is also beneficial for pedestrian impact protection. Other aerodynamic effects led to reduced size of the cooling air inlets, lower front end air dam, addition of front wheel flares, rear hatch lid spoiler, and smooth wheel covers, as well as removal of the rear segment of the drip rail (Figures 1 through 4).

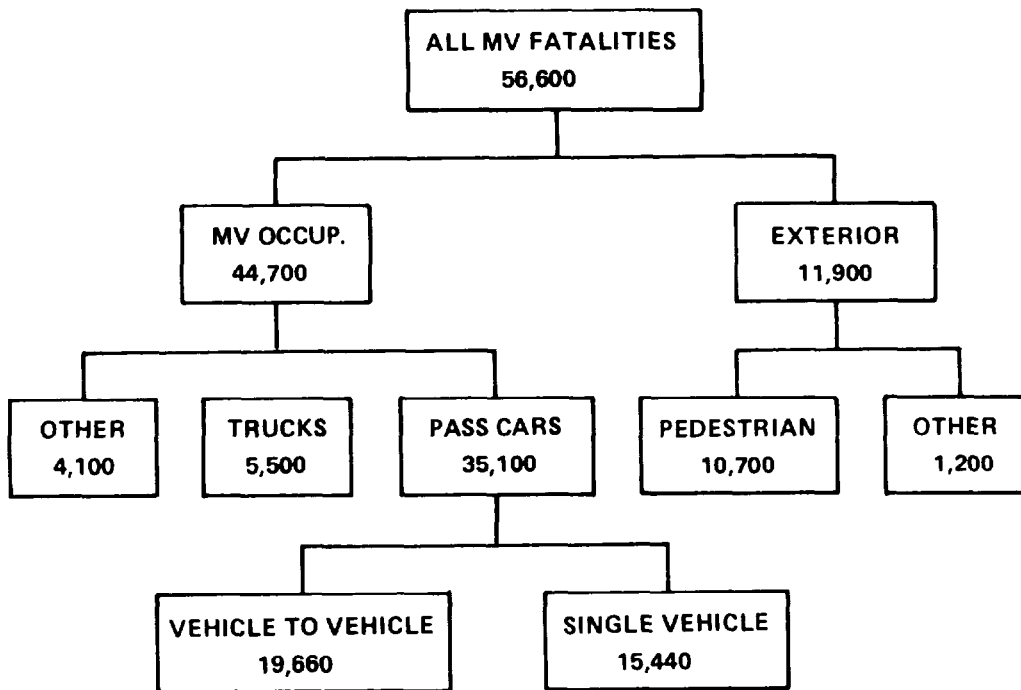
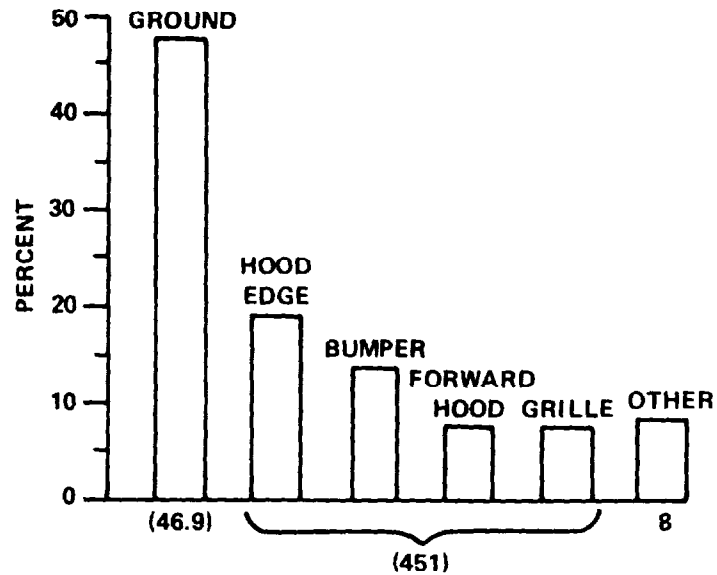
Figure 6 DISTRIBUTION OF U.S. TRAFFIC FATALITIES

Figure 7 INJURY PRODUCING ELEMENTS - ALL PEDESTRIAN INJURIES IN FRONT IMPACTS WITH FULL SIZE AMERICAN AUTOMOBILES

The Phase I study included analysis of the distribution of traffic fatalities in 1972. Some of the results are shown in Figures 6 and 7. The occupants of passenger cars represent 62 percent of the total. Pedestrians struck by vehicles make up another 19 percent. Reduction of fatalities and serious injuries in these categories would appreciably reduce the cost of transportation. In addition, a preponderous portion of pedestrian injuries arises from vehicle frontal impacts. Significant reductions in the pedestrian fatalities might be achieved by a new approach to the design of the front of the car. Such accident statistics in combination with a wide variety of background factors led to the RSV crashworthiness goals summarized in Figure 8.

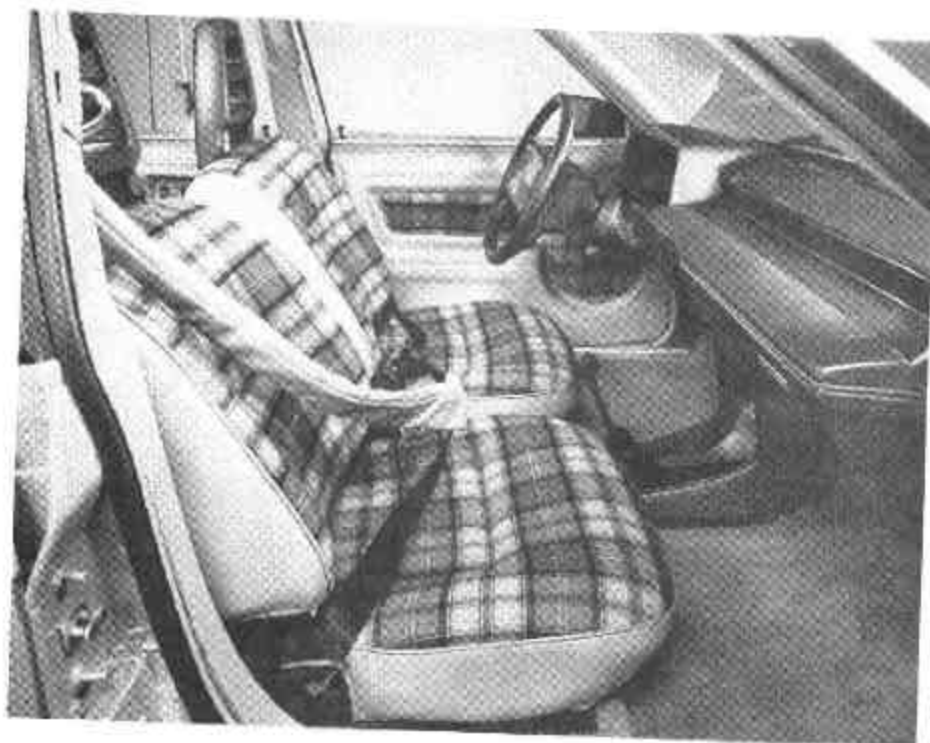
Figure 12. RSV Passenger Air Belt and Knee Blocker

Interior appearance also is similar to the Simca except for items needed to provide occupant protection in the attempt to realize the high speed impact goals (Figures 11, 12 and 13). Most noticeable among these changes are the thicker door trim pads with enclosed aluminum honeycomb energy absorbers for occupant protection during side impacts (Figure 14). The internal width of the RSV is, in fact, that of the Simca base car minus the space taken up by the additional energy absorbing padding on the sides. A decision was made for Phase III to proceed with the design and fabrication of the RSV on that basis rather than to spend the additional money required to provide the internal room needed to comfortably seat three people side-by-side. Energy absorbing foam attenuates head contact forces in side impacts. Aluminum honeycomb material reduces forces from knee impacts during frontal crashes (Figure 15). "See-through" head restraints are provided for front seat passengers both for improved driver visibility and for a feeling of added interior roomness. Automatic restraint systems, described later, are also major factors in the interior appearance.

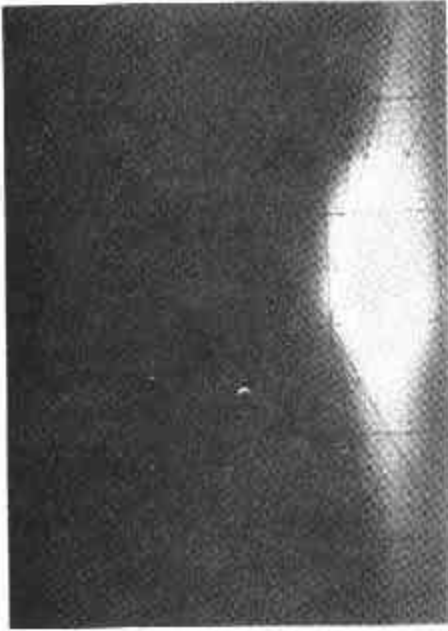
Figure 21 STANDARD TUNGSTEN SEALED BEAM LOW BEAM

RSV headlamps (Figure 20) have only one beam and use a plastic lens to attain precise aiming for improved lighting with reduced glare while effecting a weight savings (Figures 21 and 22). While not fully developed, this system could have safety advantages by providing better lighting, and eliminating improper beam usage. A suspension activated hydraulic headlamp aiming system is available to automatically compensate for vehicle loading and dynamic effects. High-level rear lamps are located on the rear roof pillars (Figure 23). They combine running, side-marker, stop, and turn functions in a highly visible location.

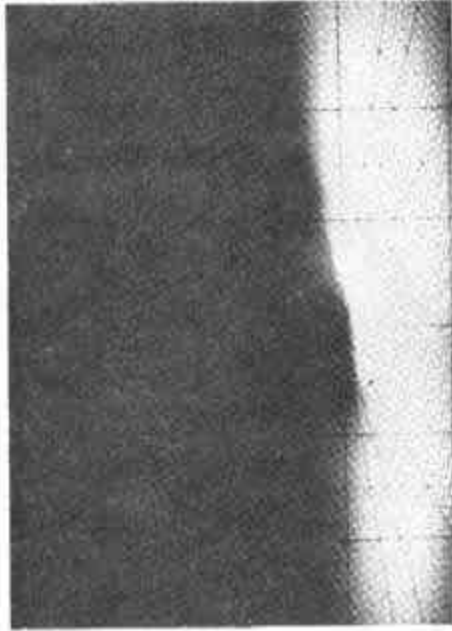
Figure 22 RSV HEADLIGHT BEAM

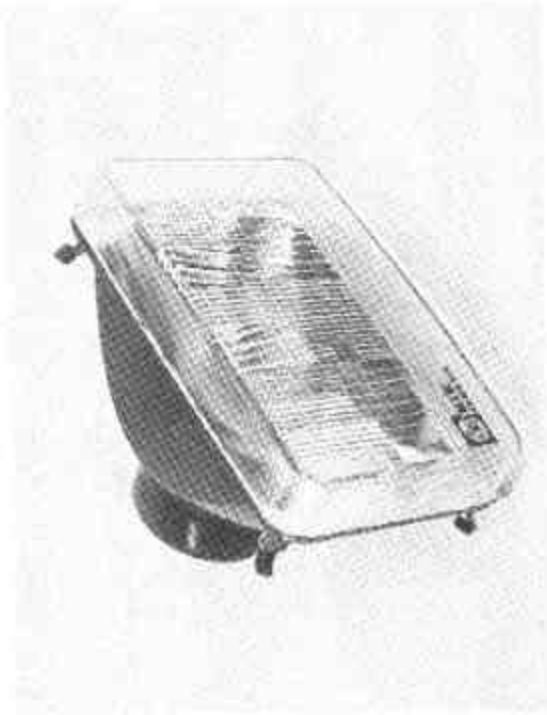
Figure 20 RSV PLASTIC HEADLAMP
